**MONITORING CONSTRUCTION ACTIVITIES AT THE
MIDDLETON PLACE MILL, 38DR16: PHASE TWO**

Michael Trinkley

Chicora Research Series 128

December 20, 1993

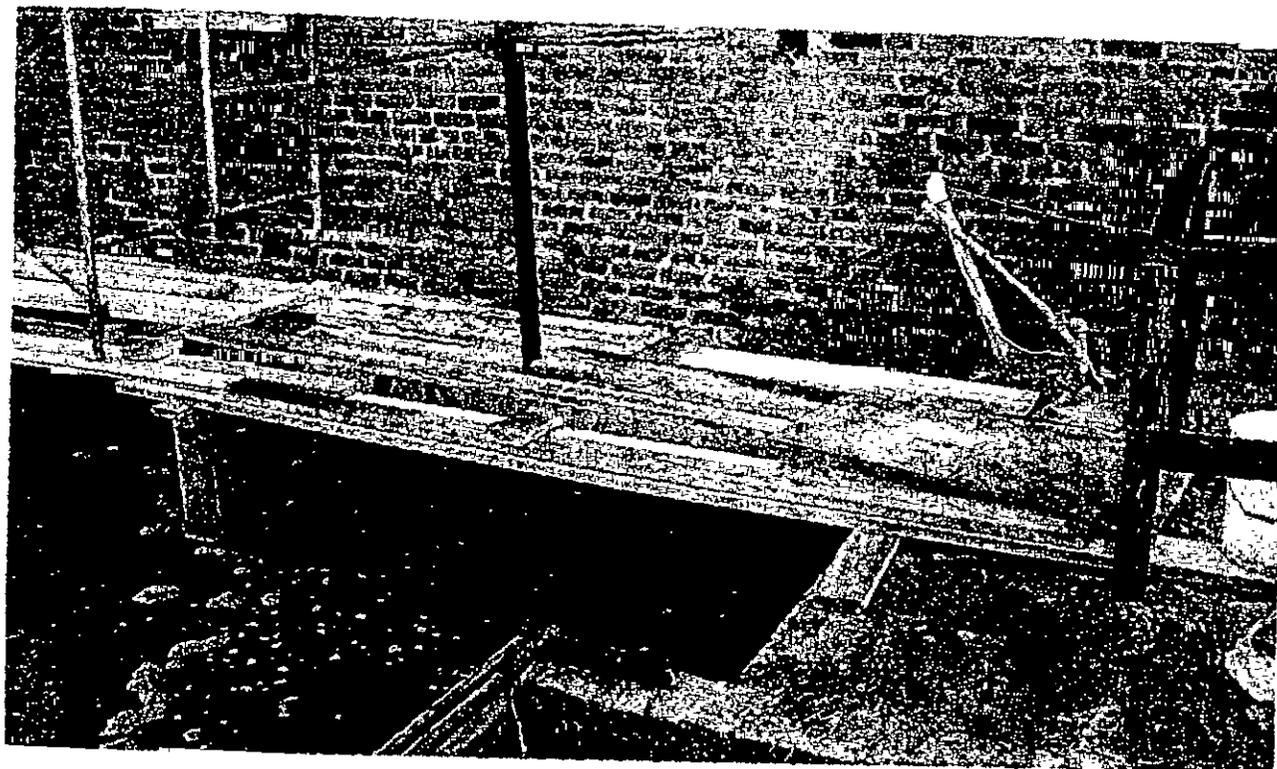
During our subsequent monitoring visit on December 17, we discovered that the contractor had disregarded this change notice -- not only placing scaffolding over and around the previously identified features, but had also mucked adjacent to the building and placed the originally proposed stucco coat (Figures 7 and 8). This work almost certainly resulted in the loss of significant archaeological information, through the construction of the scaffolding, the mucking of soil adjacent to the building foundation, the application of the stucco coat, and the possible exposure of the wood remains to damaging environmental fluctuations. At the time of our second phase of monitoring the tide was again high, so we can not determine the amount of this damage. Nor could we determine if the area was stabilized to prevent additional damage through erosion, periodic wetting and drying, and growth of vegetation.

Figure 7. Scaffolding placed over and around area removed from the scope of work.

At this point it seems likely that the most serious damage has been done. We do, however, recommend that the mill be examined at the lowest possible tide to determine if any measures can be taken to minimize the damage and secure the archaeological features.
