**Compliance and Implementation  
Monitoring of Forestry  
Best Management Practices  
For Harvesting in South Carolina  
2007-2008**

**Guy Sabin  
Environmental Program Manager  
South Carolina Forestry Commission**

**Best Management Practices  
Monitoring Report BMP-7**

Published by the South Carolina Forestry Commission, Columbia, SC July 2009

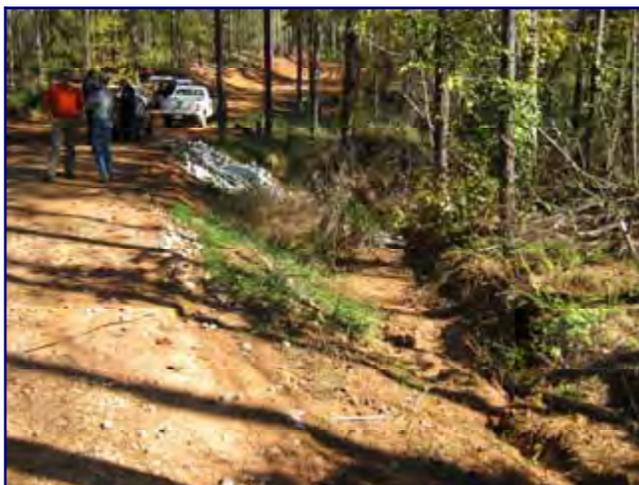
In this survey, 7% of sites surveyed for compliance with BMPs involved the construction or improvement of haul road stream crossings. Of these, one site was rated as inadequate due to a road ditch that emptied directly into a stream and caused a water quality impact.

*Road ditch feeding into stream.*

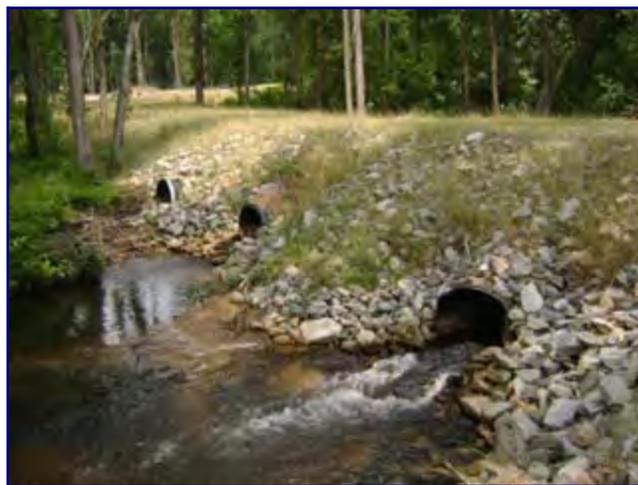
*Excellent culvert installation.*

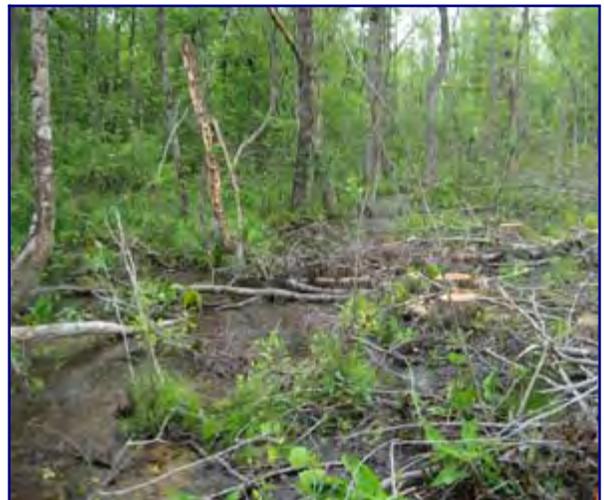
Perennial or intermittent streams were present on 48% of the sites included in this monitoring survey. Three sites were rated as inadequate primarily because of excessive harvesting within the SMZ.

*Inadequate SMZ*

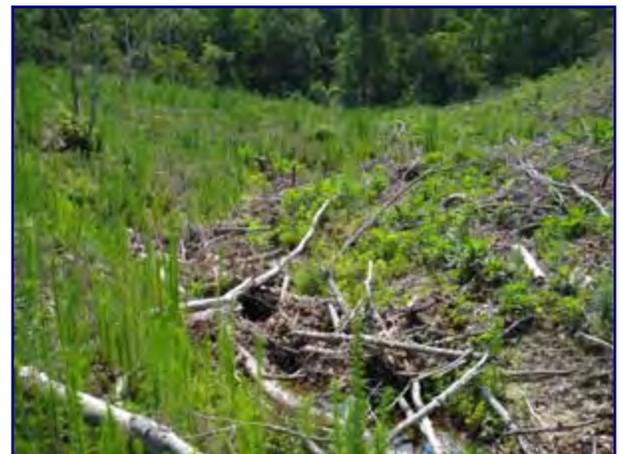
*Excessive debris in an intermittent stream*

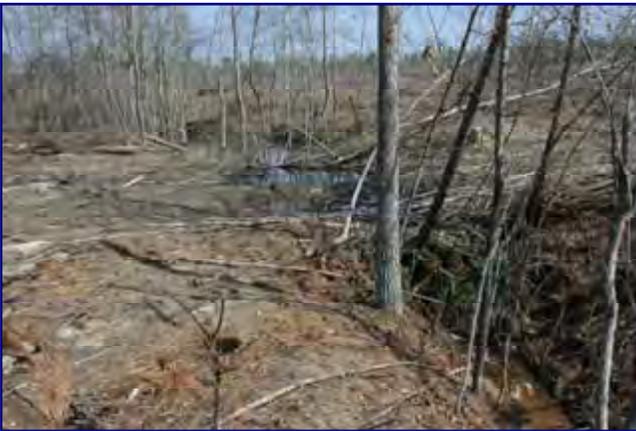
Three sites were rated as inadequate primarily because of failure to stabilize skid trails and failure to remove temporary crossings.

*From top left, use of bridge mats to cross ephemeral stream; a properly removed and stabilized skid trail crossing; a temporary debris crossing left in place; excessive rutting.*

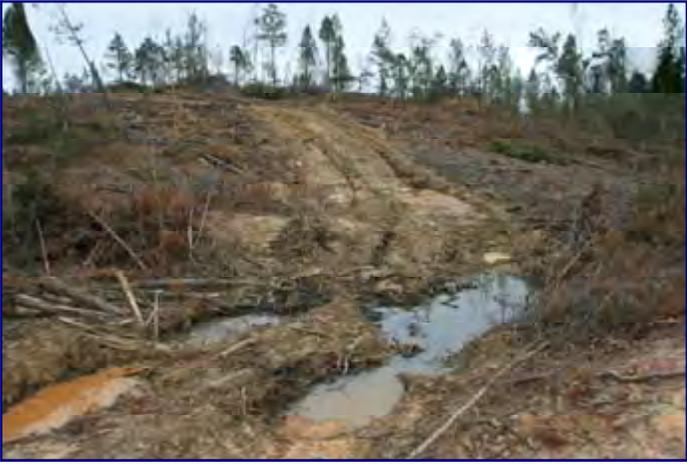
*Left, Failure to stabilize a skid trail; Right, A temporary skid trail crossing.*

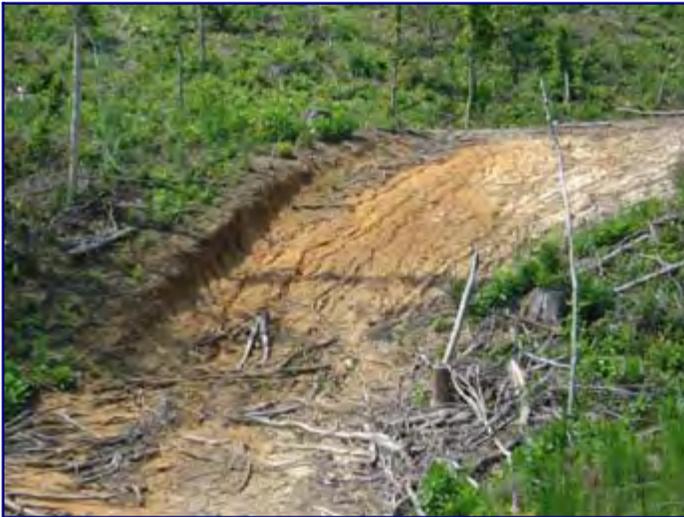
*Unstabilized approach to skid trail crossing.*

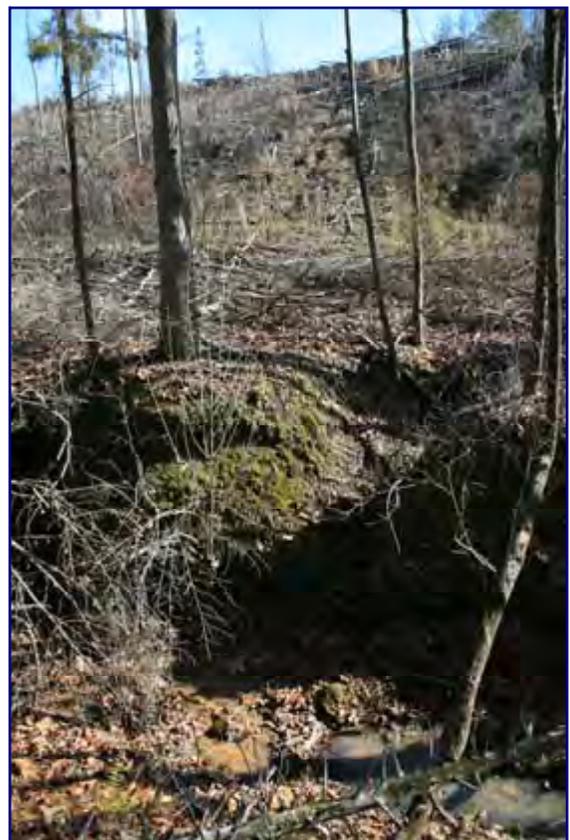
*Skid trail on steep slope causing water quality impact.*

The sites with Inadequate overall compliance failed in the categories of Harvesting Systems and Streamside Management Zones. Both sites were on erosive upland clay soils with relatively steep slopes. A total of 16 specific deficiencies in BMP implementation were identified on the two sites, including:

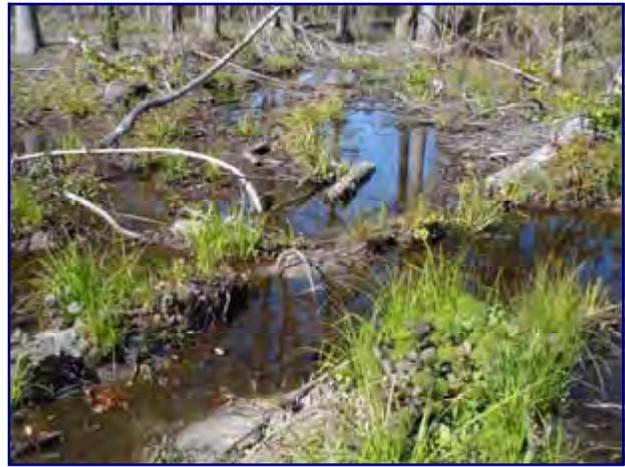
*Left, a view of the tributary stream on Florence 1; right, rutting at a crossing location.*

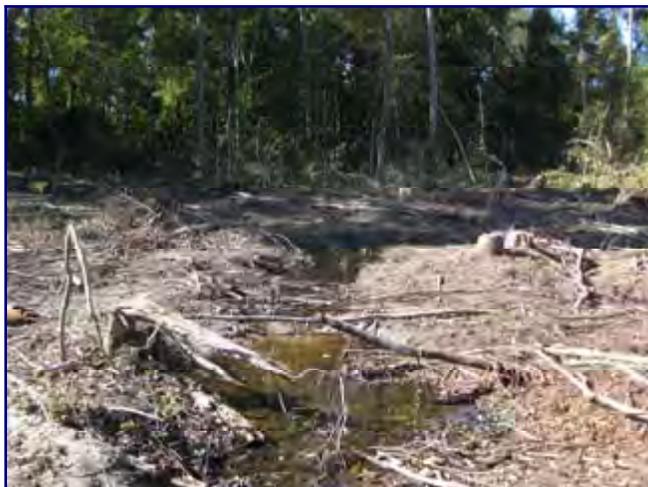
The site included multiple skid trail stream crossings, skidding within the SMZ, and stream banks that were not protected. The site was clearly not in compliance with SC BMPs for Forestry, but the group was evenly split in judging whether a water quality impact was present.

*Stream and skid trail crossing on site Kingtree 1.*

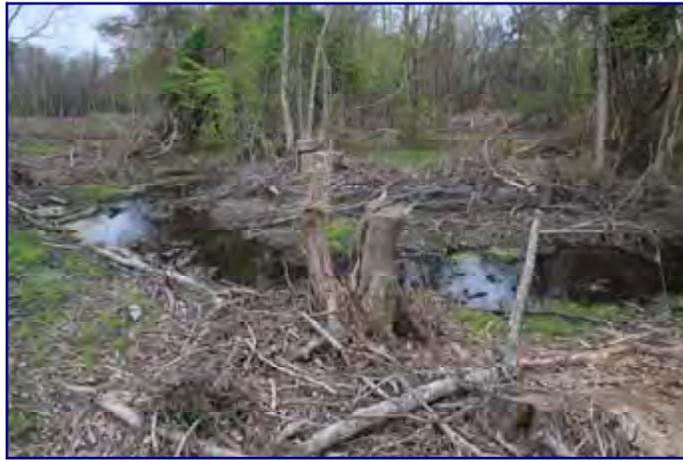
*A poorly planned skid trail crossing on Kingstree 1, with skidding in SMZ.*

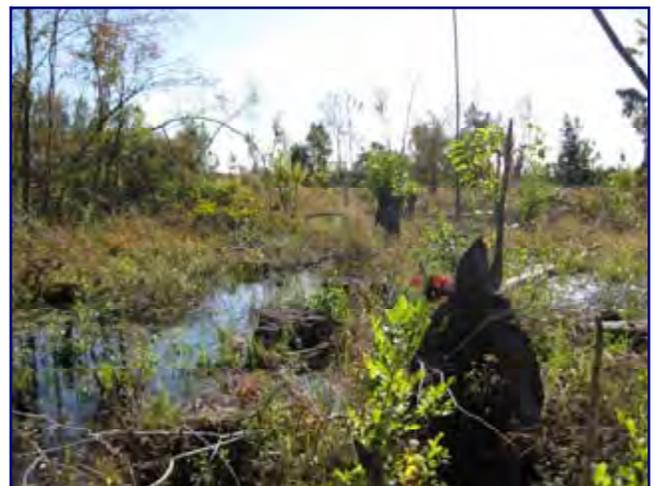
This site was rated as Inadequate by five of six reviewers, resulting in agreement of 83%. All reviewers rated Streamside Management Zones as insufficient, and three failed the Harvesting Systems category. The single reviewer who rated the site as Adequate overall qualified that decision with notes that the site was extremely difficult to call, and would require additional resources such as aerial imagery and a more thorough evaluation of the entire site to determine the relationship between this stream and the main channel in order to make a conclusion.

*Left, stream section with adequate SMZ; right, further down the same stream a SMZ was not retained on Kingstree 2.*

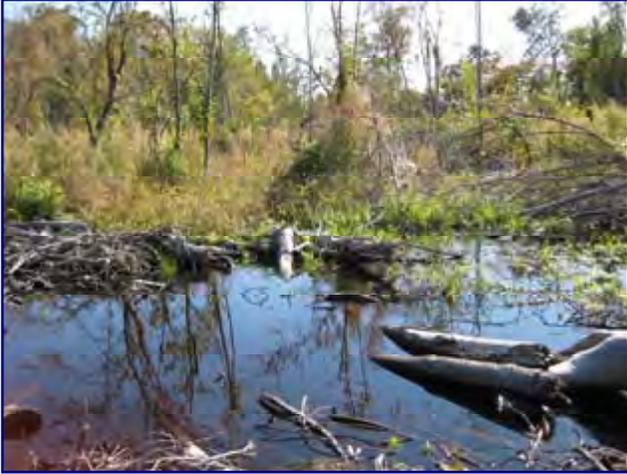
*Left, a skid trail crossing location; right, a reviewer checks algae growth in the stream on Kingstree 2.*
