Implementation Monitoring
of
FORESTRY
BEST MANAGEMENT PRACTICES

on Harvested Sites
in
South Carolina

**Best Management Practices
Monitoring Report BMP-2**

Published by the South Carolina Forestry Commission
Columbia, South Carolina
September, 1994

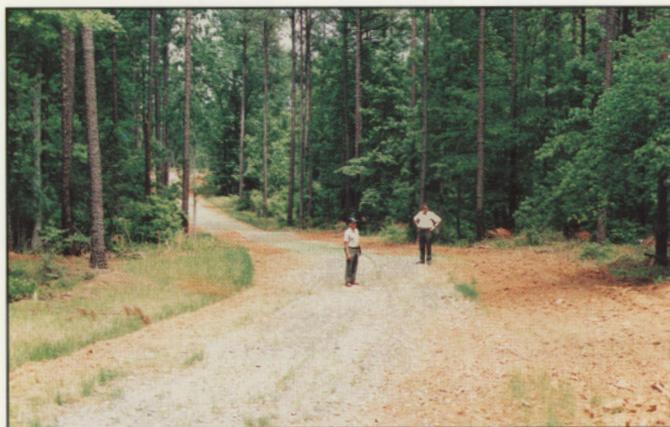
Picture 1. The use of rock surfacing, broad-based dips, and seeding the road shoulders with grass created stable conditions on this road.

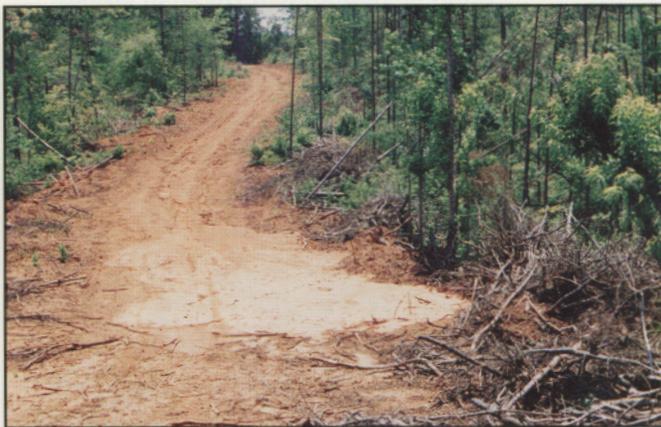
Inadequate ratings were due to the lack of adequate water diversion structures and emptying of road ditches directly into streams. All nine sites with inadequate road systems lacked adequate water diversion structures, and eight of these nine sites had road ditches which emptied directly into streams. Road layout, filter strip width, and road slope were not significant problems on a state-wide basis.

Picture 2. The lack of water diversion structures on this road resulted in erosion and deposition of sediment downhill.

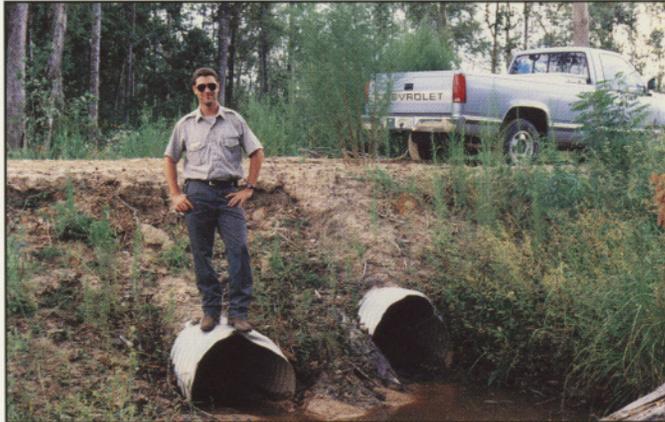
Picture 3. Proper construction of culverted stream crossings include using culverts that are long enough to extend beyond the toe of the fill, sizing culverts for expected storm flows, and stabilization of fill material.

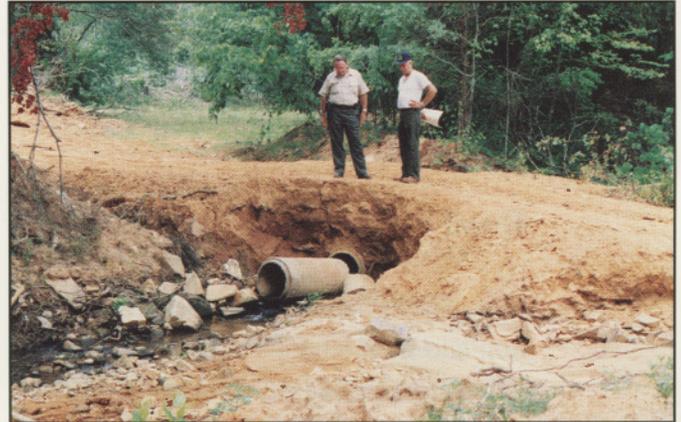
Picture 4. Lack of road water diversion structures uphill of this road stream crossing allowed road runoff to erode fill material.

The most common type of road stream crossing was the installation of culverts with soil fill. Sites with adequate ratings tended to utilize all stream crossing methods where appropriate. Sites with inadequate ratings tended to rely on two types of crossings, culvert with soil fill crossings and debris fill crossings with a soil cap. All crossings that were inspected were generally unavoidable. Where culverted crossings received inadequate ratings, the culverts were generally undersized or improperly installed, and fill material was not stabilized. The impact of poorly designed crossings was generally visible downstream.

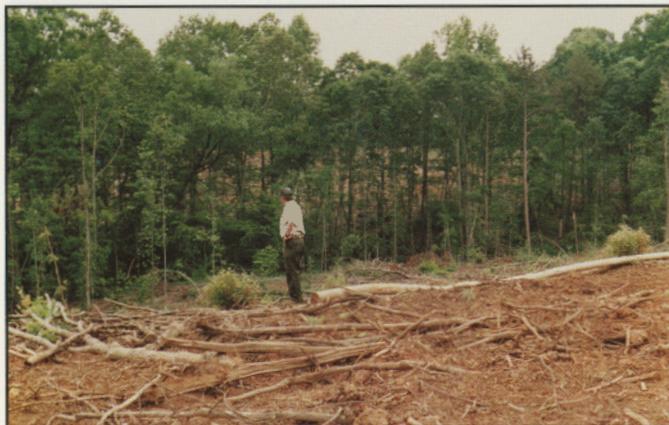
Picture 5. SMZs are useful in breaking up the visual impact of the clearcut, serving as wildlife corridors, and filtering out sediment from runoff.

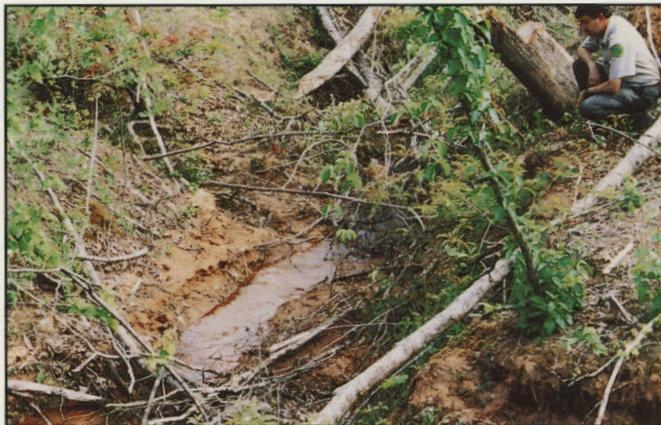
A slightly higher percentage of sites with inadequate SMZs occurred where slopes exceeded 20%. Inadequate SMZs were generally due to the total absence of SMZs rather than SMZs being narrower than recommended. In evaluating SMZs, the team did not find an SMZ inadequate if it was only slightly narrower than the recommended width. Inadequate ratings were attributed to the indiscriminant use of vehicles in the SMZ, the introduction of woody debris in the stream, and the movement of sediment across narrow SMZs.

Picture 6. Removal of SMZs allowed runoff from eroding skid trails to deposit fresh sediment in the stream.

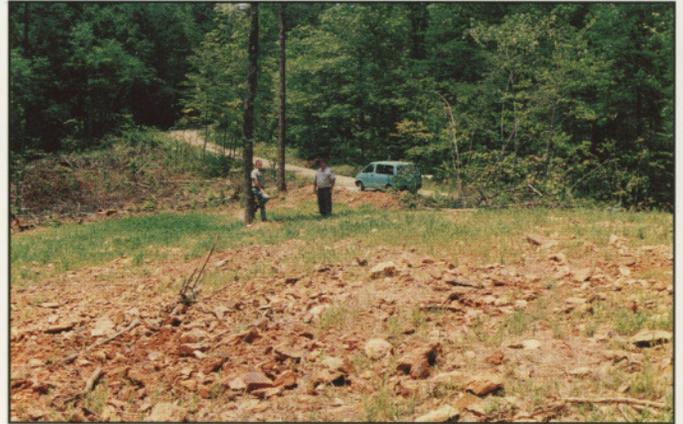
Picture 7. This log deck was correctly placed on high ground away from drainages. Upon completion of the harvest, the deck was seeded with grass.

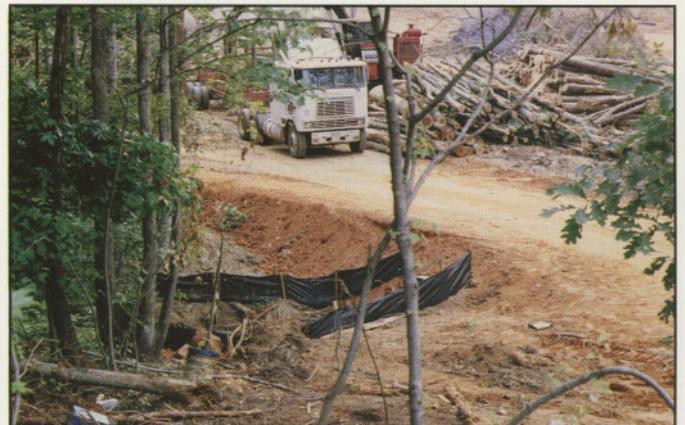
Picture 8. How many log deck BMP violations can you find in this photo? The deck is placed on low ground, concentrating roads, skid trails, and the resulting runoff into the nearby stream. Also, the deck is actually within the SMZ as is the oil and hydraulic fluid which are visible in the foreground.

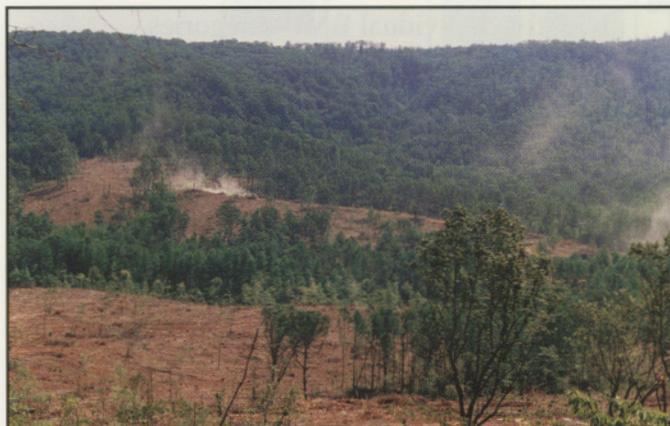
Picture 9. The skid trails on this property were designed to follow the ridge lines and eliminate any unnecessary stream crossings.

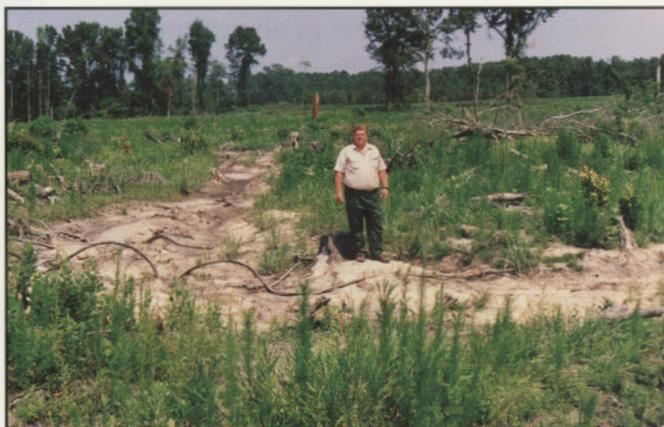
Picture 10. The primary skid trail on this low-lying property followed the sandy stream channel. Although a common practice in the past, current BMPs recommend skidding within the stream channel only in isolated, well-designed crossings.
