SOUTH CAROLINA AERONAUTICS COMMISSION

STATEWIDE AIRFIELD PAVEMENT MANAGEMENT SYSTEM UPDATE

BBP - Marlboro County Jetport - H.E. Avent Field

2023

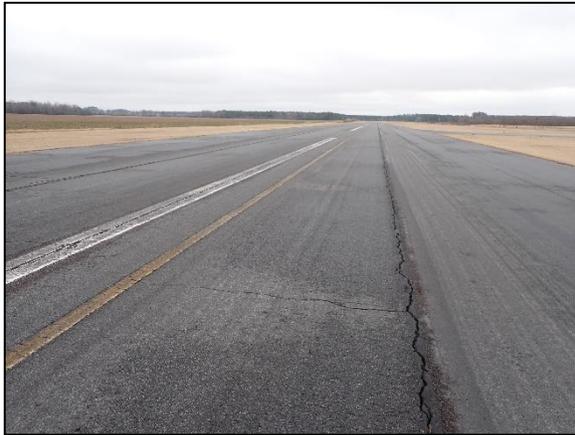
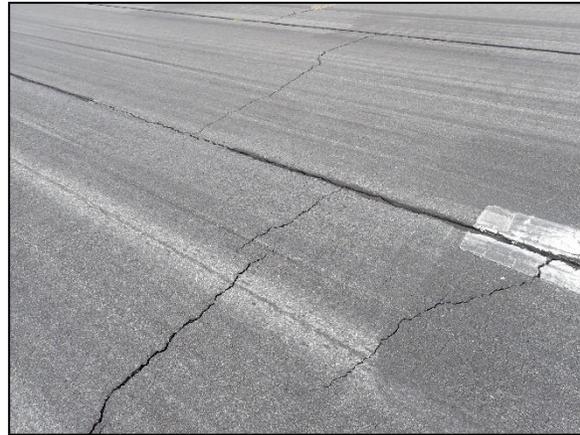
RW 7-10

Section ID	Area (SF)	Surface	Est. Last Major Work Year	Est. Last Global Treatment Year	PCI	Condition Rating	PCI % Climate	PCI % Load	PCI % Other
10	375,226	AAC	1998	2010	60	Fair	100	0	0

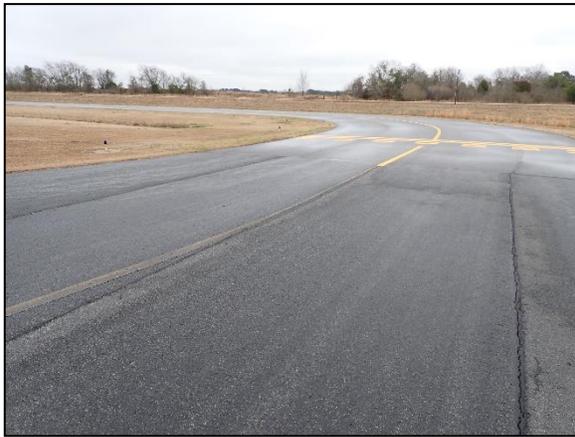
TW A-10

Section ID	Area (SF)	Surface	Est. Last Major Work Year	Est. Last Global Treatment Year	PCI	Condition Rating	PCI % Climate	PCI % Load	PCI % Other
10	2,777	AAC	1998	-	65	Fair	100	0	0
20	75,720	AAC	1998	2010	65	Fair	100	0	0
30	20,470	AC	1998	2010	62	Fair	100	0	0
40	111,246	AAC	2022	-	100	Good	0	0	0

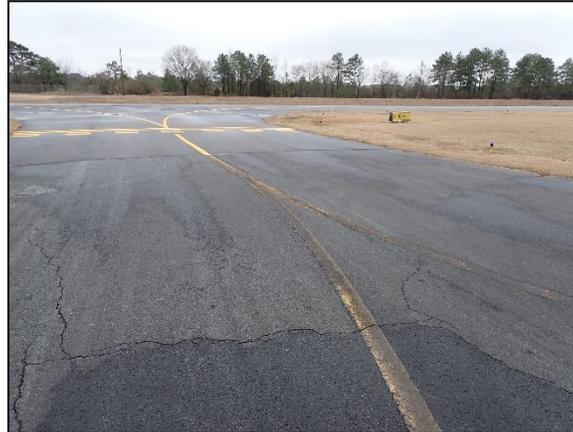
TW A1-10

Section ID	Area (SF)	Surface	Est. Last Major Work Year	Est. Last Global Treatment Year	PCI	Condition Rating	PCI % Climate	PCI % Load	PCI % Other
10	3,413	AAC	1998	2010	69	Fair	100	0	0
20	4,433	AAC	2022	-	100	Good	0	0	0

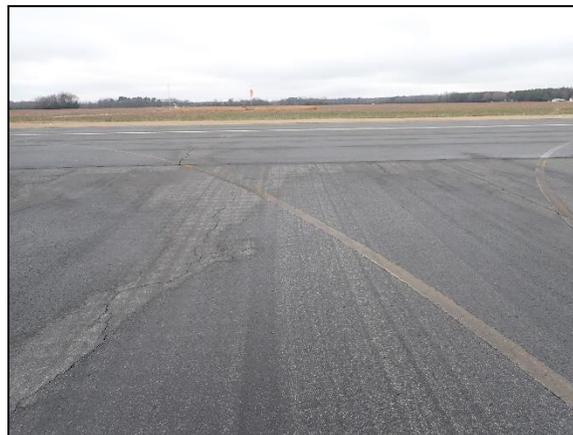
TW A2-10

Section ID	Area (SF)	Surface	Est. Last Major Work Year	Est. Last Global Treatment Year	PCI	Condition Rating	PCI % Climate	PCI % Load	PCI % Other
10	3,413	AAC	1998	2010	68	Fair	100	0	0
20	4,433	AAC	2022	-	100	Good	0	0	0
30	5,154	AC	2021	-	100	Good	0	0	0

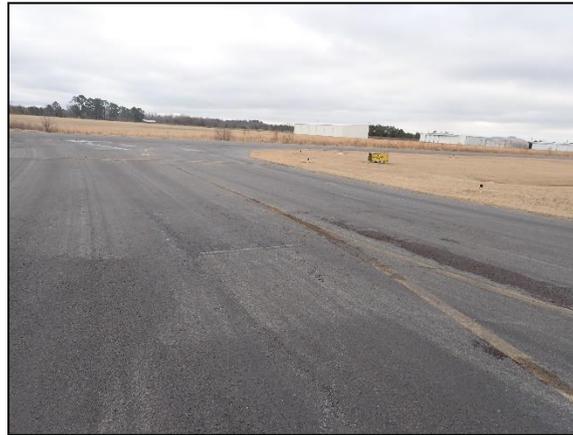
TW A3-10

Section ID	Area (SF)	Surface	Est. Last Major Work Year	Est. Last Global Treatment Year	PCI	Condition Rating	PCI % Climate	PCI % Load	PCI % Other
10	7,846	AAC	1998	2010	69	Fair	100	0	0

BBP	TW A2	10	WEATHERING	Medium	341	SF	10.0%	Stopgap	Surface Seal	341	SF	\$ 1.65	\$ 570
BBP	TW A3	10	L & T CR	Medium	125	LF	1.6%	Stopgap	AC Crack Sealing Narrow	125	LF	\$ 3.50	\$ 440
BBP	TW A3	10	WEATHERING	Medium	389	SF	5.0%	Stopgap	Surface Seal	389	SF	\$ 1.65	\$ 650

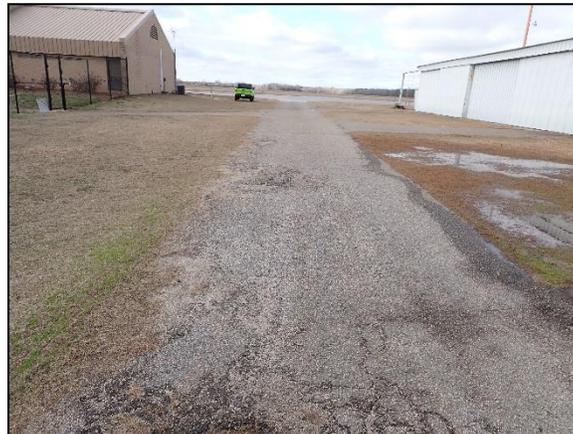
TL 01-10

Section ID	Area (SF)	Surface	Est. Last Major Work Year	Est. Last Global Treatment Year	PCI	Condition Rating	PCI % Climate	PCI % Load	PCI % Other
10	6,126	AC	1990	-	27	Very Poor	64	36	0

BBP	TL 01	10	RAVELING	Medium	4,372	SF	71.4%	Stopgap	Surface Seal	4,372	SF	\$ 1.65	\$ 7,220
BBP	TW A	10	L & T CR	Medium	32	LF	1.2%	Stopgap	AC Crack Sealing Narrow	32	LF	\$ 3.50	\$ 120
BBP	TW A	10	WEATHERING	Medium	278	SF	10.0%	Stopgap	Surface Seal	278	SF	\$ 1.65	\$ 460
BBP	TW A	20	L & T CR	Medium	386	LF	0.5%	Stopgap	AC Crack Sealing Narrow	386	LF	\$ 3.50	\$ 1,360
BBP	TW A	20	WEATHERING	Medium	3,786	SF	5.0%	Stopgap	Surface Seal	3,786	SF	\$ 1.65	\$ 6,250
BBP	TW A	30	L & T CR	Medium	926	LF	4.5%	Stopgap	AC Crack Sealing Narrow	926	LF	\$ 3.50	\$ 3,250
BBP	TW A	30	WEATHERING	Medium	1,024	SF	5.0%	Stopgap	Surface Seal	1,024	SF	\$ 1.65	\$ 1,690
BBP	TW A1	10	L & T CR	Medium	49	LF	1.4%	Stopgap	AC Crack Sealing Narrow	49	LF	\$ 3.50	\$ 180
BBP	TW A1	10	WEATHERING	Medium	341	SF	10.0%	Stopgap	Surface Seal	341	SF	\$ 1.65	\$ 570
BBP	TW A2	10	L & T CR	Medium	62	LF	1.8%	Stopgap	AC Crack Sealing Narrow	62	LF	\$ 3.50	\$ 220

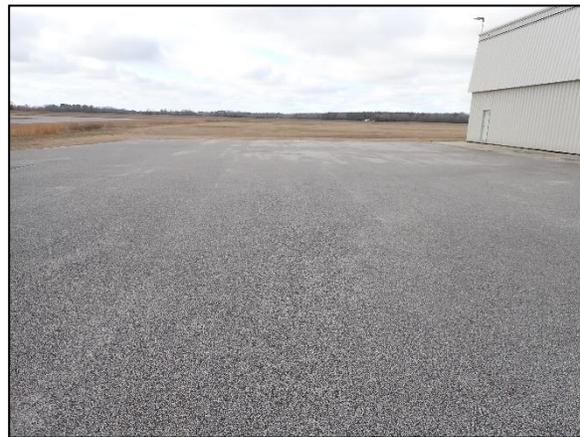
AP 01-30

Section ID	Area (SF)	Surface	Est. Last Major Work Year	Est. Last Global Treatment Year	PCI	Condition Rating	PCI % Climate	PCI % Load	PCI % Other
10	57,390	AC	2021	-	100	Good	0	0	0
20	89,052	AC	2009	-	74	Satisfactory	100	0	0
30	11,911	AC	2017	-	80	Satisfactory	100	0	0
