South Carolina Brick Masonry - Green Forever

Insights in Preservation and Restoration

South Carolina Preservation Month Workshop, May 14, 2010

Denis A. Brosnan, PhD, PE

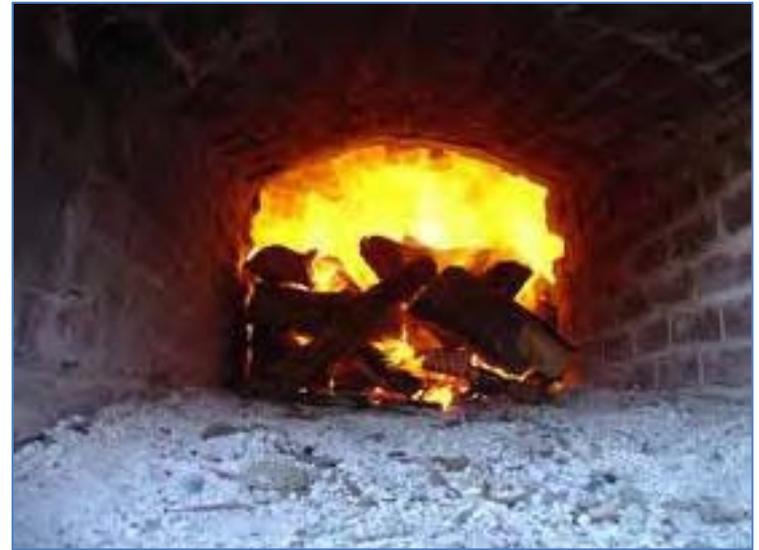
Limestone or sea shells (CaCO_3) are “burned” in a pit or a kiln, the latter sometimes called a “shaft kiln”, to a temperature of at least 800°C (1475°F) to produce lime (CaO). The lime is mixed with sand and water to constitute the mortar. It “sets” on reaction with CO_2 in the atmosphere. *A good example of a colonial lime kiln can be seen at the Santee Canal Park.*

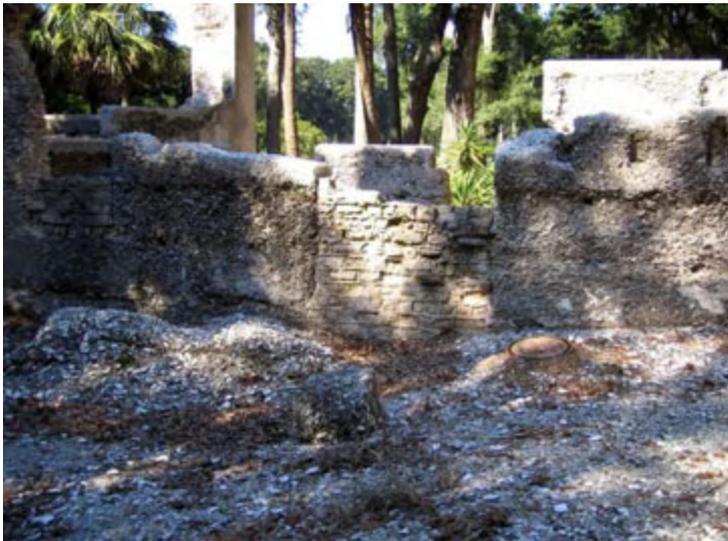
Tabby foundation with bricks and tabby mortar under door opening; Ruins of the Sams Plantation House (1786), Dataw Island, SC.

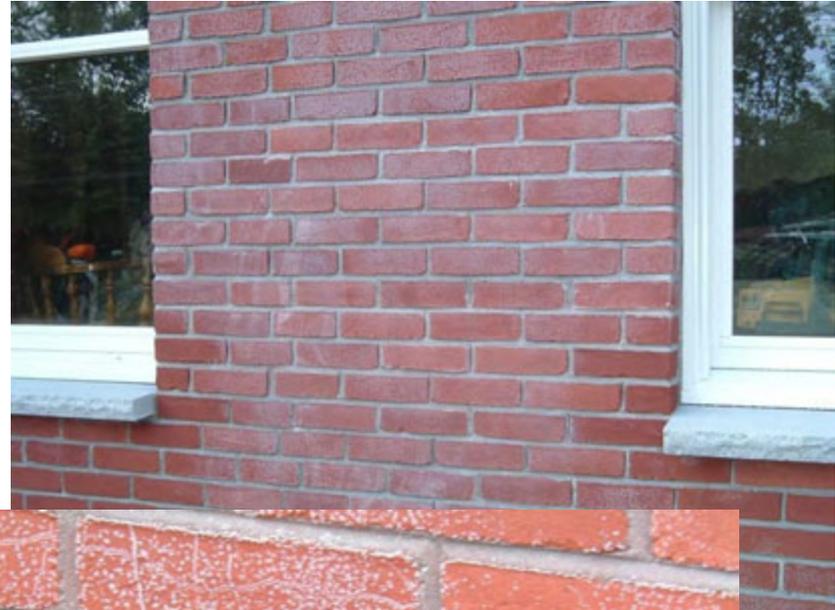
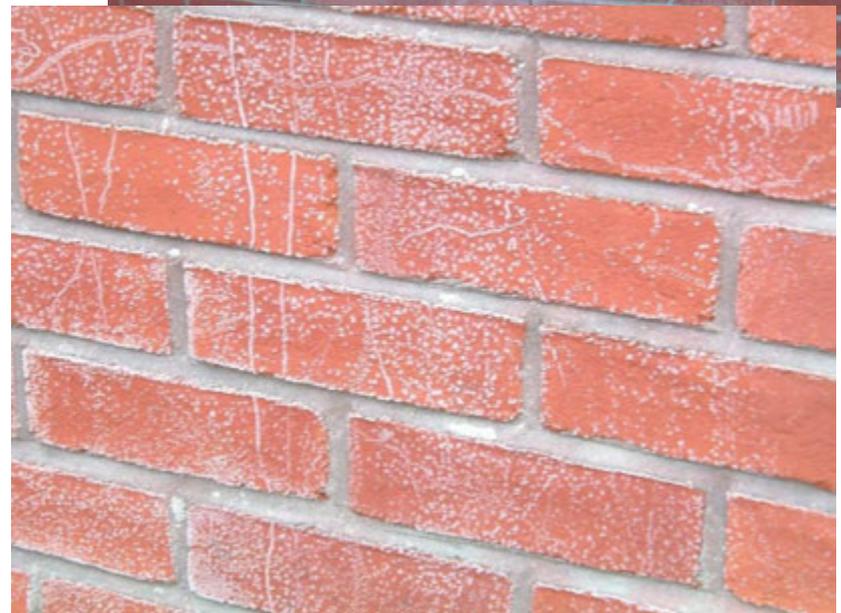
- Efflorescence is a discoloration due to the deposition of soluble salts on the surface of a masonry wall during a “drying period”.
- Wetting is essential for efflorescence to develop – more water is usually linked to more efflorescence.

USE CARE! I do not recommend use of masonry cements or mortar cements in ANY historic preservation and restoration effort without careful laboratory evaluation of its efflorescence potential.

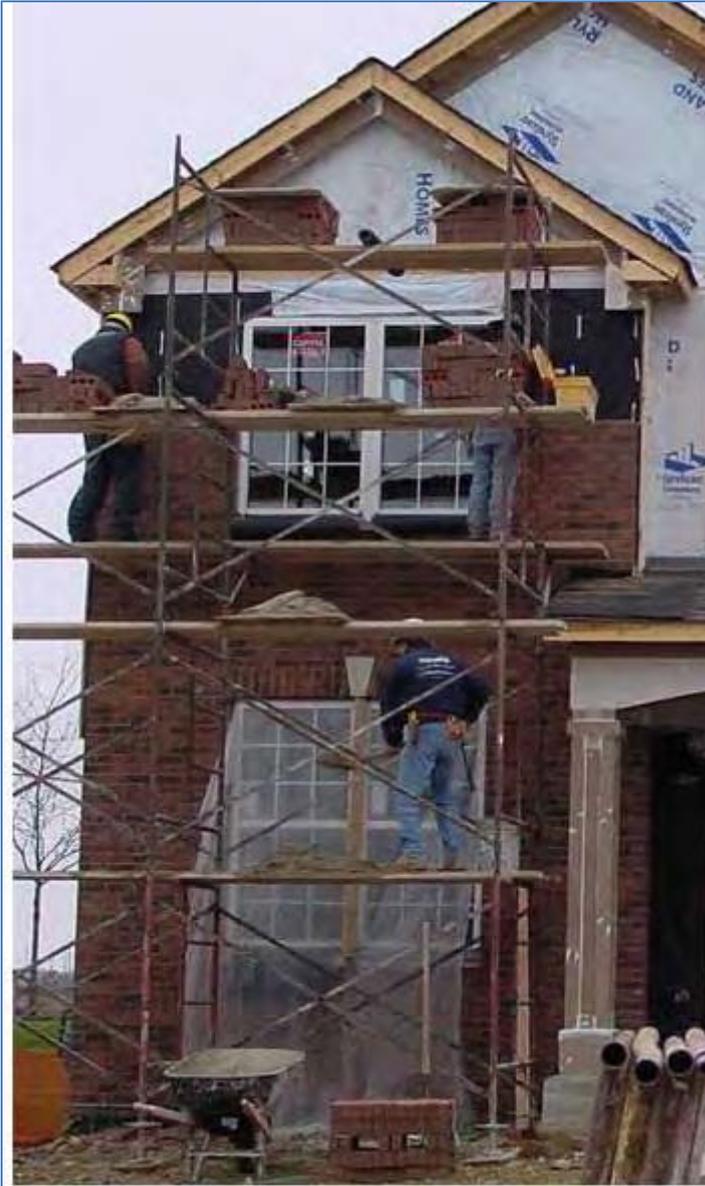
Wood Frame Structure with Brick Veneer.
Technically: Drainage Wall Construction

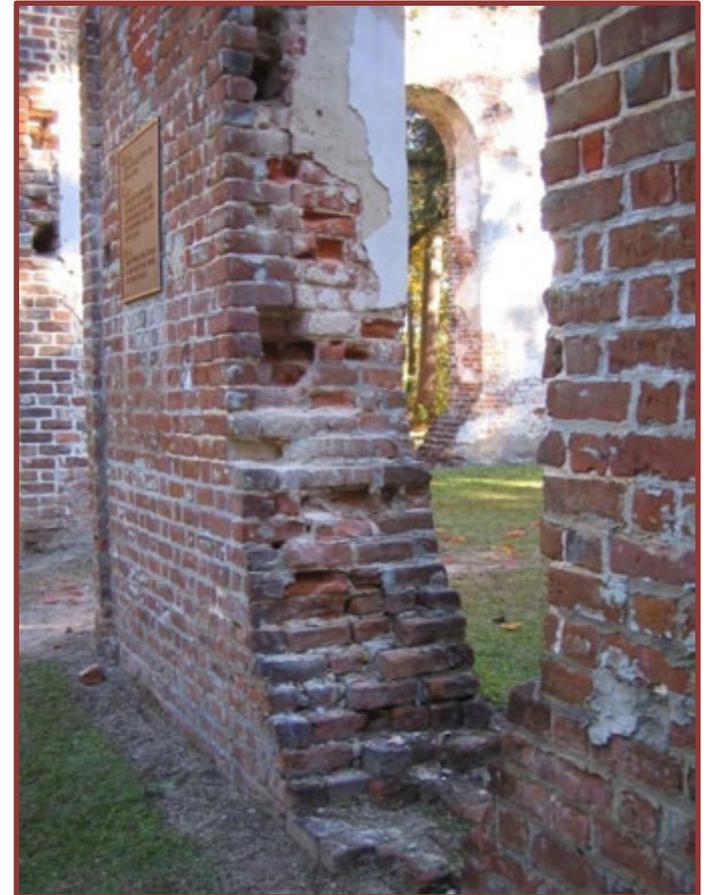
Load Bearing Wall Sheldon Church
Technically: Barrier Wall Construction

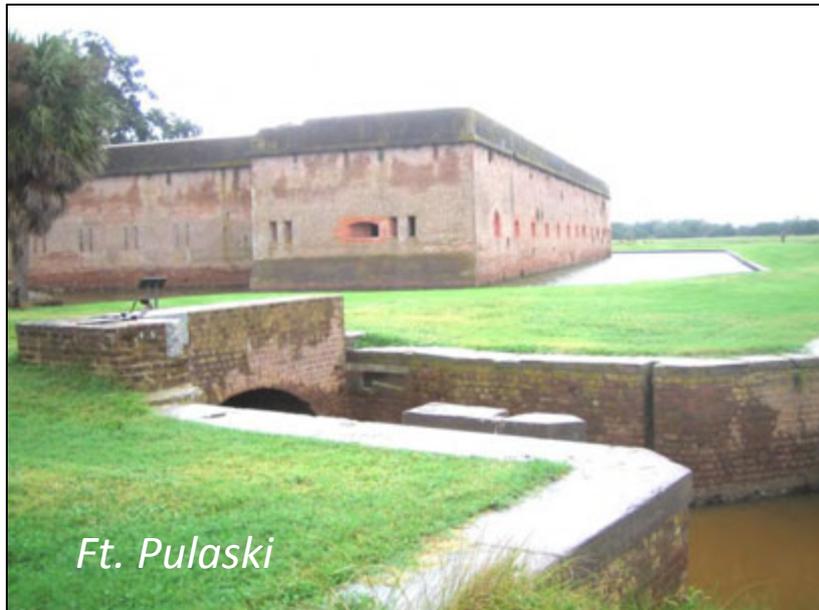
Ft. Pulaski

The solubility of calcium carbonate in water is 0.0014 grams in 100 cubic centimeters. This is sufficient for the long-term destruction of the carbonate phase in lime based mortars. Salts from ground water or sea water exacerbate the solution of the lime. This is frequently seen when there is pooling of water in a foundation.

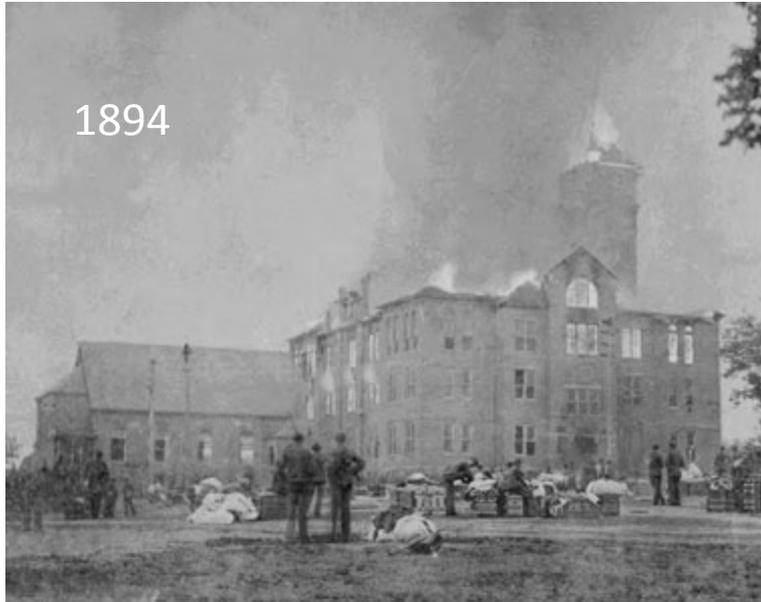
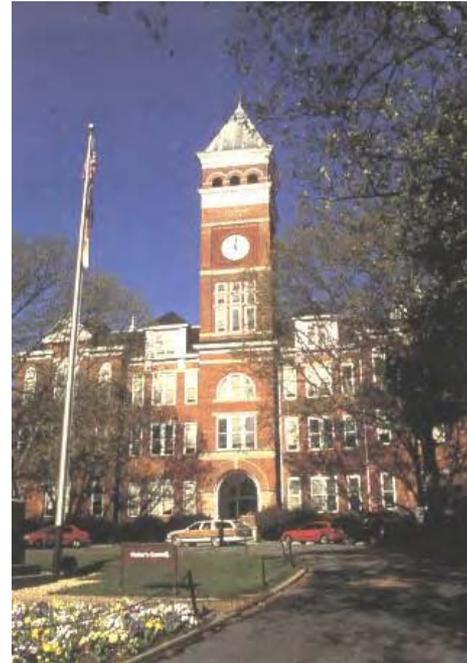
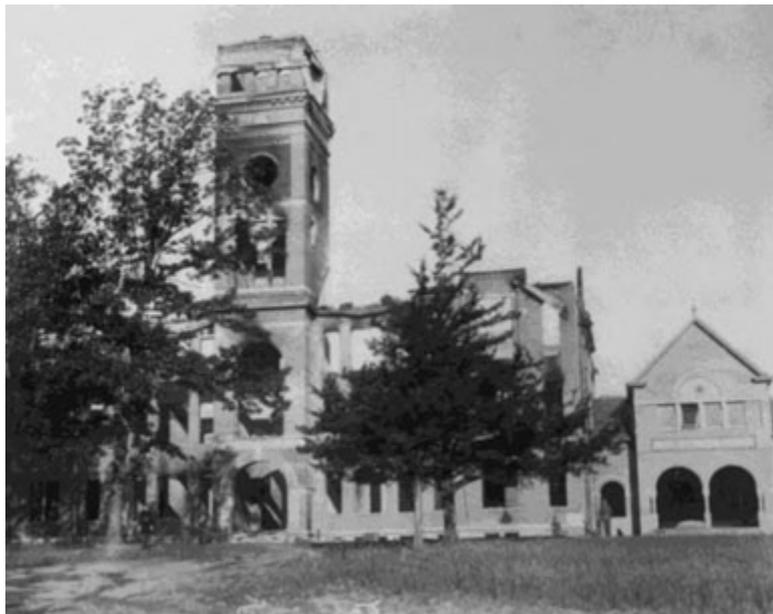
Calcium carbonate decomposes before 1775°F . Modern engineers think this destroys the mortar joint. What they don't know is that the mortar will "re-carbonate" *given enough time*. It was common practice prior to WWII to reuse the load bearing shell of a building after a fire.

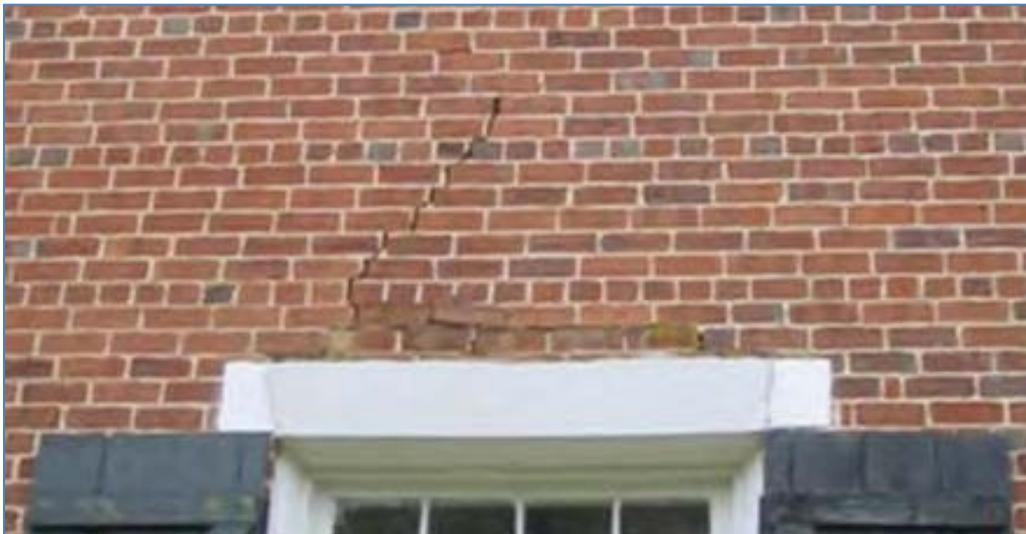
It is fairly common to see cracks in the mortar joint where foundation subsidence provides a “familiar” stepwise crack up the masonry (below).

On a corner, forces where walls meet may cause fractures through bricks suggesting movements were caused, in part, by thermal expansion of the walls.

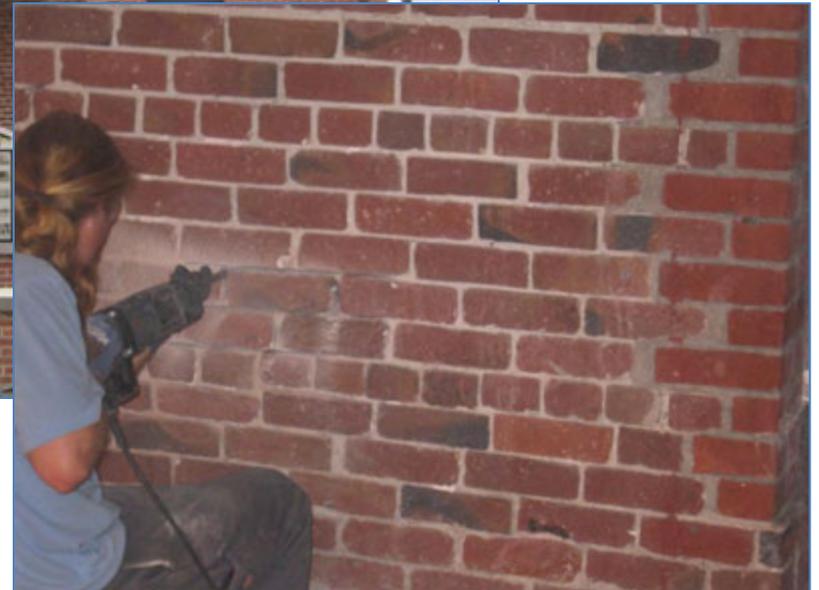
← The 1907 brick was hand molded, and contains some mineral phases only attributable to the San Francisco area.

The 1967 replacement bricks were hand molded and did not meet ASTM C 216 SW property values suggesting they were of Mexican origin. →

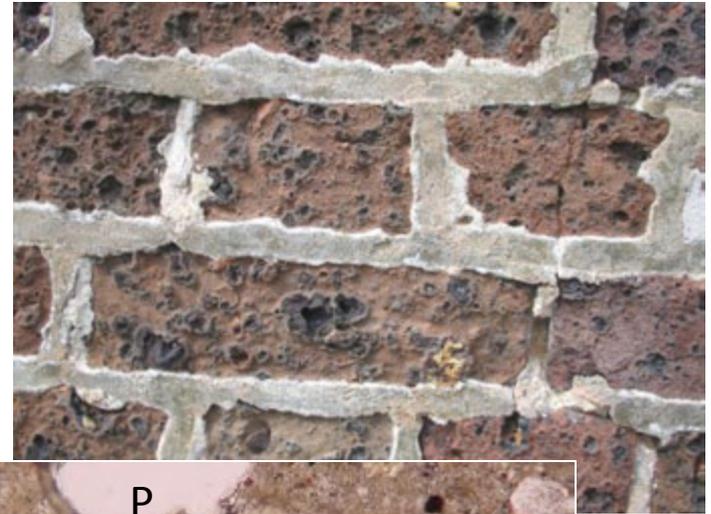
Pointing – periodic replacement of surface mortar is required to maintain effective barriers to the elements. Pointing mortars are lightly “sanded” to form a smooth surface.

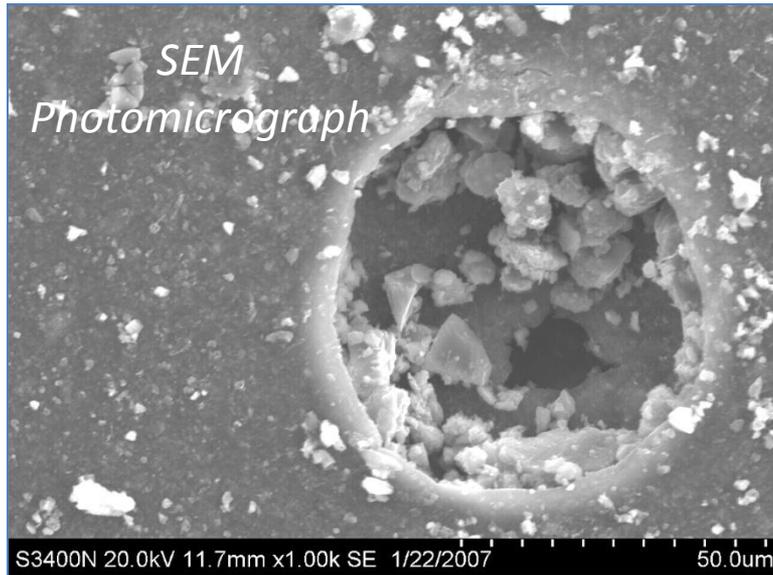
“Pinhole” in Coating With Salt Crystals Visible
