FORENSIC ARCHAEOLOGICAL
EXAMINATION OF A DISPUTED
SURVEY MONUMENT

FORENSIC ARCHAEOLOGICAL EXAMINATION OF A DISPUTED SURVEY MONUMENT

Prepared by:
Michael Trinkley, Ph.D.
and
Debi Hacker

September 26, 1996

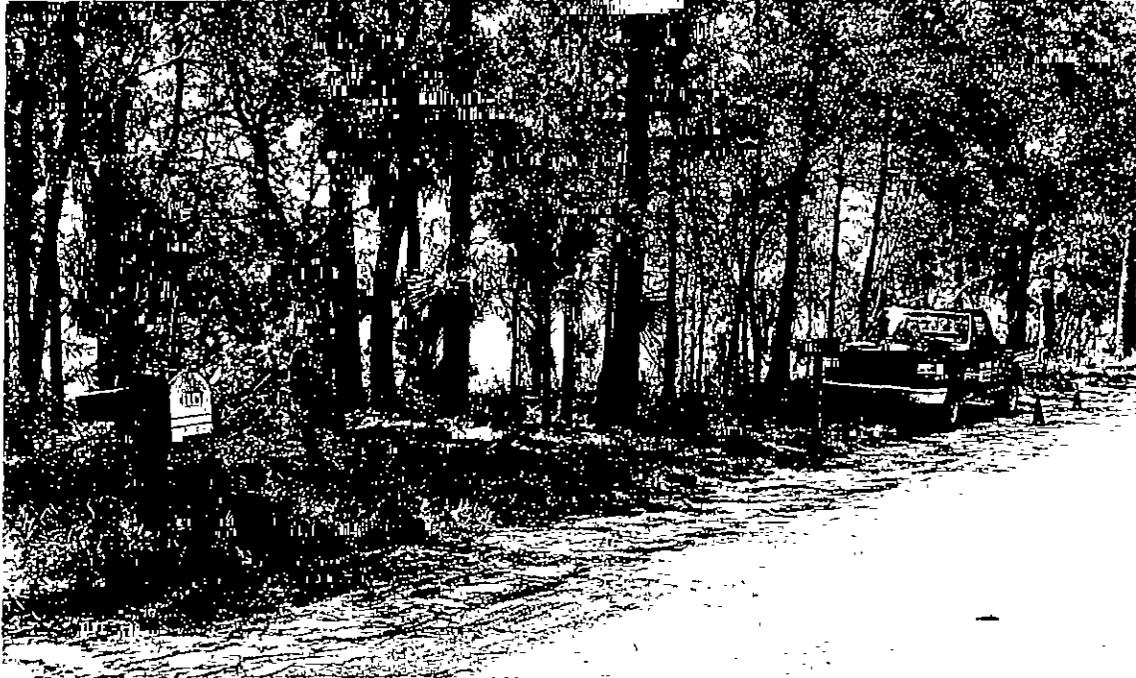
Figure 2. Project area from the north side of Jonesville Road, looking south-southwest.

The disputed monument is situated about 15 feet south of Jonesville Road (Figure 2), a dirt road which roughly parallels Old House Creek about 200 feet to the south (although the marsh is only about 50 feet to the south) and Jarvis Creek about 4000 feet to the north. North of the study tract is a northwest-southeast running dirt road which is shown on the 1972 aerial photographs of the area (stereo pairs 45013-172-56/57) but which is not shown on the 1965 aerials (stereo pairs CDU-1GG-294/295; see Figure 3). Therefore, this dirt road or easement was constructed sometime after November 1965 and before early 1972. There are a series of aerial photographs covering the six year gap, so it might be possible to more closely identify the date of the easement's construction. This, however, is

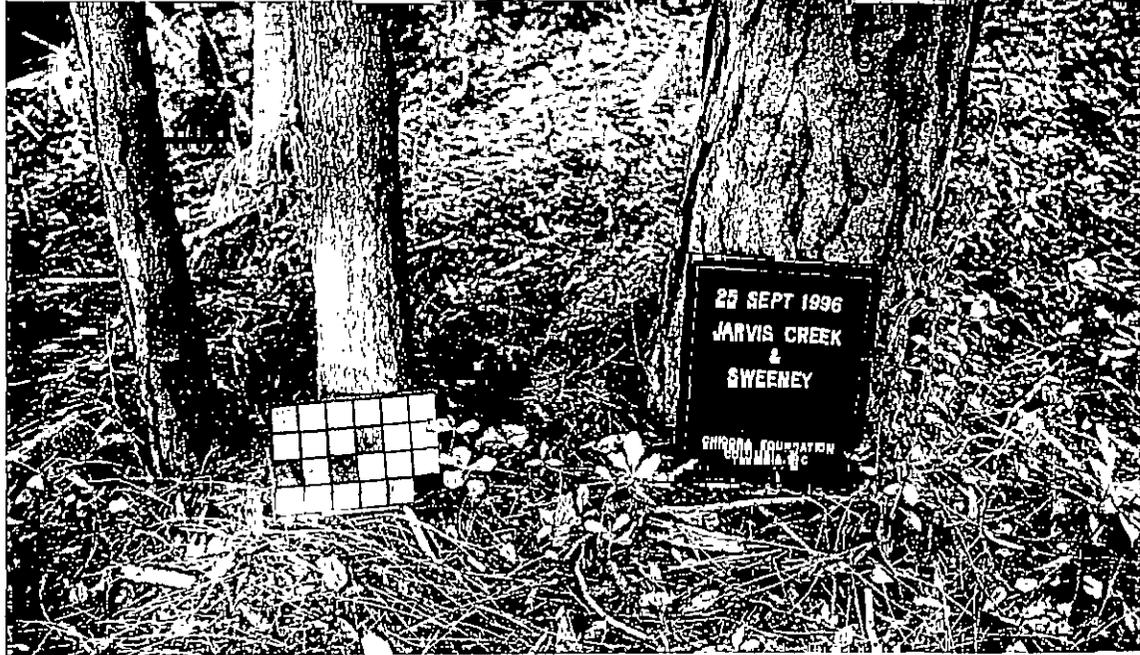
Upon arrival at the monument, we found that it was situated between two trees. A pine (*Pinus* sp.) with a dbh of 16 inches (1.3 feet) was found 2.9 feet north of the monument. An oak (*Quercus* sp.) with a dbh of 6 inches (0.5 foot) was found 1.2 feet to the south (Figure 4).

Figure 4. Trees surrounding the survey monument.
