A CONSERVATION ASSESSMENT AND
PRELIMINARY PRESERVATION PLAN FOR FORT
HOWELL, HILTON HEAD ISLAND, BEAUFORT
COUNTY, SOUTH CAROLINA

**A CONSERVATION ASSESSMENT AND PRELIMINARY
PRESERVATION PLAN FOR FORT HOWELL,
HILTON HEAD ISLAND, BEAUFORT COUNTY, SOUTH CAROLINA**

Research Series 50

December 1996

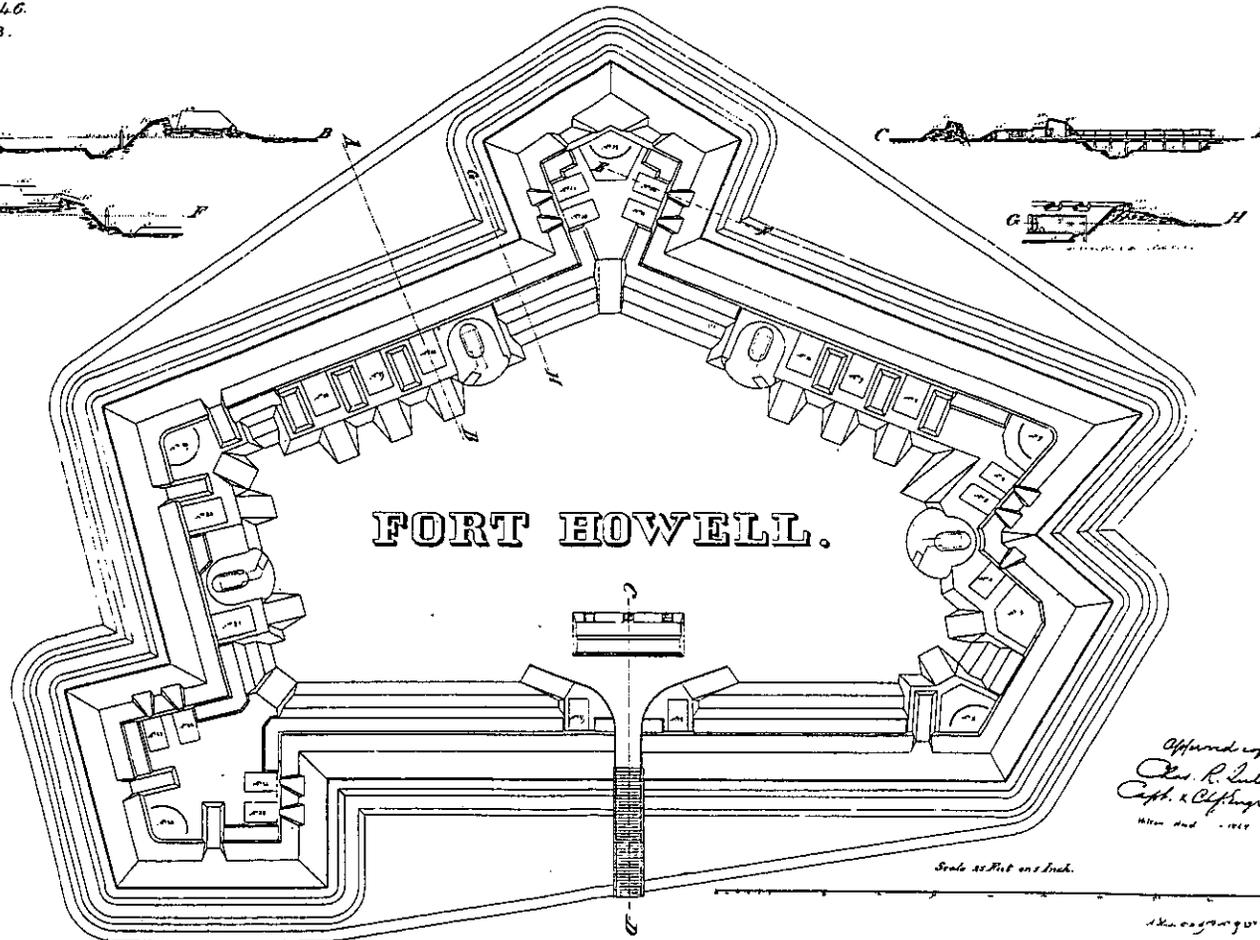
Figure 3. Plan of Fort Howell prepared by A. Riviere, Co. D, 47th New York Vols. and approved by Captain Charles R. Suter, Chief Engineer (National Archives, RG 77, Drawer 146, Sheet 18).

Figure 3 provides a profile, labeled A-B, through one barbette battery. It reveals that the fort was constructed without a glacis, which is more often found in permanent fortifications where a siege was thought likely (Wright 1982:19). The first ditch was about 4 feet in depth, followed by a smaller inner ditch (previously discussed) an additional 2 feet in depth.

A relatively wide berm was likely needed to support the sandy soil, throwing the weight of the parapet back from the scarp. Between the berm and exterior slope of the parapet a wooden palisade is shown, providing additional protection to the parapet and slowing down the invading army. Curiously, however, this palisade was not placed at the foot of the counterscarp, where it was normally recommended. Such a position provided "no room to stand on the counterscarp and swing an axe downward while at the same instance being exposed to point-blank musketry" (Wright 1982:40). The placement of the palisade at Fort Howell would have allowed axe men to stand on berm while attacking the logs, relatively protected from musket fire.

There is no evidence of the traverse shown on Figure 3. As previously discussed, it seems likely that it was used to create the ditch fill allowing access to the fort. Careful inspection of this area fails to reveal any residual mounding or topographic anomaly (Figure 24).

Once removed it could be used to reconstruct the missing traverse, based on both the archaeological research and the Fort Howell site plan (Figure 3). We estimate that the ditch currently contains about 150 cubic yards of soil. In contrast, the traverse will require about 210 cubic

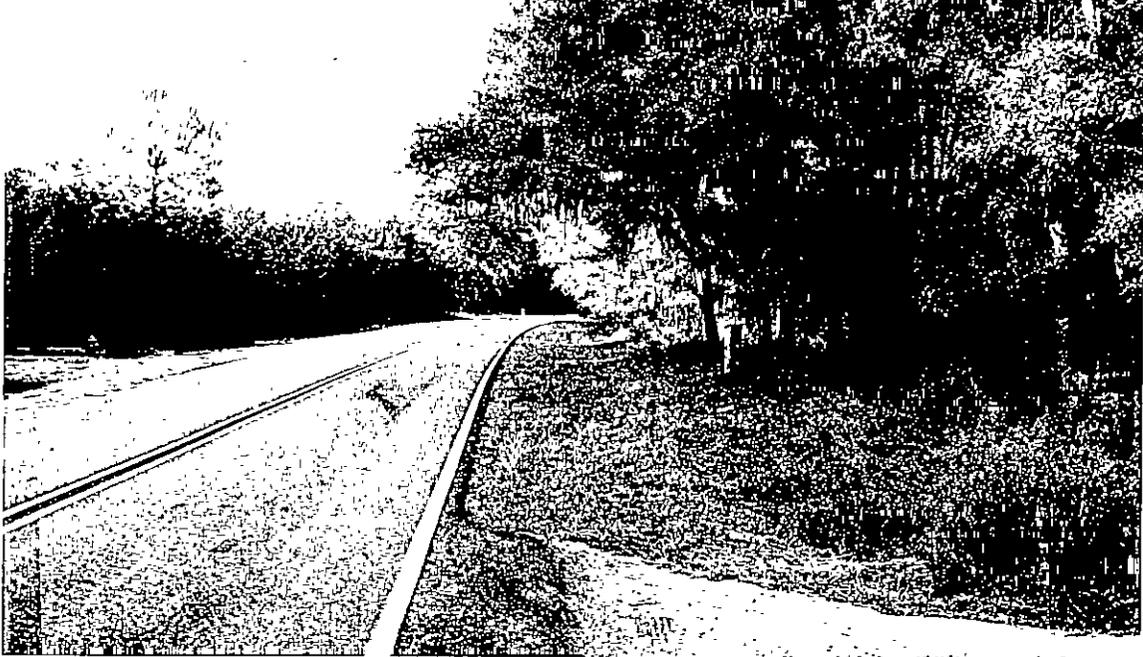
Figure 5. Beach City Road from Fort Howell gate, looking southwest.

Fort Howell is located immediately off Beach City Road (SC 333). There is no advance notice of the required turn and there are blind curves to the NNE and SSW. Figures 5 and 6 show the area as it currently exists.

The extant turning radius, while tight, is adequate for school bus traffic, but the holding area (between the road and the gate, measuring 37.5 feet) is insufficient to allow an average school bus (with a length of 39.5 feet) to safely pull entirely off the road if the gate is locked or closed. Once through the gate there is a crush-run apron ranging from 20 to 23 feet in width for about 155 feet. This provides adequate room for bus pull-in, but fails to provide adequate space for turning around (Figure 7). Consequently, buses using the parking facility currently have to back out onto Beach City Road — a dangerous undertaking under the best of circumstances.

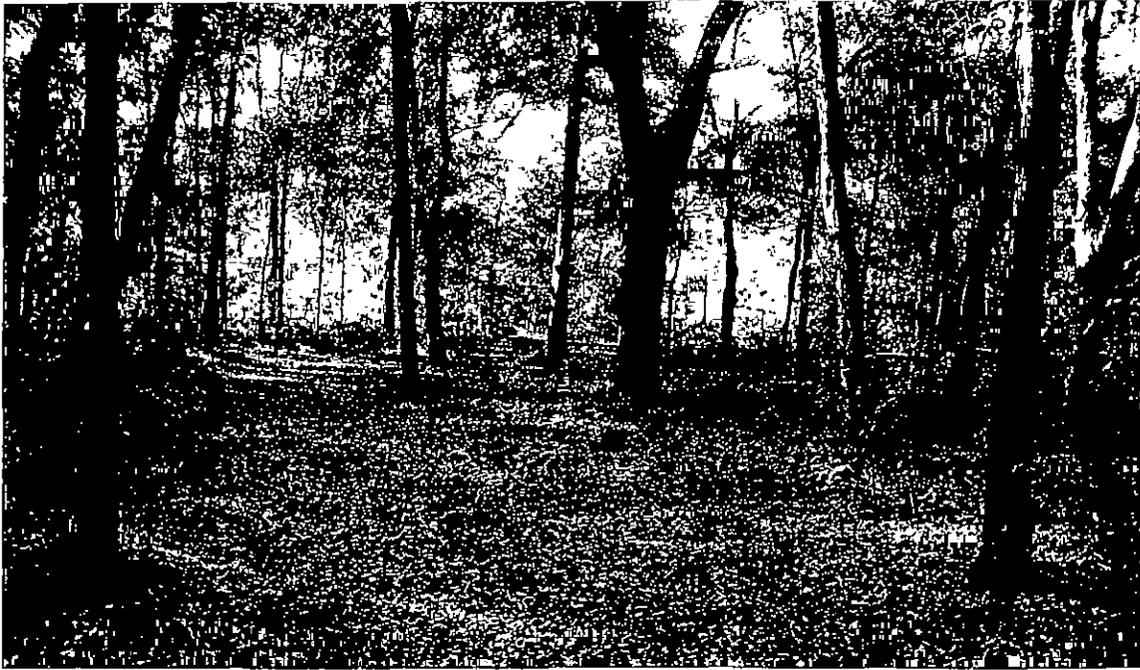
Figure 9. Area where the path narrows and becomes less distinct. View to the south.

The path narrows to about 8 to 10 feet (Figure 9) and winds around trees, eventually leading to the Fort's outlet or sally port. The pathway is relatively firm in most areas, but consists of only pine straw or oak leaves. Branches and other obstacles are common on the path, making it hazardous for elderly visitors and difficult for wheelchairs or the disabled. The landscape in this area is unspectacular, being characterized by a variety of young oaks. There is at least one pile of concrete and iron pipe debris which detracts from the experience.

The current pathway is from 8 to 10 feet in width. A two-way walk requires only 4 feet, while a two-way wheelchair walk requires only 5 feet. We recommend a design width of 6 feet.⁶ This seems to be more than adequate for the traffic anticipated at Fort Howell.

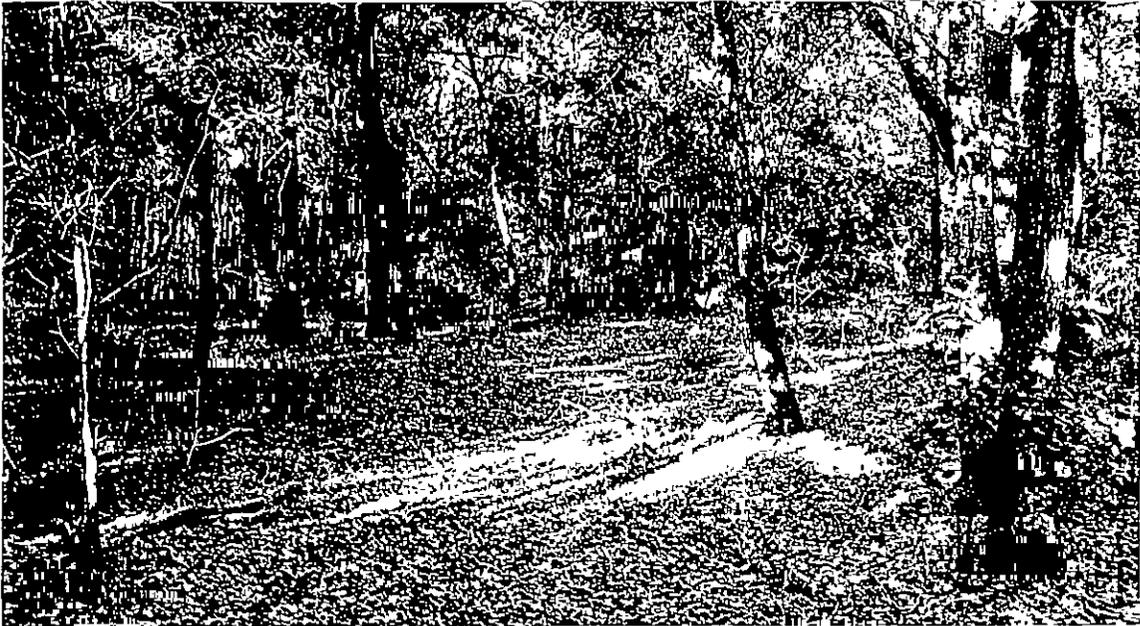
Figure 10. Portion of old road bed integrated into path leading to Fort Howell. View to the west with the ditch and rampart in the background.

About halfway to the fort the path incorporates what appears to be an old road bed (Figure 10) which is about a half foot below the

surrounding ground in some areas. This creates an uneven walking surface. In this same area there is a pedestrian gate to Fort Howell, which apparently is always kept locked. The canopy is open in this area and sand is exposed, creating a very loose, consolidated walkway.

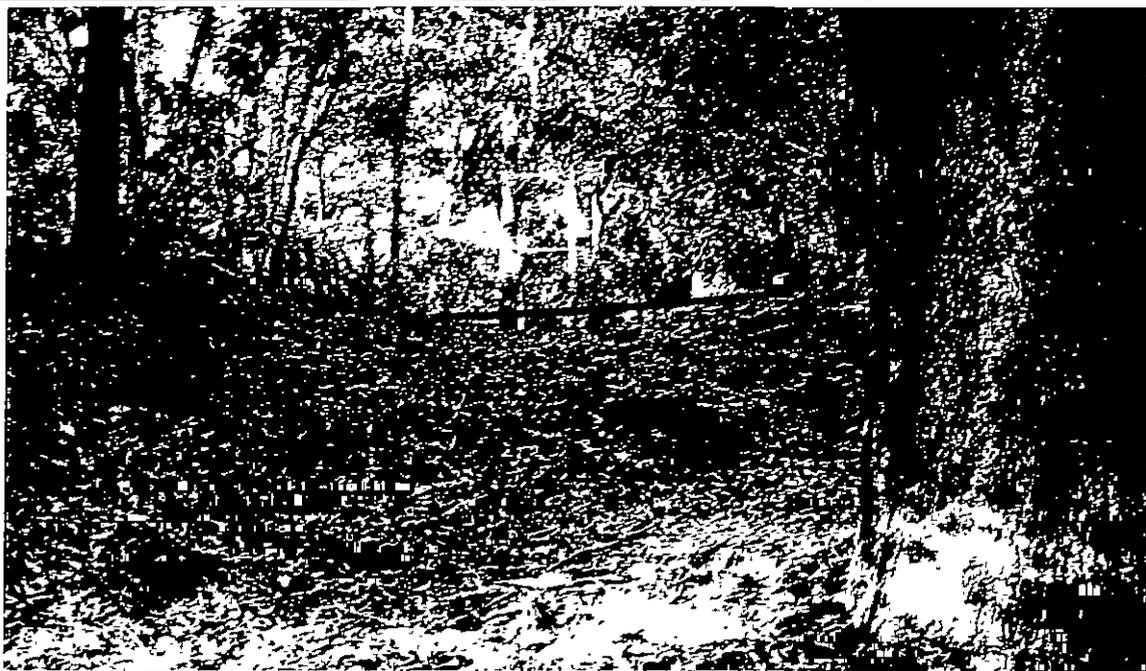
Figure 15. Erosion at the east corner of the priest-cap, showing the use of 1 by 4 barricades.

There are two major erosional areas. One is situated to the south of the entrance where the damage has been caused by dirt bikes in an area measuring about 15 by 10 feet, to a depth of about 1 foot. A similar area is found north of the entrance along this same wall.

Previous efforts to stop use of these erosional areas consisted of creating 1x4 barricades, some of which are still extant, or partially so (Figure 15). While they appear to have been effective in stopping traffic in these areas, they are now serious trip hazards and do nothing

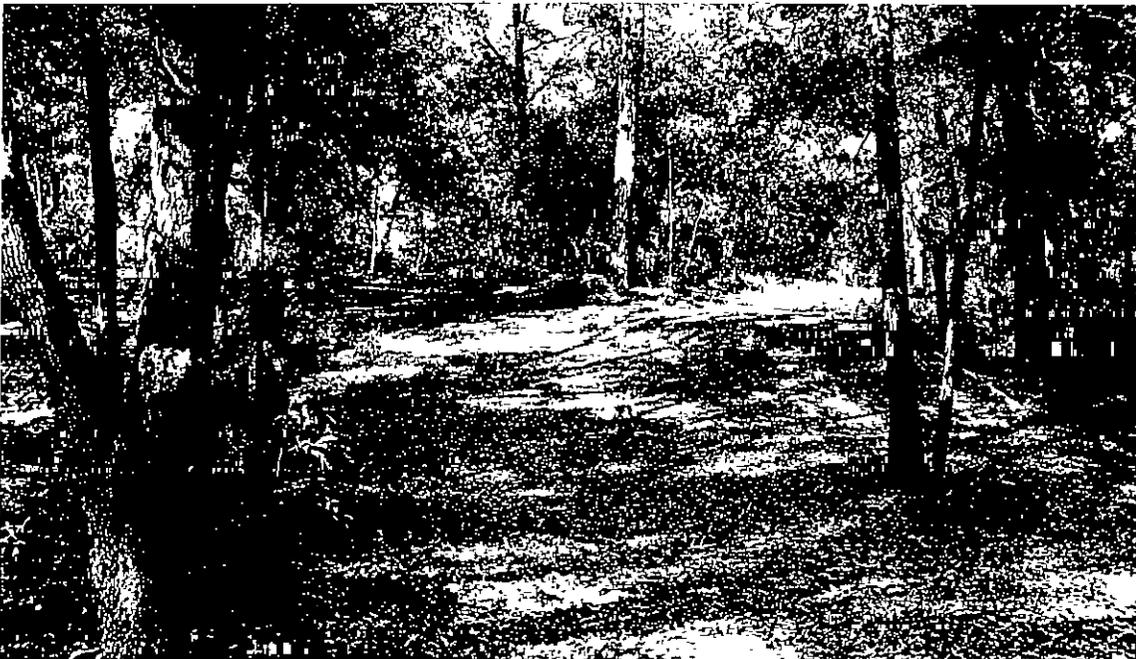
Figure 20. Heavily worn path up to the north bastion on the fort interior. View to the northwest.

There is a clear pedestrian pathway from the terreplein of the fort up to the north bastion and thence to the south along the top of the parapet wall. In several areas this path has caused, or encouraged, erosion of the sandy soil (Figure 20).

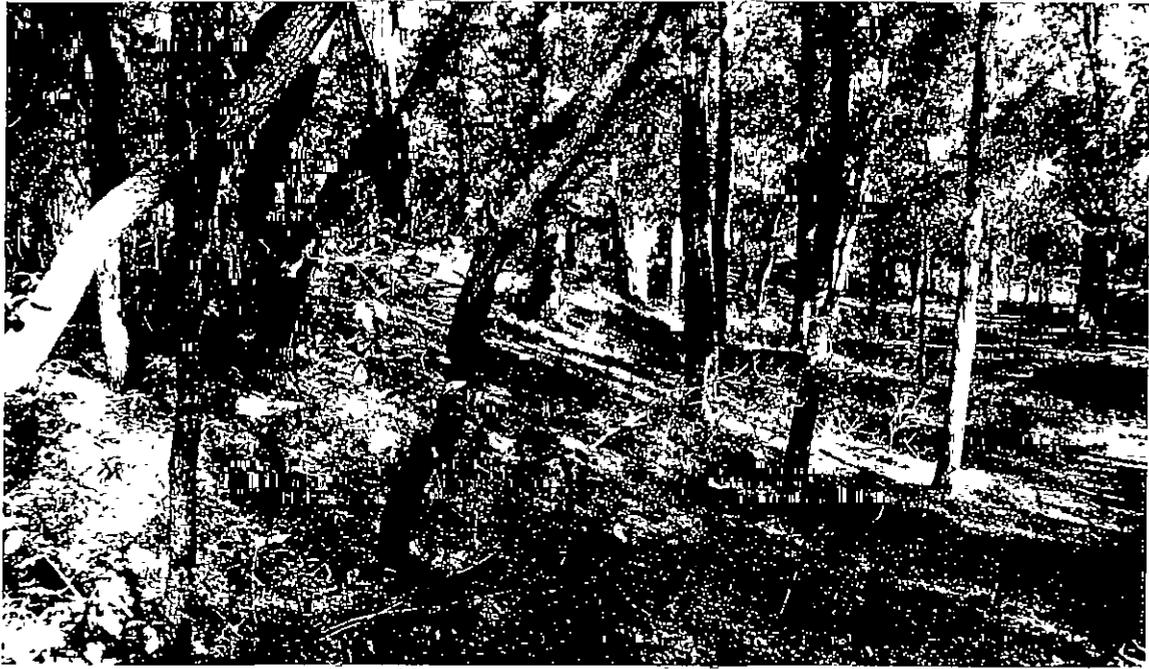
Figure 21. Salient southwest of the north bastion, view to the north.

These walls include six gun positions, all en barbette, and two magazines. The three gun platforms between the north bastion and the salient are the best preserved at Fort Howell (Figure 21). Some remnant evidence of the actual platform areas is present. In addition, there are slight rises which correspond to the earthen walls between the positions. The three ramps leading to the barbette batteries are also clearly present. The two magazines, one at each end of the salient, are in relatively good condition.

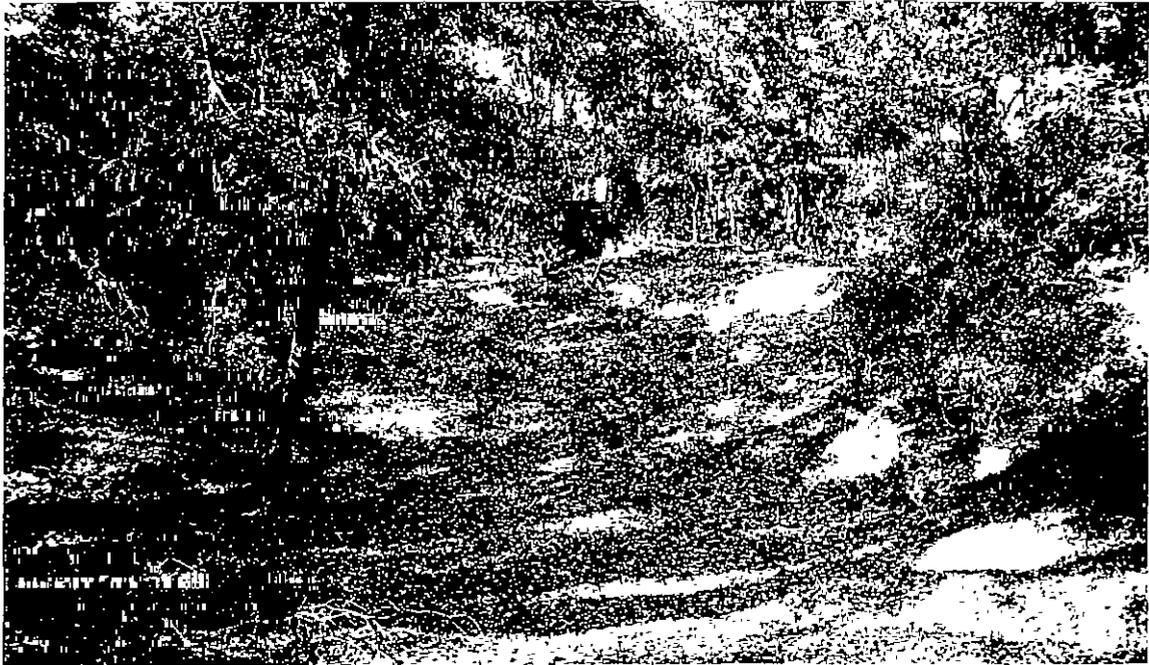
Figure 23. Erosion at south bastion. View to the west.

The south bastion also included five guns, four en embrasure and one en barbette. Like the north bastion, it has suffered considerable erosion and none of the surface details are visible. In addition, there are four areas of extensive erosion. On the western flank of the bastion is an area of erosion measuring about 10 feet square, to a depth of about 1.0 foot. On the southwest face is an area measuring about 10 feet by 20 feet, eroded to a depth of nearly 2.0 feet. At the intersection of the southeast face and eastern flank is an erosional area measuring about 15 feet by 30 feet, with damage to a depth of nearly 2.5 feet. On the eastern flank is another area of heavy erosion damage, measuring about 25 by 30 feet, to a depth of about 1.0 foot. Several of these areas have remnant 1x4 board barricades, but there has been no effort to stabilize the loose, unconsolidated sands (Figure 23).

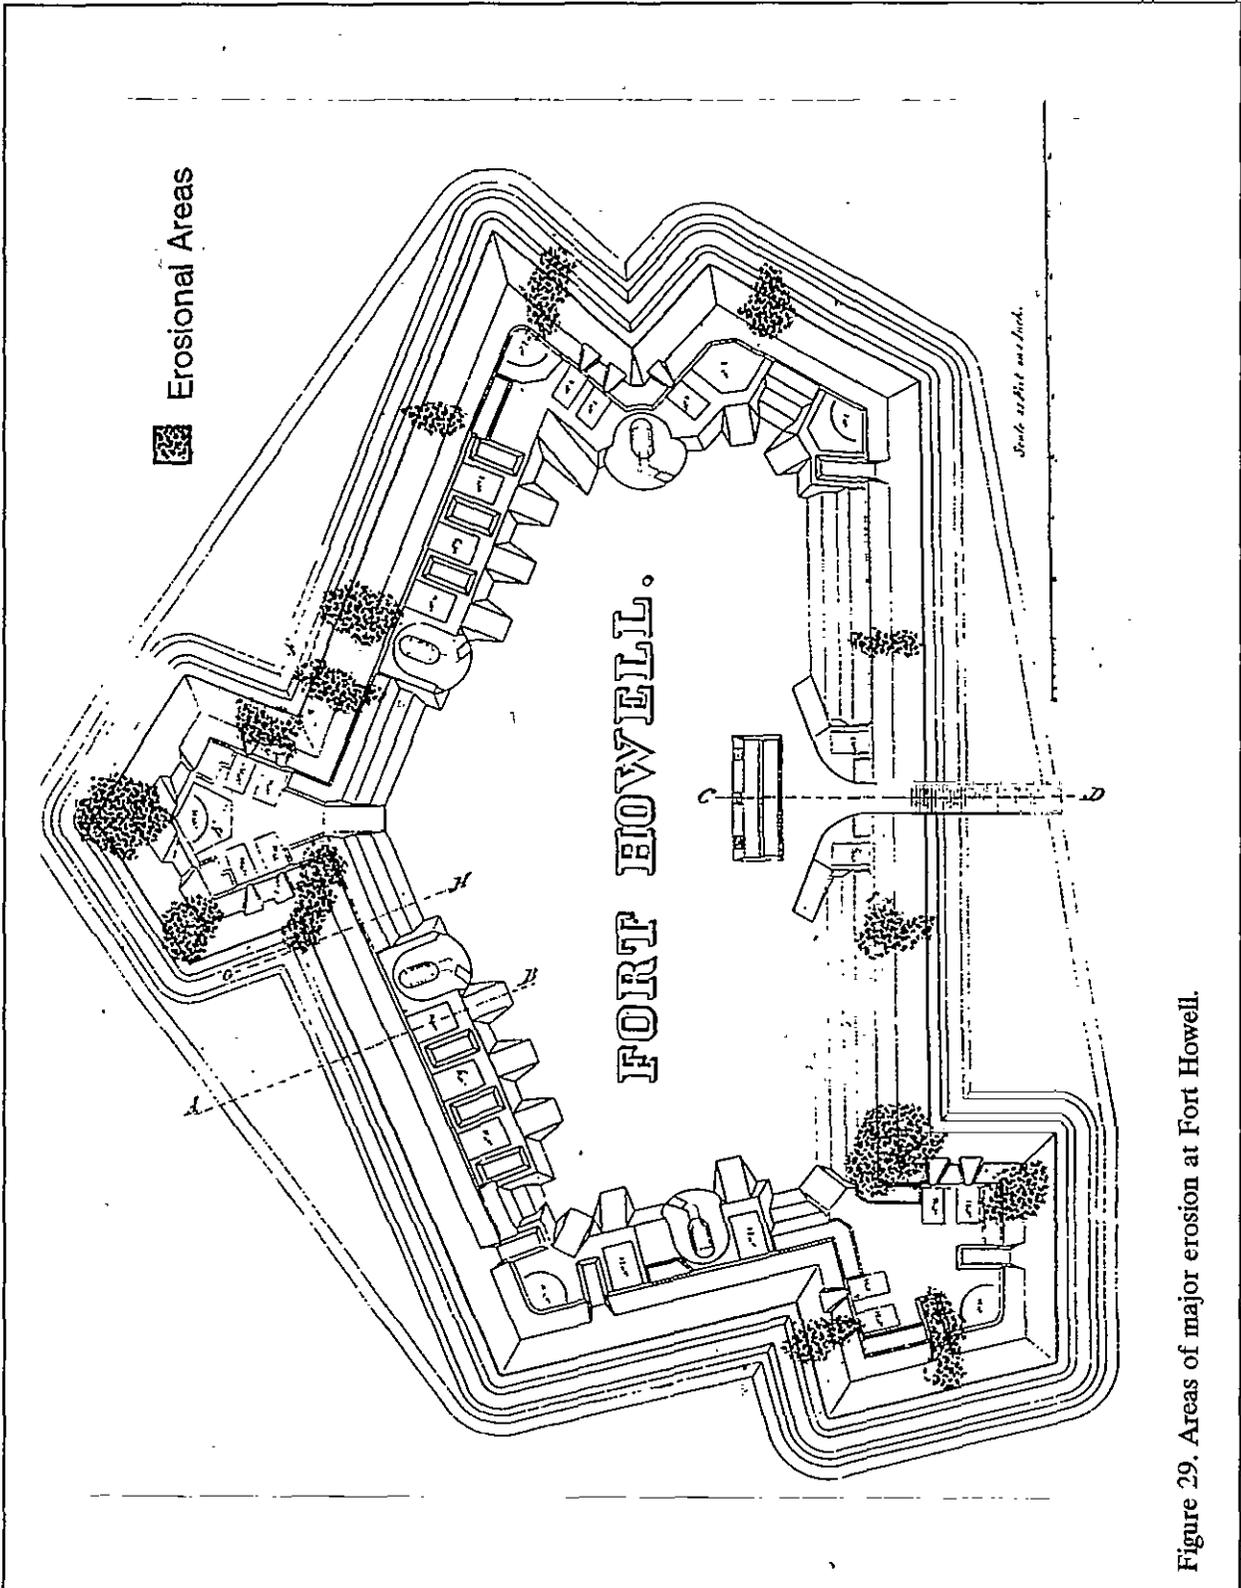
Figure 29. Areas of major erosion at Fort Howell.

As discussed in the previous assessment, there are 14 major erosional areas at Fort Howell (and several more minor areas) (Figure 29). Some are today more stable than others, but all pose a serious threat to the long-term preservation of the earthwork and require immediate attention.
