**ASSESSMENT OF TORNADO DAMAGE AT
THE OAK GROVE CEMETERY,
AMERICUS, GEORGIA**

CHICORA RESEARCH CONTRIBUTION 468

March 26, 2007

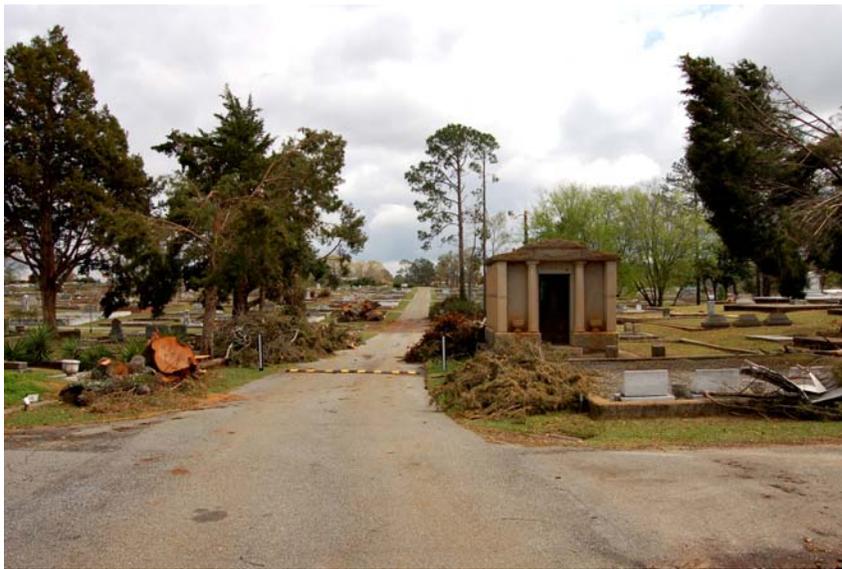
Figure 2. View of the cemetery, along center drive facing east.

The tornado tracked across Oak Grove cemetery, entering at the southwest corner, directly crossing a portion of the historic section, and exiting the cemetery at East Lamar Street (Figure 1). However, given the width of the storm, the entire cemetery was affected (Figures 2 and 3).

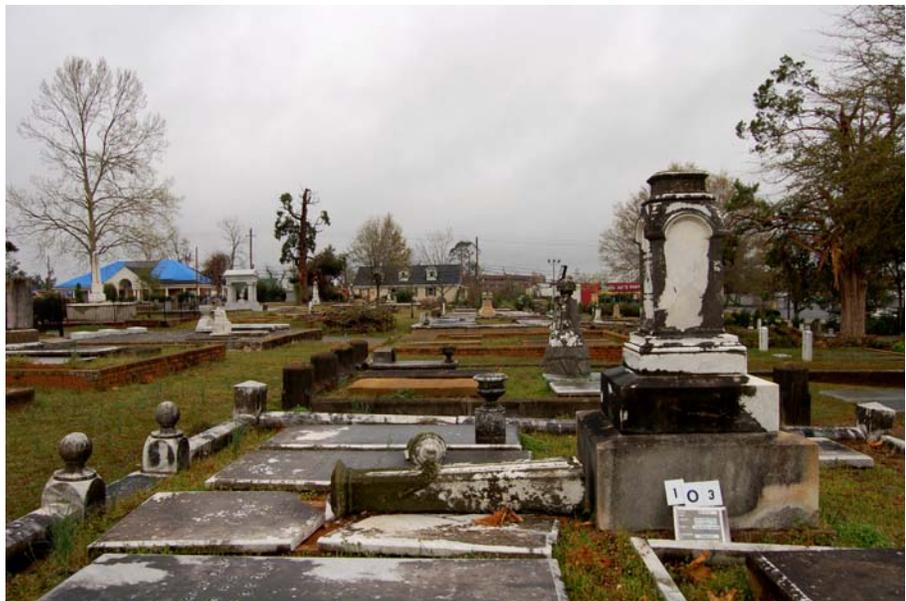
Figure 3. View of the cemetery.

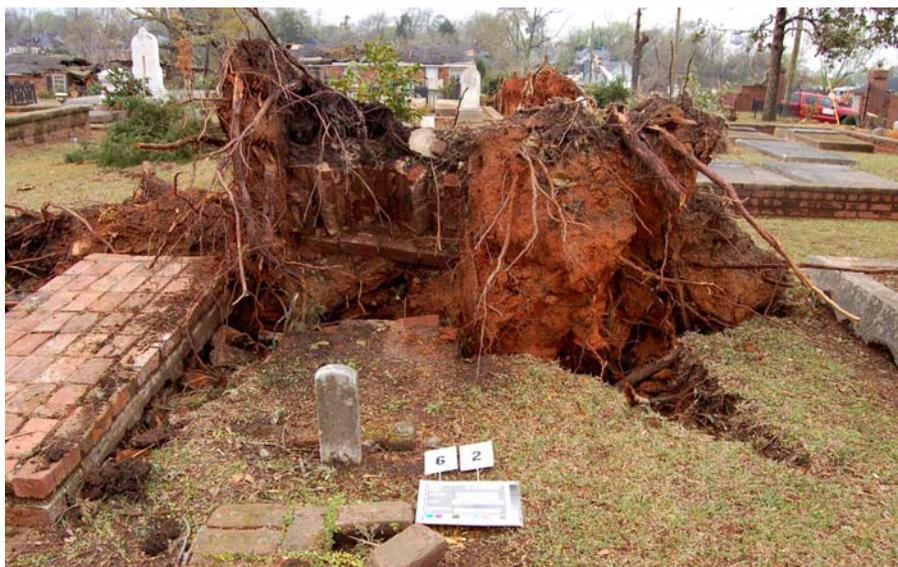
Figure 5. Example of vault damage requiring archaeological investigation. The open vault should also be secured prior to conservation treatment to prevent looting, desecration, or vandalism.

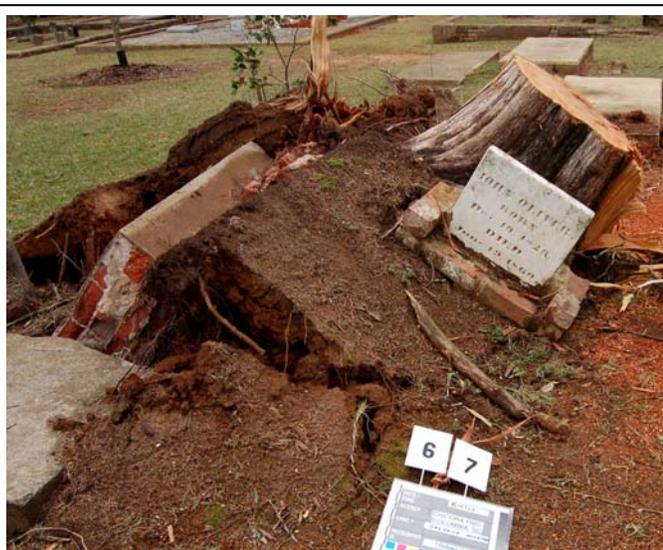
Figure 6. Tree root uplift that has potentially disturbed the grave and requires archaeological investigation prior to removal.

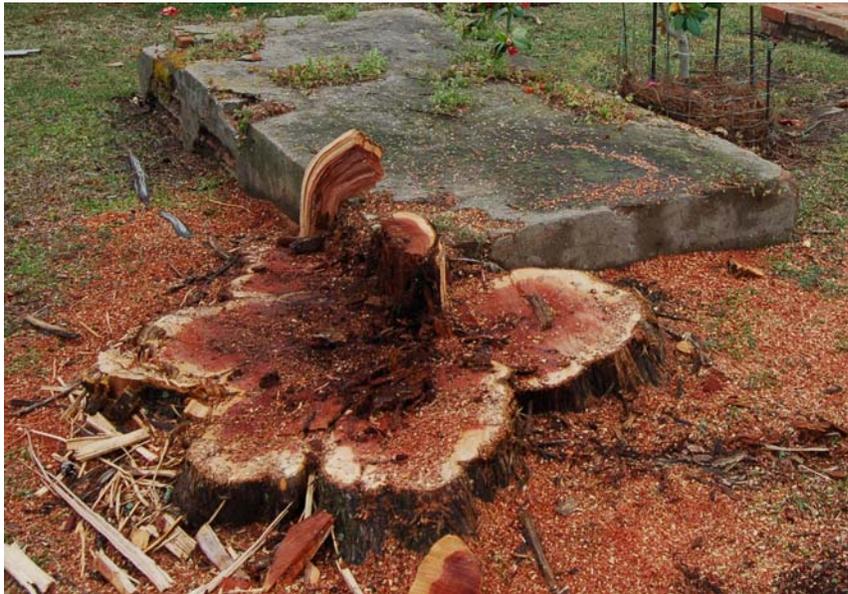
Figure 7. This is an example of a stump that should not be removed or ground, but left in place to allow natural decay. The protruding tree sections should be carefully removed.

For those stumps which are not partially or wholly removed from the soil, stump grinders may be used *only if the equipment can be placed without endangering monuments and all surrounding monuments may be protected by plywood from flying chips*. Grinding should extend no more than 2-3 inches below grade. It is also acceptable to flush-cut stumps to grade and allow them to naturally decompose.

Once all stumps have been removed, the remaining depressions should be filled with

clean white sand (or some soil that is distinguishable from the cemetery soil) and compacted.

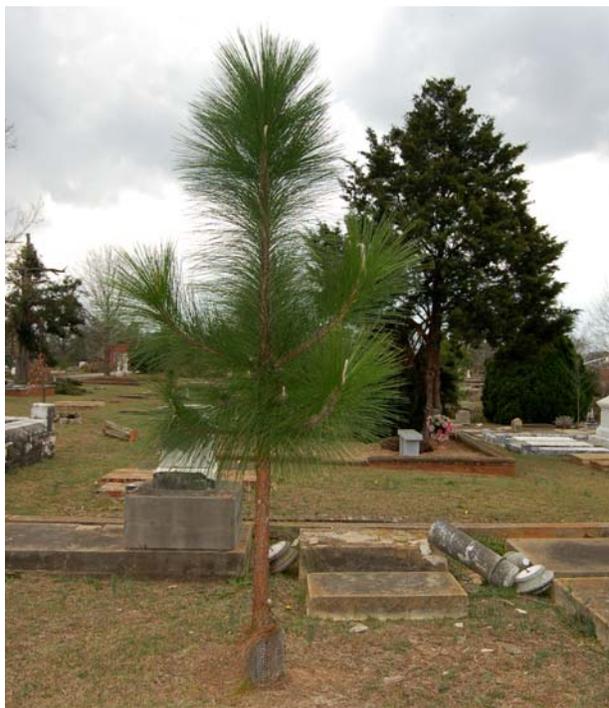
Figure 8. Pines such as this are not a good choice for cemetery planting. We recommend that they be removed and that lost pines not be replanted.

Pines are not an especially appropriate tree for cemetery use. They drop sap on monuments; produce much litter; are inherently

weak and prone to wind and ice damage; and require large amounts of water, limiting the growth of understory vegetation or turfgrass.

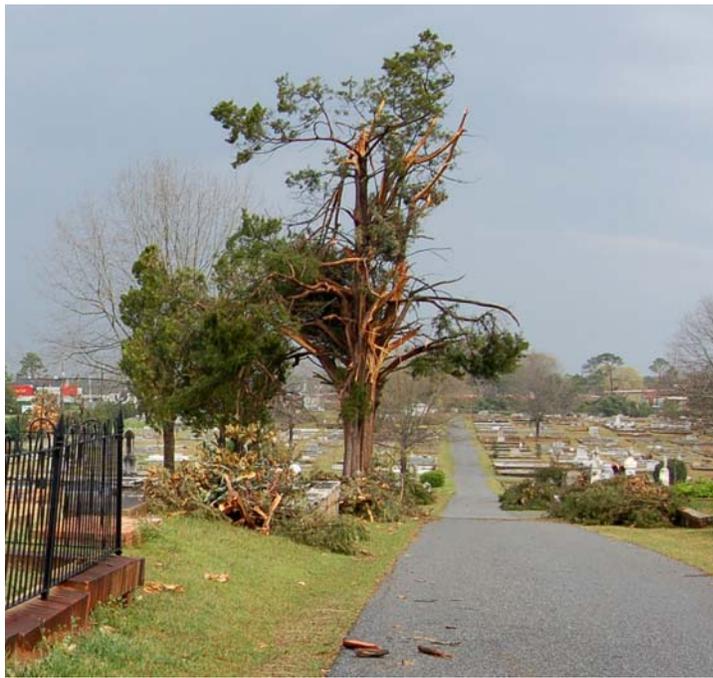
Figure 9. Example of a tree that requires an assessment by a certified arborist to determine if restoration pruning is possible.

typically handle the removal of trees in open areas or the removal of dead or hazardous limbs, a certified arborist is needed for much of the work encountered in a cemetery. In particular, a certified arborist should remove leaning trees, removing any limbs that require climbing, restoring trees, and pruning to

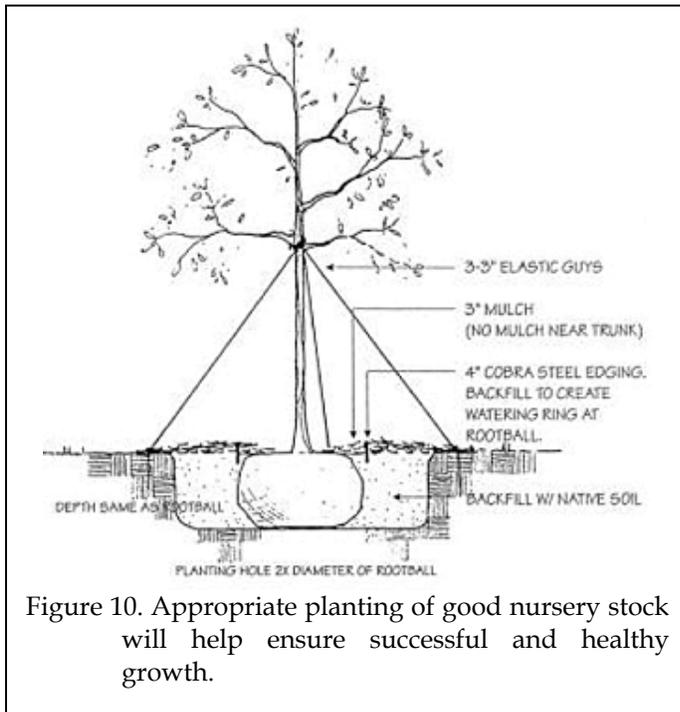
4. The relationship between caliper, height and root ball size shall meet the ANSI Z60.1 standard.
5. There should be one dominant leader to the top of the tree with the largest branches spaced at least 6 inches apart

(see illustration top-left). There can be a double leader in the top 50% of the tree on a quality plant or in the top 10% of the tree on a plant of exceptional quality.

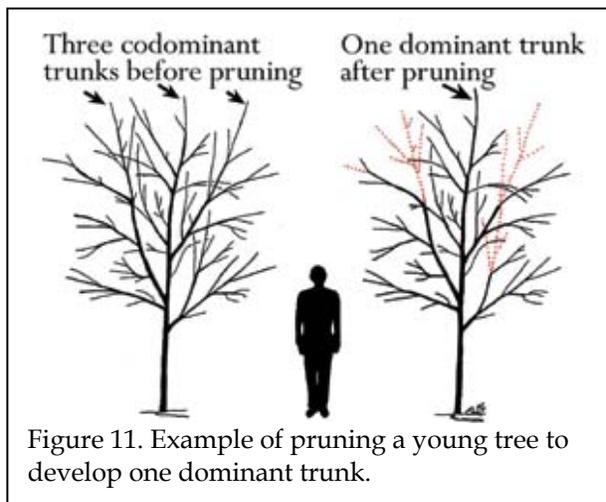
Figure 11. Example of pruning a young tree to develop one dominant trunk.

Pruning trees is a very complex issue and we can't begin to do it justice here. For example, one critical issue in pruning young trees is ensuring that they develop one dominant trunk - achieved by shortening competing braches with reduction cuts. When performed regularly, this makes trees stronger by allowing the main trunk to grow larger than the branches.
