CHICORA FOUNDATION, INC.

Re: Cultural Resources Survey of the Laurens Electric Cooperative Parking Area

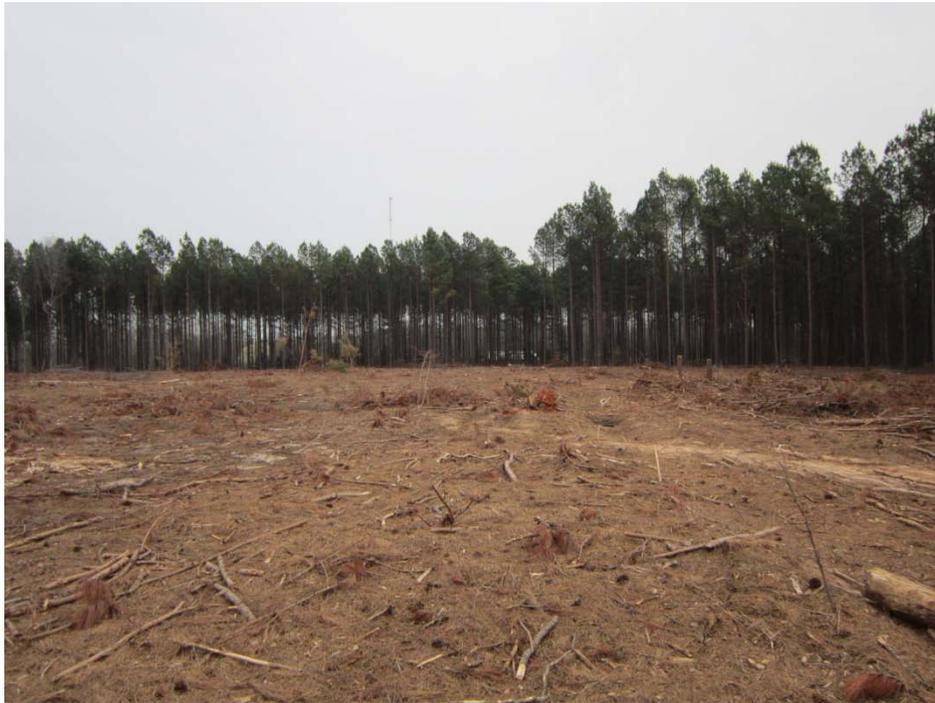
Figure 4. Project site looking north.

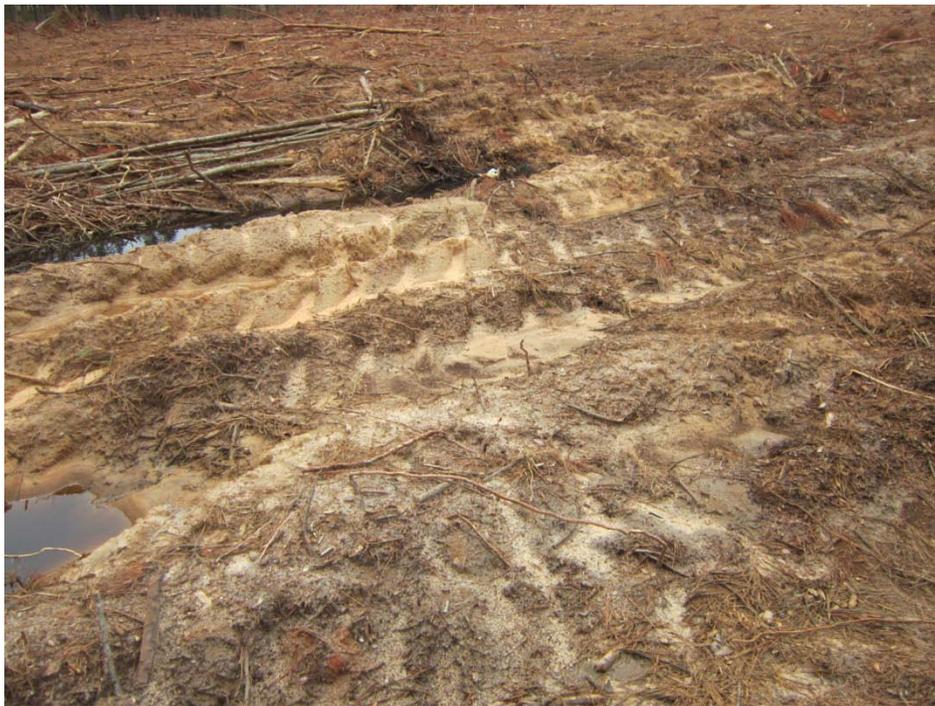
Part of the Cotton Plantation Area, Trimble observed high antebellum erosive land use with postbellum continuation. This resulted in the loss of as much as 0.6 foot of soil in this area historically. By the 1930s the USDA Soil Conservation Service documented moderate sheet erosion throughout his area of Laurens County. This damage is still visible today, shovel tests in the study area revealed no more than 0.1 foot of Ap soils overlying yellowish-red to red sandy clay subsoil. The process of logging has exacerbated soil profile damage, with ruts in some areas at least a foot in depth.

Figure 5. Severe rutting in the project site.
