CHICORA FOUNDATION, INC.

September 11, 2003

This letter provides you with an overview of our one-day on-site assessment of the Old City Cemetery in Sandersville, Georgia. Before going on, however, let me again thank you, Roy, and everyone else there in Sandersville for both the kindness shown us and also the extraordinary hospitality.

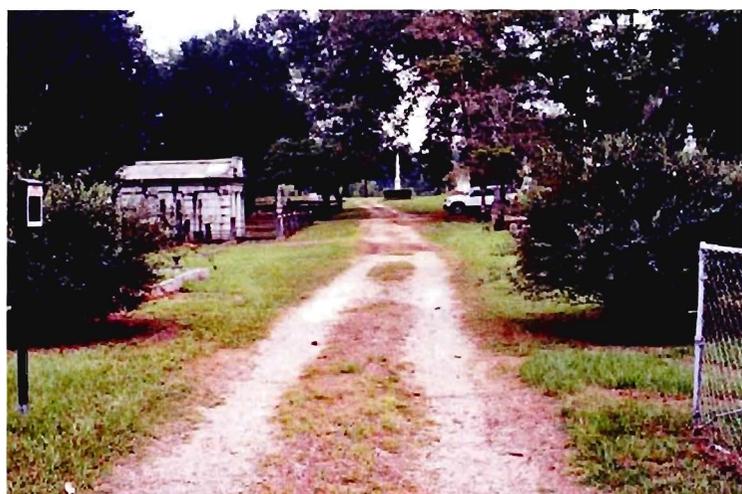
Entrance to the Old City Cemetery off Church Street, looking north. Note the abundance of 3-dimensional markers and Pringle vault.

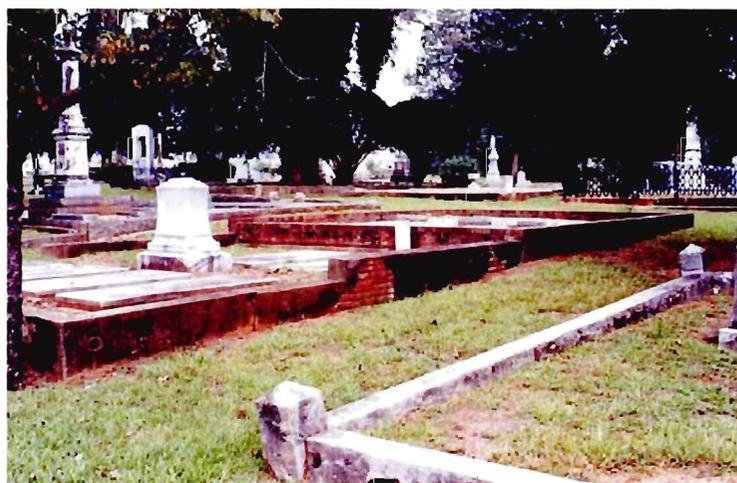
The landscape character is defined by geometric layout with curbing, large family memorials, ironwork, and rolling topography.

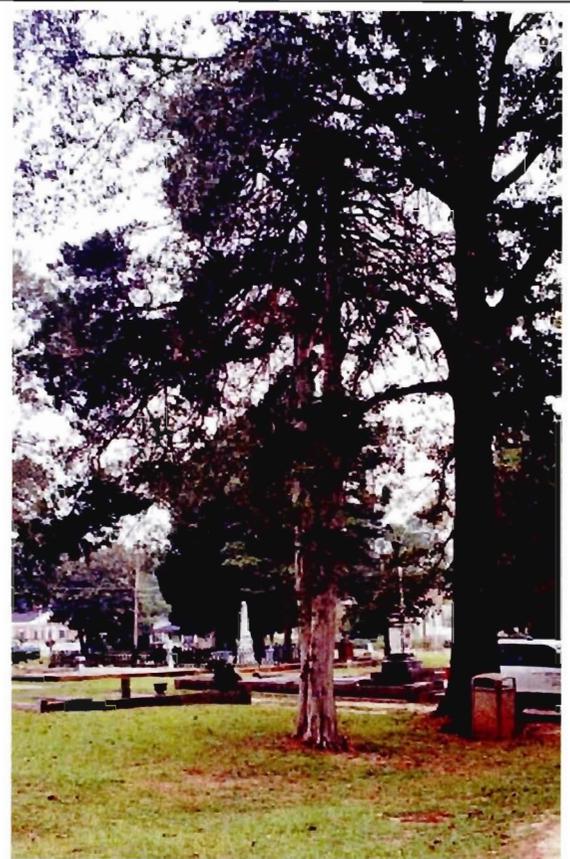
Oak and cedar trees showing damaged limbs and need for careful, professional pruning and fertilization.

I recommend that a certified arborist (a member of the International Society of Arborists) be retained to inspect, fertilize, and prune the trees in the cemetery. It may be necessary to remove the dogwoods that are doing so poorly at present. If so, it is absolutely essential that they be replanted with an appropriate species (i.e., one that is historically appropriate and also one that has no or limited undesirable cemetery preservation

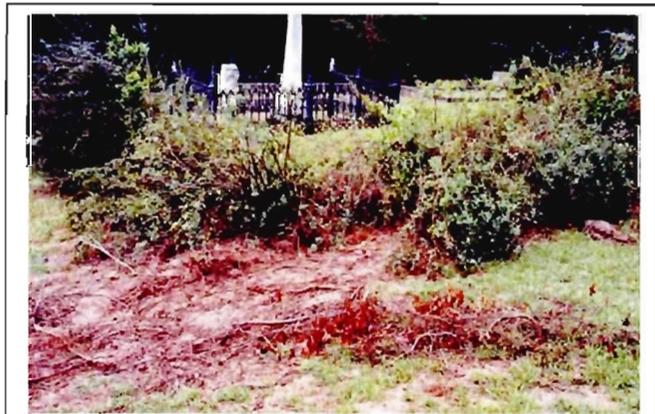
Dense volunteer growth partially overwhelming plantings. Note previous removals have left bare earth that will be subject to erosion.

I also recommend that efforts be made to continue to remove the invading volunteer growth. It is particularly important to remove the poison ivy that has taken over one oak in the cemetery. The application of herbicides must be strictly limited within the cemetery. There should be no broadcast or spraying of herbicides. If it is necessary to kill a volunteer plant, the stump should be cross cut and an appropriate herbicide painted on the exposed cut to allow penetration into the roots.

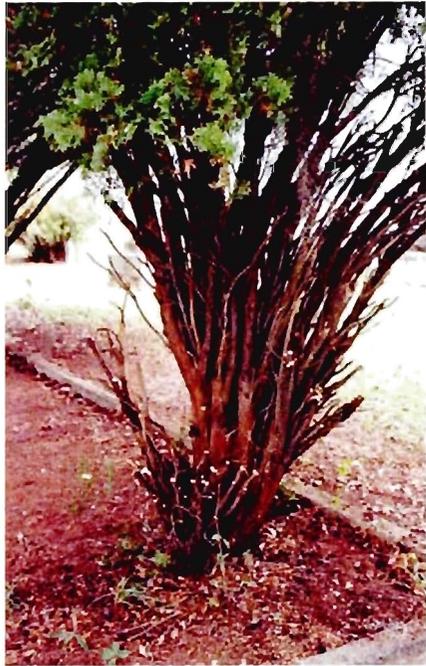
Inappropriate pruning of small cedar that has left a number of branch stubs. This should be corrected by an individual trained in pruning techniques.

Only individuals trained in appropriate pruning techniques who also have knowledge of the correct pruning season for the different plants should conduct pruning in the cemetery. Every effort should be made to ensure that the pruning damage I've seen be halted immediately.

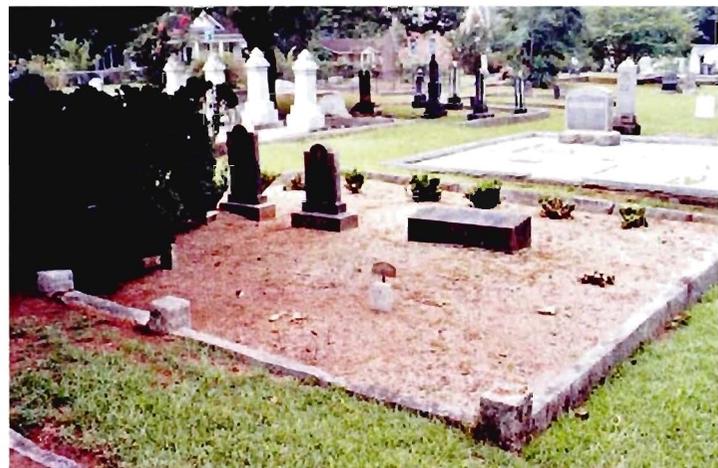
Extensive damage has been done to these boxwoods. Some are putting out new growth, others have been killed by excessive pruning. All are dwarfed by those not pruned. The character of the lot has been dramatically affected.

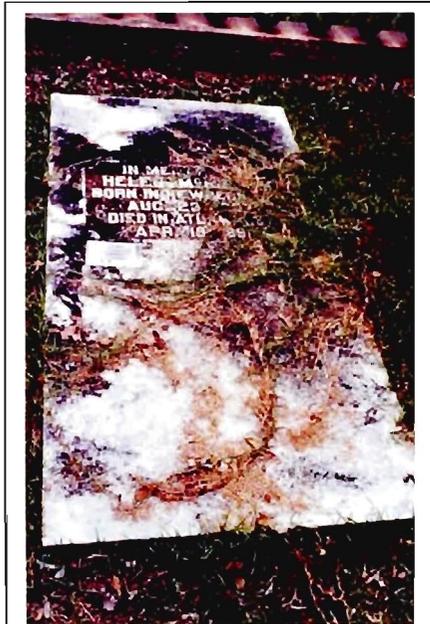
Part of lawn maintenance should be the removal of grass that grows over ledgers such as this one.

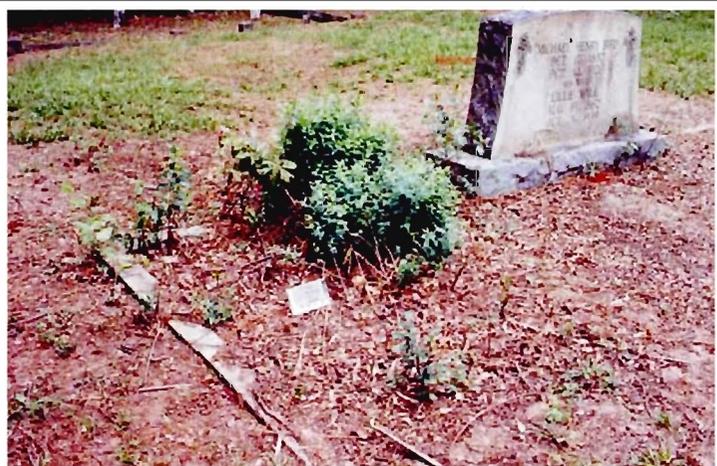
Bare areas such as this will require power raking, top dressing, seeding, and care to promote new grass growth.

It will be necessary to power rake some lawn areas, top dress and reseed to help establish lawn in those areas where the grass is thin, non-existent, or heavily infested with weeds. An herbicide should not be used in the cemetery to deal with weeds.

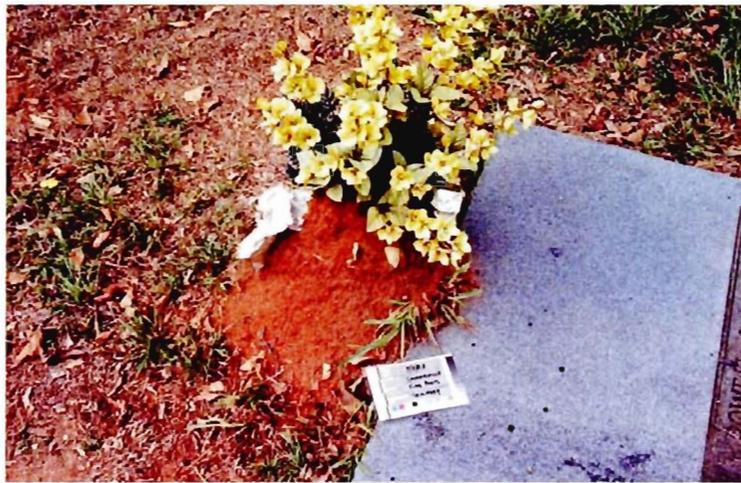
Fire ants are a significant problem in the cemetery and treatments should begin immediately.

Lawn maintenance should also include treating for fire ants (which are a significant problem in the cemetery), picking up branches and other debris on a routine basis, picking up trash, and emptying trash containers.

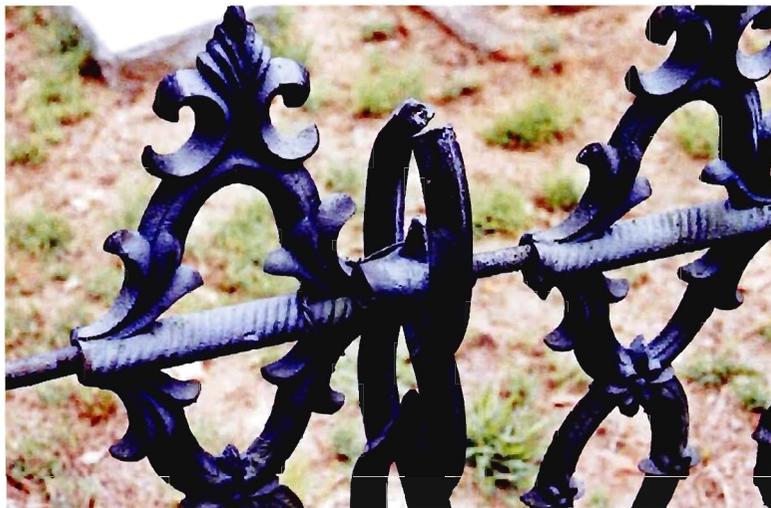
Inappropriate ironwork repair using wire to retain loose parts. Note also corrosion and flaking of paint.

All of the fences are in need of routine maintenance – priming and painting to minimize corrosion damage. All are also in need of security measures to prevent the theft of gates, while some need security to ensure that loose fence segments are not further damaged or stolen. Some fences are in need of extensive repairs – repairing breaks,

resetting posts, replacing missing elements, resetting loose joints, and creating new slip joints to secure elements.

Routine maintenance and securing loose elements should receive the highest priority, with additional repairs made as funding becomes available. I understand that the local technical college may be able to assist in many of the repairs. This is a wonderful source of assistance, so long as the repairs are conducted to preservation specifications.

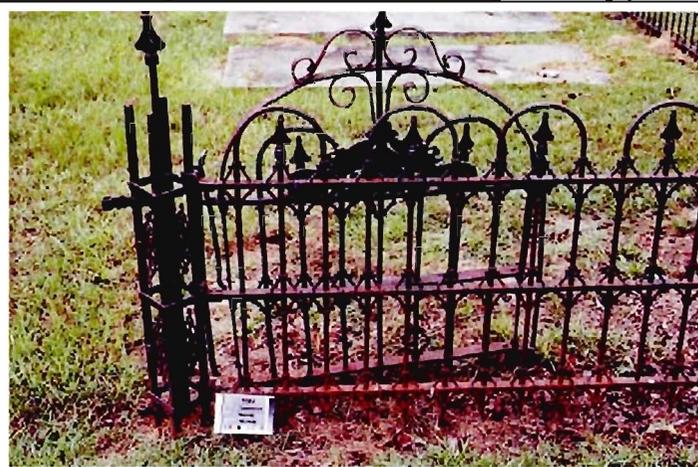
Loose gate leaning against fence. This needs to be secured immediately.

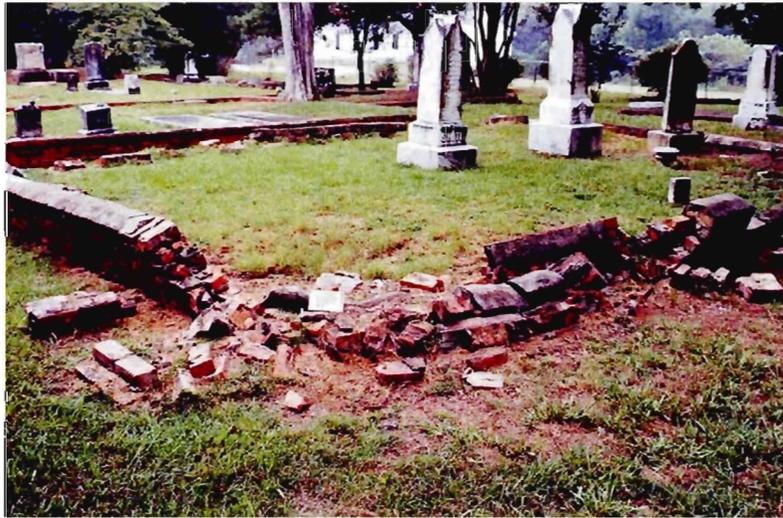
Brick coping or wall around a plot that has failed. The brick needs to be salvaged and the wall rebuilt using the same bond and with period appropriate mortar.

Much of the brick coping has failed and needs to be rebuilt. Some concrete coping has also failed and needs to be reset.

It is critical that all brick repair efforts use appropriate mortar mixes –

mixes that are not too rich in Portland cement and that are color matched to the original. Wherever possible the bricks should be salvaged and reused. Where additional bricks are necessary they should be matched as closely as possible in size, color, and strength. Bonding patterns must match those still present in the wall.

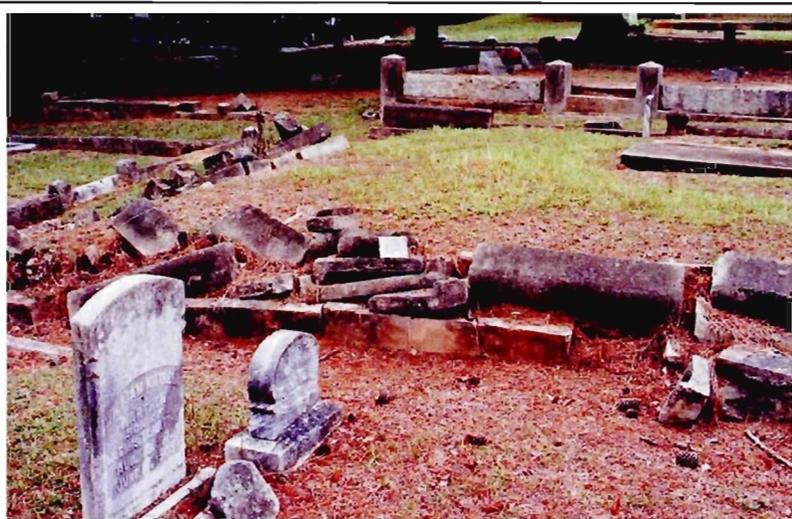
Precast concrete coping that failed and was stacked up. This coping needs to be reset in order to restore this family lot and improve the visual appearance of the cemetery.

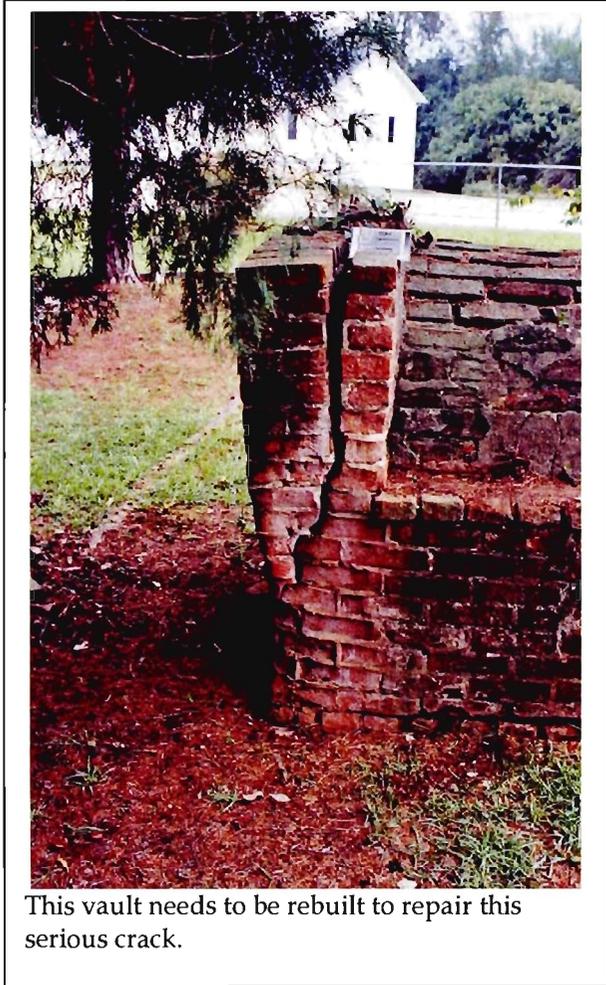
This vault needs to be rebuilt to repair this serious crack.

The one evidencing a large crack from tree root damage will need immediate intervention to prevent that wall from failing. After detailed drawings and/or photographs, a mason will need to remove the wall, salvage the bricks and then rebuild the wall using appropriate soft lime mortar. Both vaults should be covered using a non-Portland cement stucco and covered with lime wash.

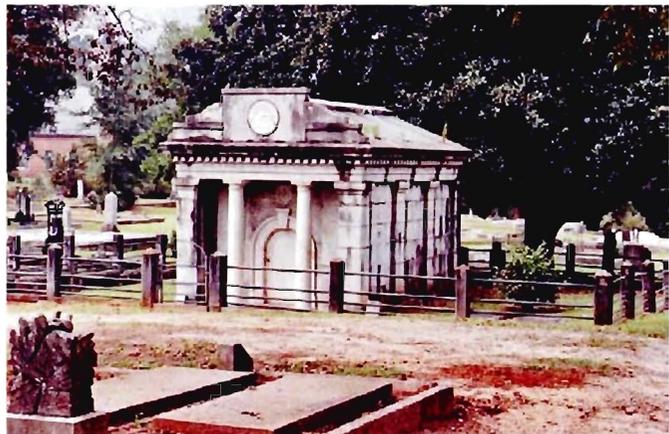
this tomb, nor did I do any detailed examination of the external structure. Nevertheless, there is evidence of considerable staining on the exterior of the structure. Much appears associated with drainage and/or leaching from the joints. The gable roof consists of slate panels. There is grass or other vegetation growing on the roof joints. I found that mortar was brittle and readily flaked out of the joints on the exterior; this may allow water intrusion. Otherwise the structure appears sound and plumb.

The Pringle Vault requires cleaning, removing vegetation from the roof, and repointing.

I recommend cleaning using

low water pressure (60-80 psi) and D/2 Architectural Antimicrobial. Vegetation on the roof should be removed at that time. A mason should inspect the joints and repoint as necessary. If access can be gained to the interior it would be wise to inspect the walls to determine if re-caulking is necessary.

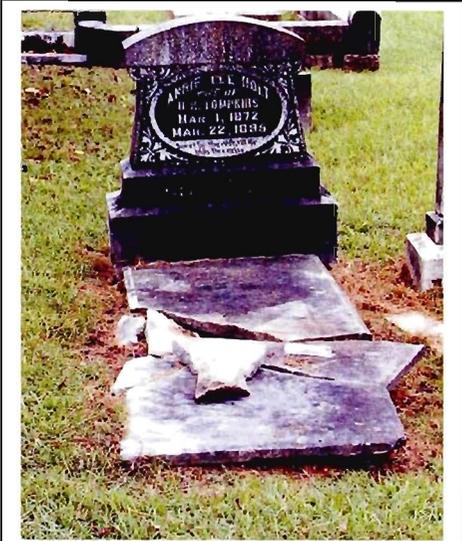
The 1895 Annie Lee Holt grave consists of a marble die on base and a marble ledger. While such ledgers usually cover an earthen grave, in this case the casket was laid into a brick vault. The vault was bricked over and the ledger laid on these bricks – there was no earthen backfill of the grave. Through time, either by accident or through vandalism, the Holt ledger has been broken and the brick vault penetrated. We found fragments of the vault displaced and a large hole extending into the burial chamber. Initially we identified this only as a safety hazard, but after closer examination we identified human bone, coffin remains, and coffin hardware in the vault.

Broken ledger over the Holt grave or brick vault.

The collapsed brick debris should be removed. Afterwards the human remains and coffin items returned to the grave, the vault reroofed by a mason, and a new ledger placed on the grave (since the ledger does not have any engraving, it will be more cost effective to replace, rather than repair, the

ledger). We have enclosed a proposal for this work as a separate document.

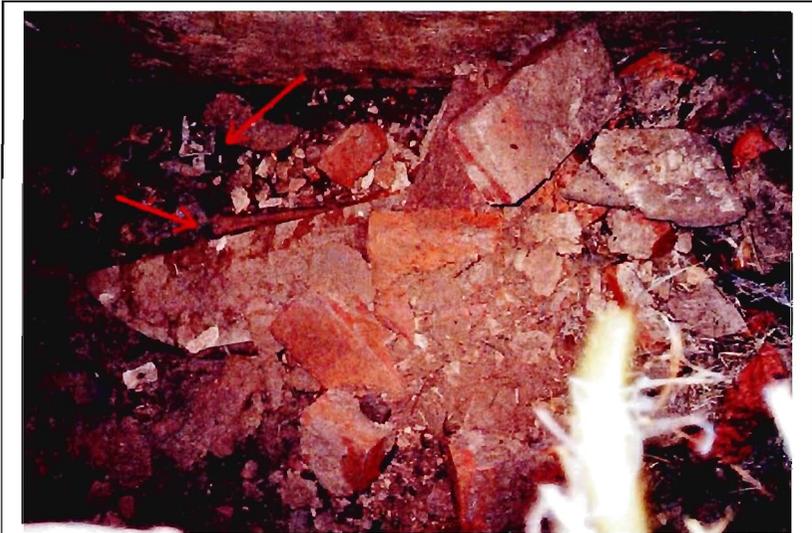
Interior of the Holt vault or grave. Arrows point out locations of human bone and a coffin handle. Note also brick from collapsed vault roof.

We recommend that this be immediately subjected to an archaeological study for the purpose of recovering the human remains and associated coffin fragments. This will provide a unique opportunity to

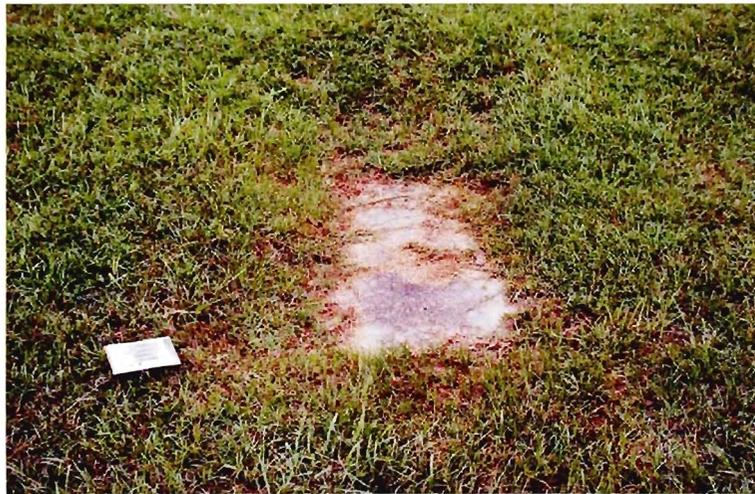
There are a number of graves across the cemetery that have sunk. As the coffin and the remains decompose, the overlying soil compacts and sinks, leaving a depression. These depressions, while characteristic of historic cemeteries, may present hazards to the public. In many cases the sinking also endangers the marker, causing it to either crack (if it is a ledger) or to tilt and fall (if a three-dimensional monument). As long as the grave is marked, the depression can be filled and the grave leveled.

Sunken grave covered with a ledger. Repair here will include carefully removing the ledger, filling the grave, and releveling the ledger. This requires great care since the ledger is likely fragile from constant exposure to ground moisture.

Graves should be filled with good soil and reseeded to encourage grass growth.

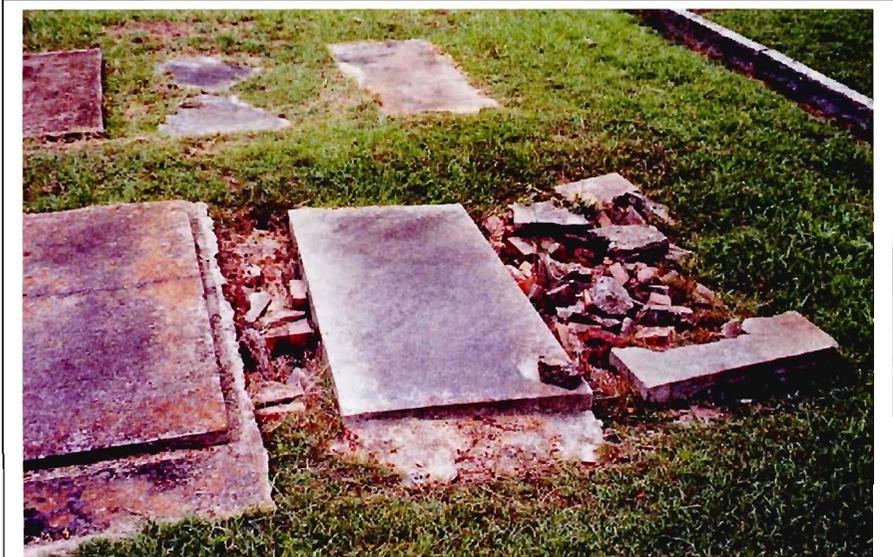
Example of a concrete ledger that should be recast on-site using modern cement. In background are two marble ledgers – one broken and one sinking.

A final issue worthy of brief mention are the concrete ledgers at the site. A few of these are in very poor condition with the concrete fragmented and displaced. Often these have debris stacked up and are visually distracting. These can be repaired by the use of form boards to create a ledger the same size as that being replaced and pouring new concrete. Generally air entrained concrete should be used and the ledger finished to resemble the one it replaces. Care should be taken to prevent damage to nearby stones by concrete splattering or workers. In virtually every case it will be necessary to have the concrete wheel barrowed to the grave site – it is not safe to bring the truck into the cemetery.
