Monumental Issues

Chicora Conducts Assessment of South View Cemetery in Atlanta

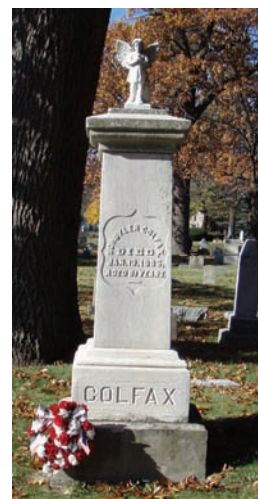
When part of a monument is damaged or lost, sometimes there is an urge to make a replacement — and too often we get results like shown here. The replacement angel is entirely too small, making the monument appear off balance.

In such cases it is better not to make replacements. Remember that the Secretary of the Inte-

rior's Standards for Preservation (http://www.nps.gov/history/hps/tps/standguide/preserve/preserve_standards.htm) specify that original fabric is to be respected and the character of the monument will be preserved. It's better to have a damaged marker than one that is no longer historic.

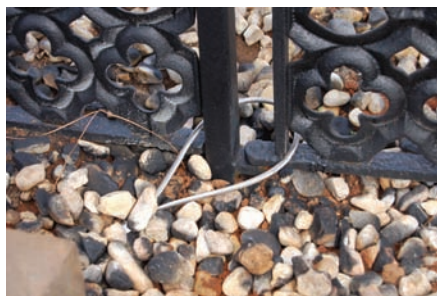
A properly secured gate will make theft more difficult, perhaps protecting your ironwork from becoming a statistic. It is also almost invisible — and it requires only \$20 per gate.

Cemeteries can protect themselves by hardening the target — making it more difficult and time consuming to steal gates. Like any thief, they want to get in and get out quickly.

We've advocated using woven stainless steel cable to attach gates to their hinge posts. The woven wire is tough and hard to cut. It'll prevent thieves from just picking up the gate — they'll have to spend 4-5 min-

utes cutting through the wire — assuming they have the correct tools. Chances are, they'll leave and go where the picking is easier.

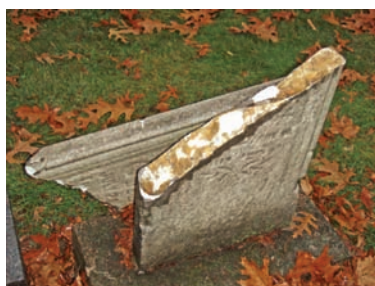
A typical “simple” epoxy repair that was doomed to failure. This inappropriate repair will make a correct repair more time consuming — and costly.

But attempting to re-attach a typical marble ground break with only epoxy isn't going to be a long-term solution. While the epoxy is very “strong,” the stone isn't, and the repair fails just above or below the original break. The monument falls, often breaking into more frag-

Another problem is that continuous epoxy joints are impermeable. This creates an area where moisture contributes to failure.

The only effective solution in most cases is a more complex blind pin repair, which requires the training of a professional stone conservator.
