Monumental Issues

Work Completed for NPS at Kings Mountain National Military Park

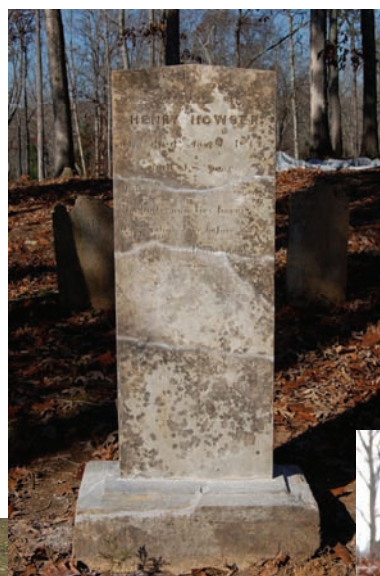
Henry Howser's stone after repair

Three of the stones were repaired using blind pinning — a technique in which the stone is carefully matched and holes are drilled for the insertion of stainless steel or fiberglass pins, set in epoxy, to mend the breaks.

the illustration here you can see how much the stone has lightened in only a matter of few days. With D/2 the stone continues to lighten for several weeks. It also helps the stone resist new biological growth for up to a year.

Once repaired areas of loss in the stone are infilled with a repair material such as Jahn that matches the physical properties of the stone being repaired.

After repair the stones were washed with Cathedral Stone's D/2 Biological Solution — designed to kill biologicals without harming the stone. In

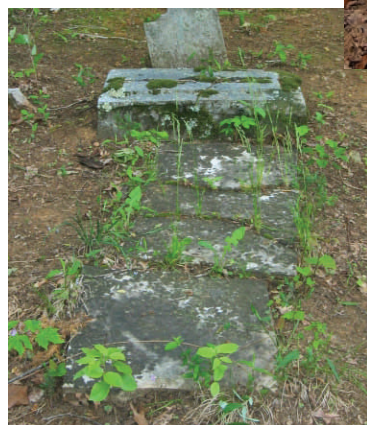
Henry Howser's 1842 stone before treatment.

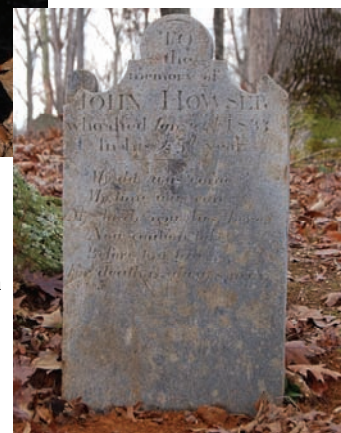
John Howser's stone after cleaning to allow easy reading of the 176 year old inscription

Chicora's conservation team was retained by the National Park Service to make repairs at the Howser Cemetery in Kings Mountain National Military Park. Four broken stones were repaired using blind pinning and other stones were cleaned to allow the inscriptions to be read more easily.

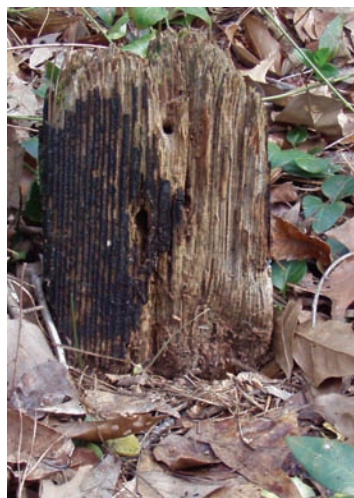
Their enemies include weathering, moisture, mold, lichen, fungus, insects, fire. Mechanical damage, and theft. Unfortunately there is often little that can be done to preserve these unique markers

Typical wood headboard from the early 20th century suffering from weathering, decay, and even fire.

Borate rods inserted in the end

grain or a lateral face that is below the ground provide some protection, especially from insects and fungi.
