CHICORA FOUNDATION, INC.

August 4, 2014

This letter provides you with an overview of our one-day on-site assessment of the Toussaint L'Ouverture Cemetery in Franklin, Tennessee. Before going on, however, let me again thank you for both the kindness shown me and the opportunity to visit your cemetery. I am attaching our invoice for the one additional hotel night necessary to allow us to visit the cemetery.

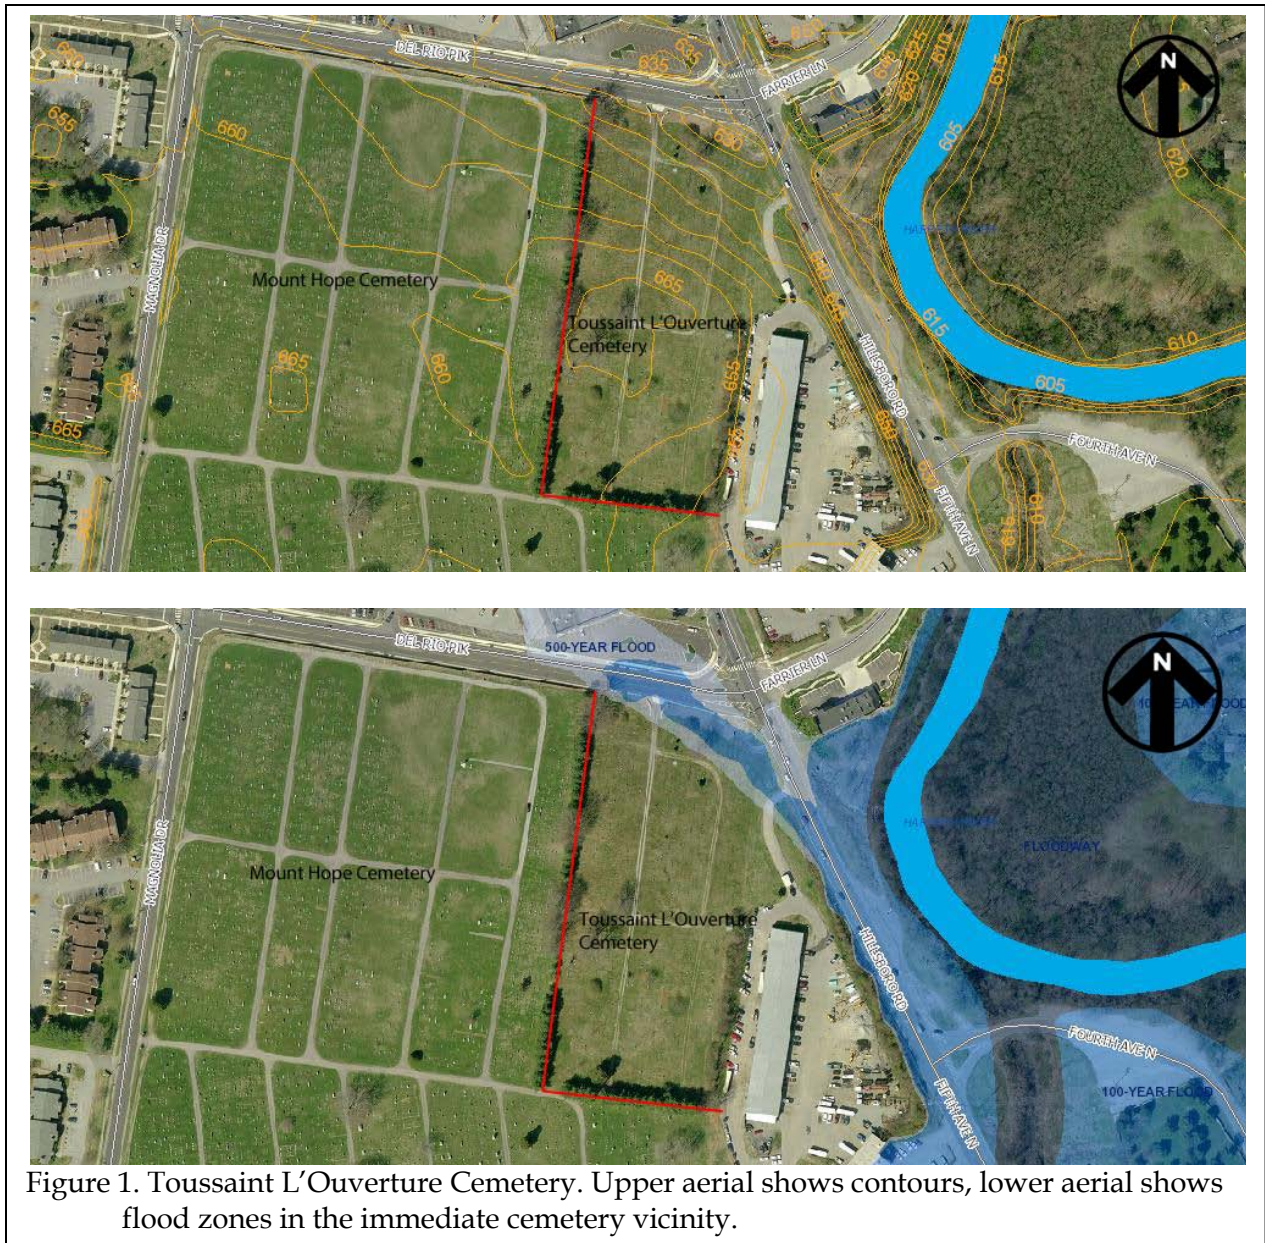
Figure 1. Toussaint L'Ouverture Cemetery. Upper aerial shows contours, lower aerial shows flood zones in the immediate cemetery vicinity.

The cemetery is situated on an east side slope with elevations ranging from 630 feet above mean sea level (AMSL) at the northeastern edge to 665 feet AMSL in the south central portion. It is bordered by Del Rio Parkway at the north. To the south and west is Mount Hope Cemetery, the boundary marked by planted white pines. To the east is Hillsboro Road and now vacant city property (Figure 1).

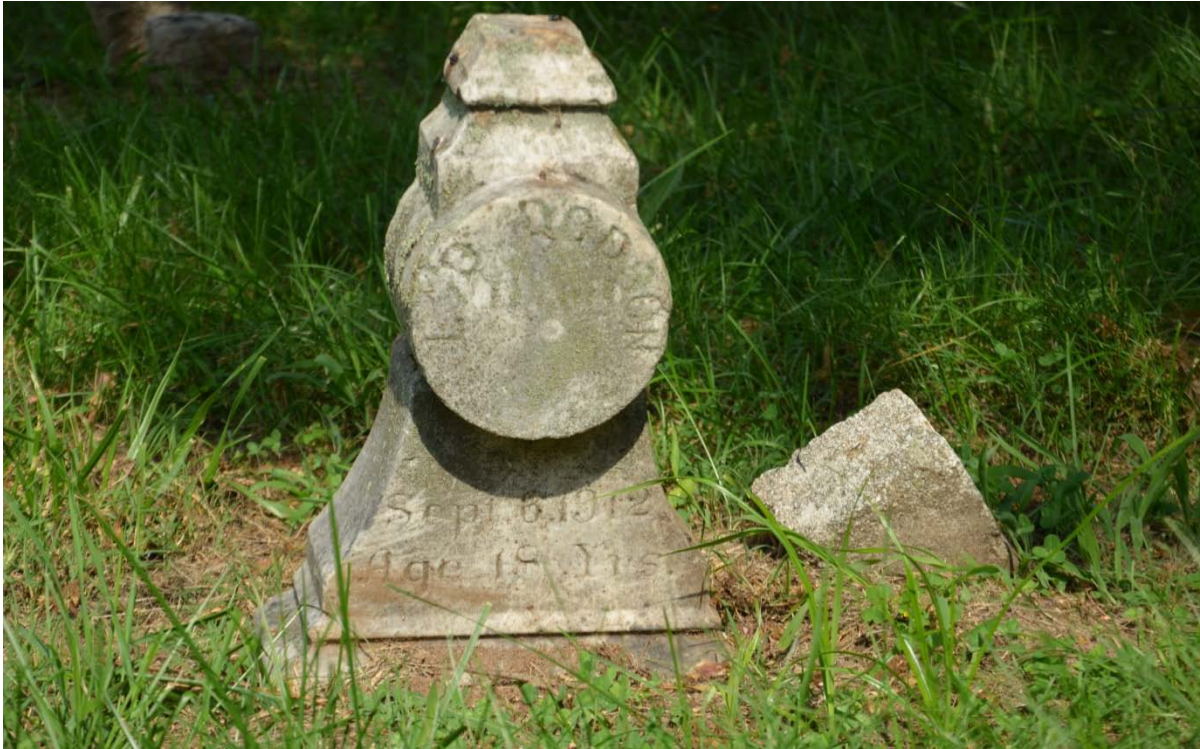
Figure 4. Unusual style marker at the Toussaint L'Ouverture Cemetery, Section D.

The cemetery also exhibits some unusual marker designs (see Figure 4). It is likely that the variety is greater than indicated by this assessment since we only closely examined Section D.

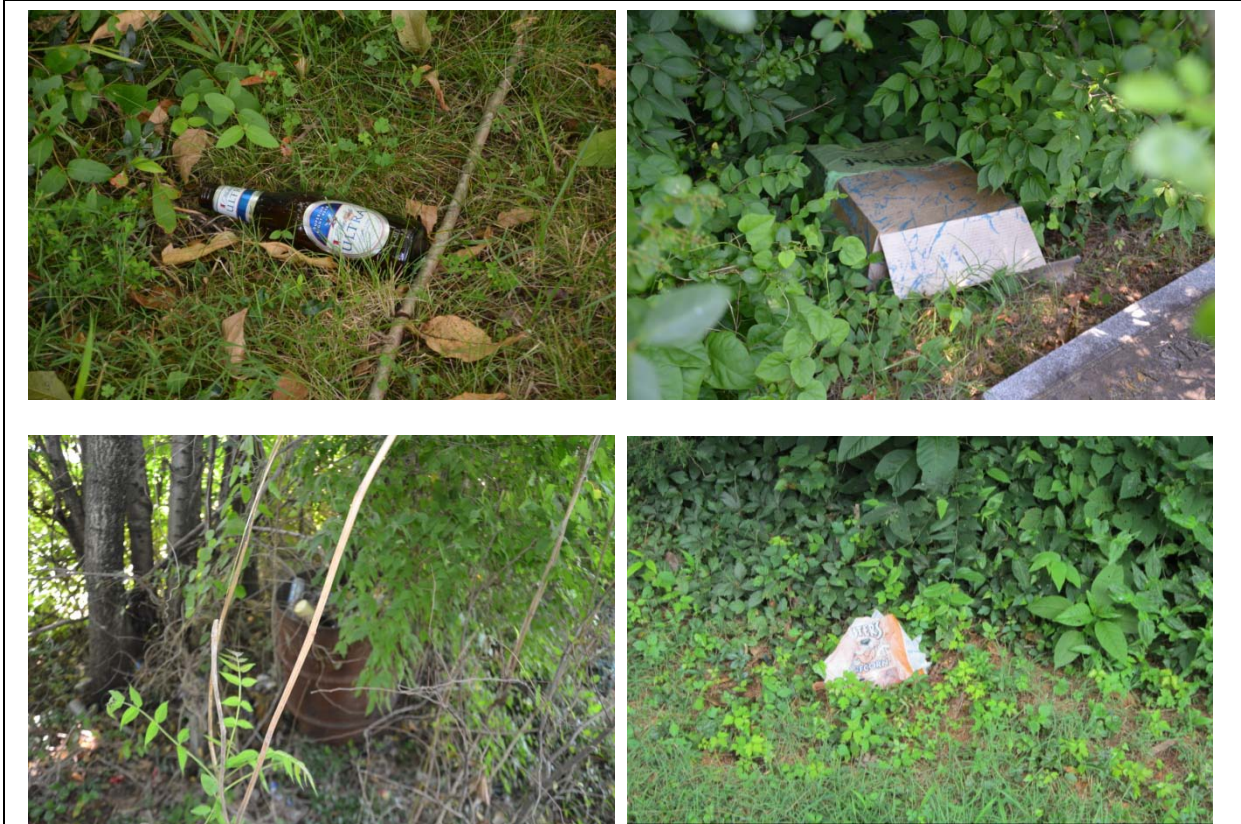
Figure 7. Examples of trash in the cemetery.

While we saw no vandalism that could be directly attributed to the porous boundaries (distinct from damage resulting from lawn maintenance), we did see abundant trash, especially in the eastern woods line. In particular, there are numerous alcohol containers, as well as a 55-gallon drum filled with trash. This should be of concern at several levels. First and most fundamentally, it is inappropriate behavior in a cemetery. Second, it creates a situation where those with legitimate business may become fearful to visit the cemetery. And third, the presence of inebriated individuals is eventually likely to lead to vandalism, whether present currently or not.

At this juncture, the best proactive methods to minimize problems will be to remove the vegetation and debris along the eastern property line, including the abandoned metal building, and ensure that all trash is removed from the cemetery on a regular basis.

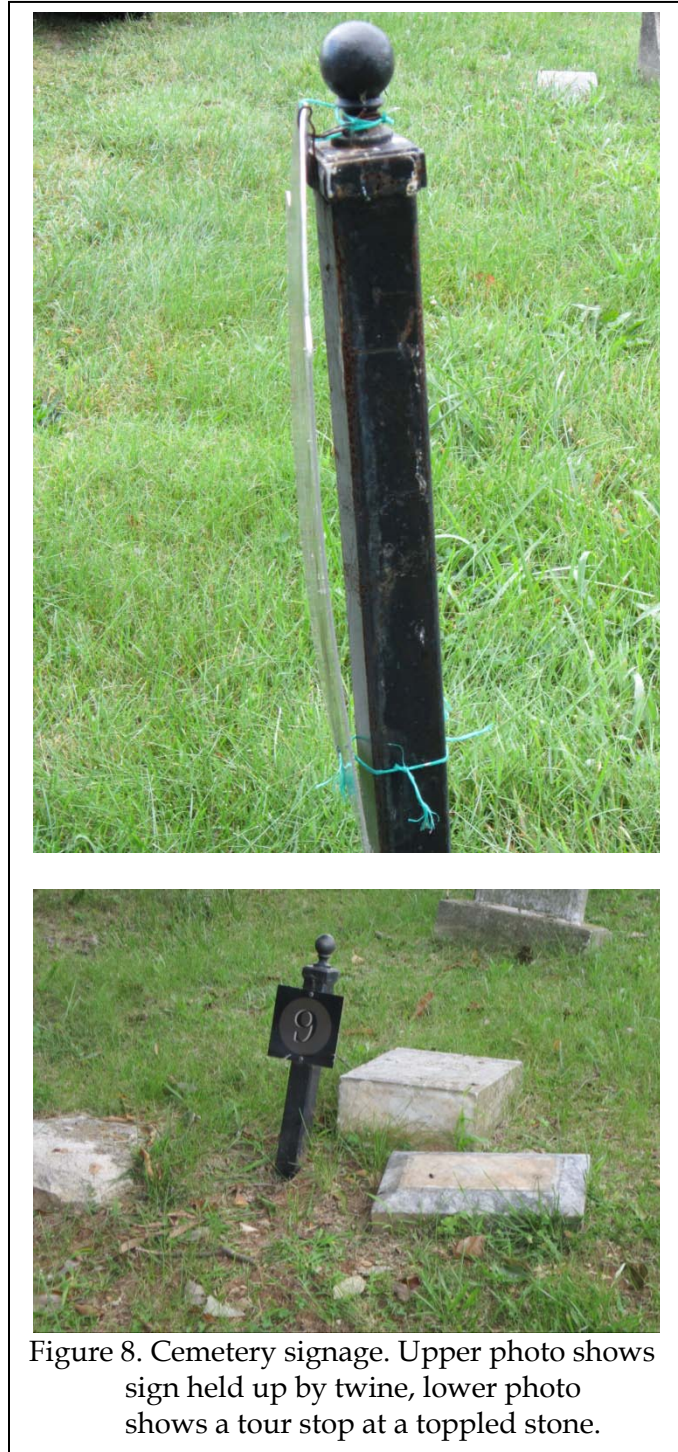
Figure 8. Cemetery signage. Upper photo shows sign held up by twine, lower photo shows a tour stop at a toppled stone.

It is critical that signage be maintained. We observed that section markers in the cemetery were leaning and one was tied onto its post using twine. This gives the public the impression that the cemetery is uncared for and encourages a lack of visitor respect.

We recommend that identification and regulatory signage be combined and erected at the entrance. This would include the name of the cemetery, when founded, and that it is listed on the National Register. The regulations listed on the sign should include, at a minimum, these rules:

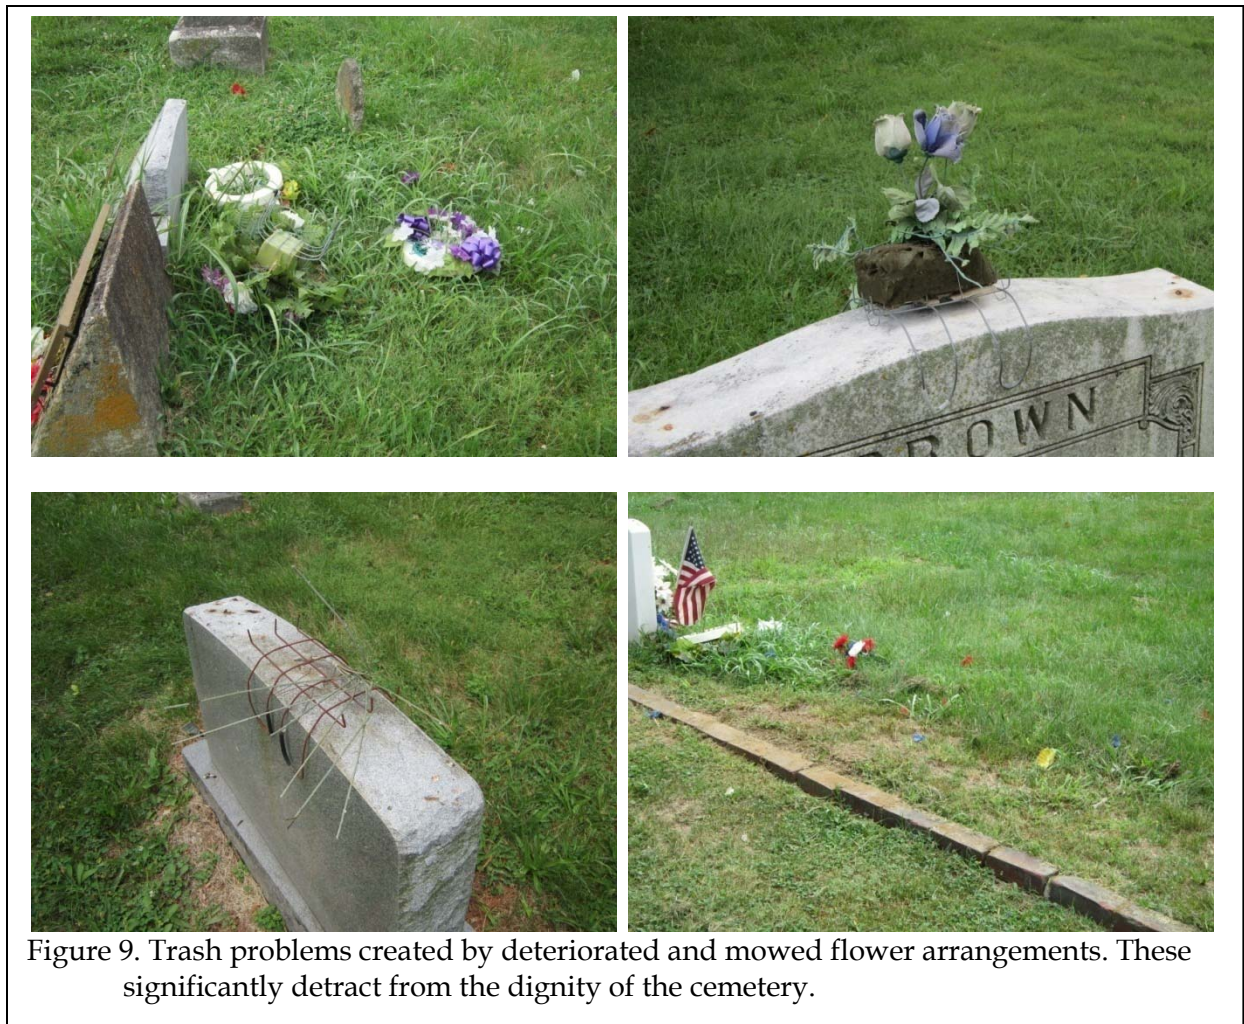
Figure 9. Trash problems created by deteriorated and mowed flower arrangements. These significantly detract from the dignity of the cemetery.

A significant problem in the cemetery is uncollected flower arrangements. It is sad that families are not proactive in the removal of deteriorated flowers – but they are not. We observed faded, damaged, and badly deteriorated arrangements across the cemetery. We also observed that many arrangements had been thrown in the woods at the east side of the cemetery. Other arrangements had simply been mowed. All of these practices give the cemetery an uncared for appearance.

It is essential that all deteriorated flower arrangements be collected on a monthly basis for proper disposal. It is equally essential that no arrangements be mowed as this simply scatters the flowers.

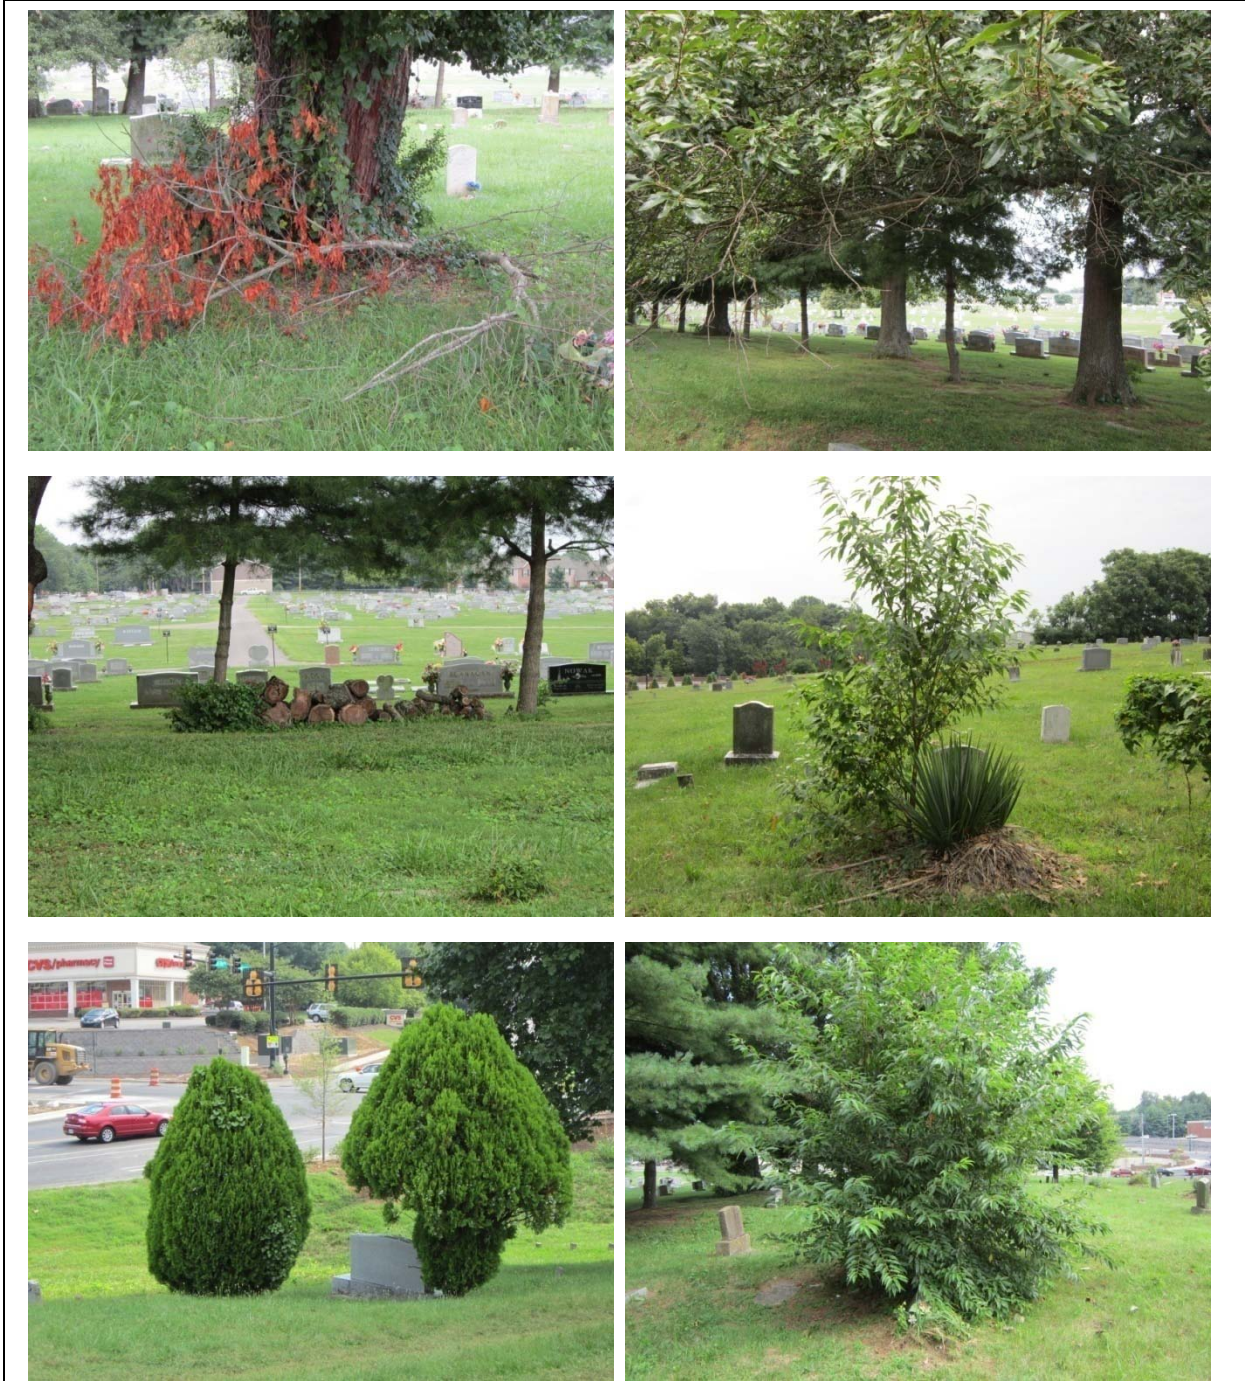
In addition to removing dead branches from the ground, it is critical that all debris either be removed immediately or chipped for mulch. We observed piled wood at the edge of the cemetery. Its condition suggests that this wood has been present for many months. This must be removed.

Figure 10. Tree and shrub problems. The upper left photo shows dead branches at the base of a tree. Upper right photo shows dead wood in a tree that requires pruning. Middle left photo shows stacked wood in the cemetery. Middle right photo shows scrub tree growing in the middle of a yucca. Lower left photo shows inappropriately pruned arborvitae. The lower right photo shows a trash tree that should be removed.

All trees require inspection and pruning by a member of the International Society of Arboriculture (ISA) on a yearly basis. All pruning must comply with the American National Standards Institute (ANSI) A-300 Pruning Standard. This is more than simply ensuring correct cuts are made close to the branch collar, that no stubs are left, and that the pruning does not injure the collar. It also requires that the condition of the entire tree be evaluated. In some cases only damaged braches or dead wood will be removed, while in other cases it is appropriate to remove live branches in order to promote the overall health of the tree. This is why it is critical to have trees evaluated by a certified arborist.

Much of the wood being removed can be chipped and used as mulch under trees in the cemetery. This will promote the health of the trees and reduce the area to be mowed. Mulch should never be applied more than 3-inches in depth.

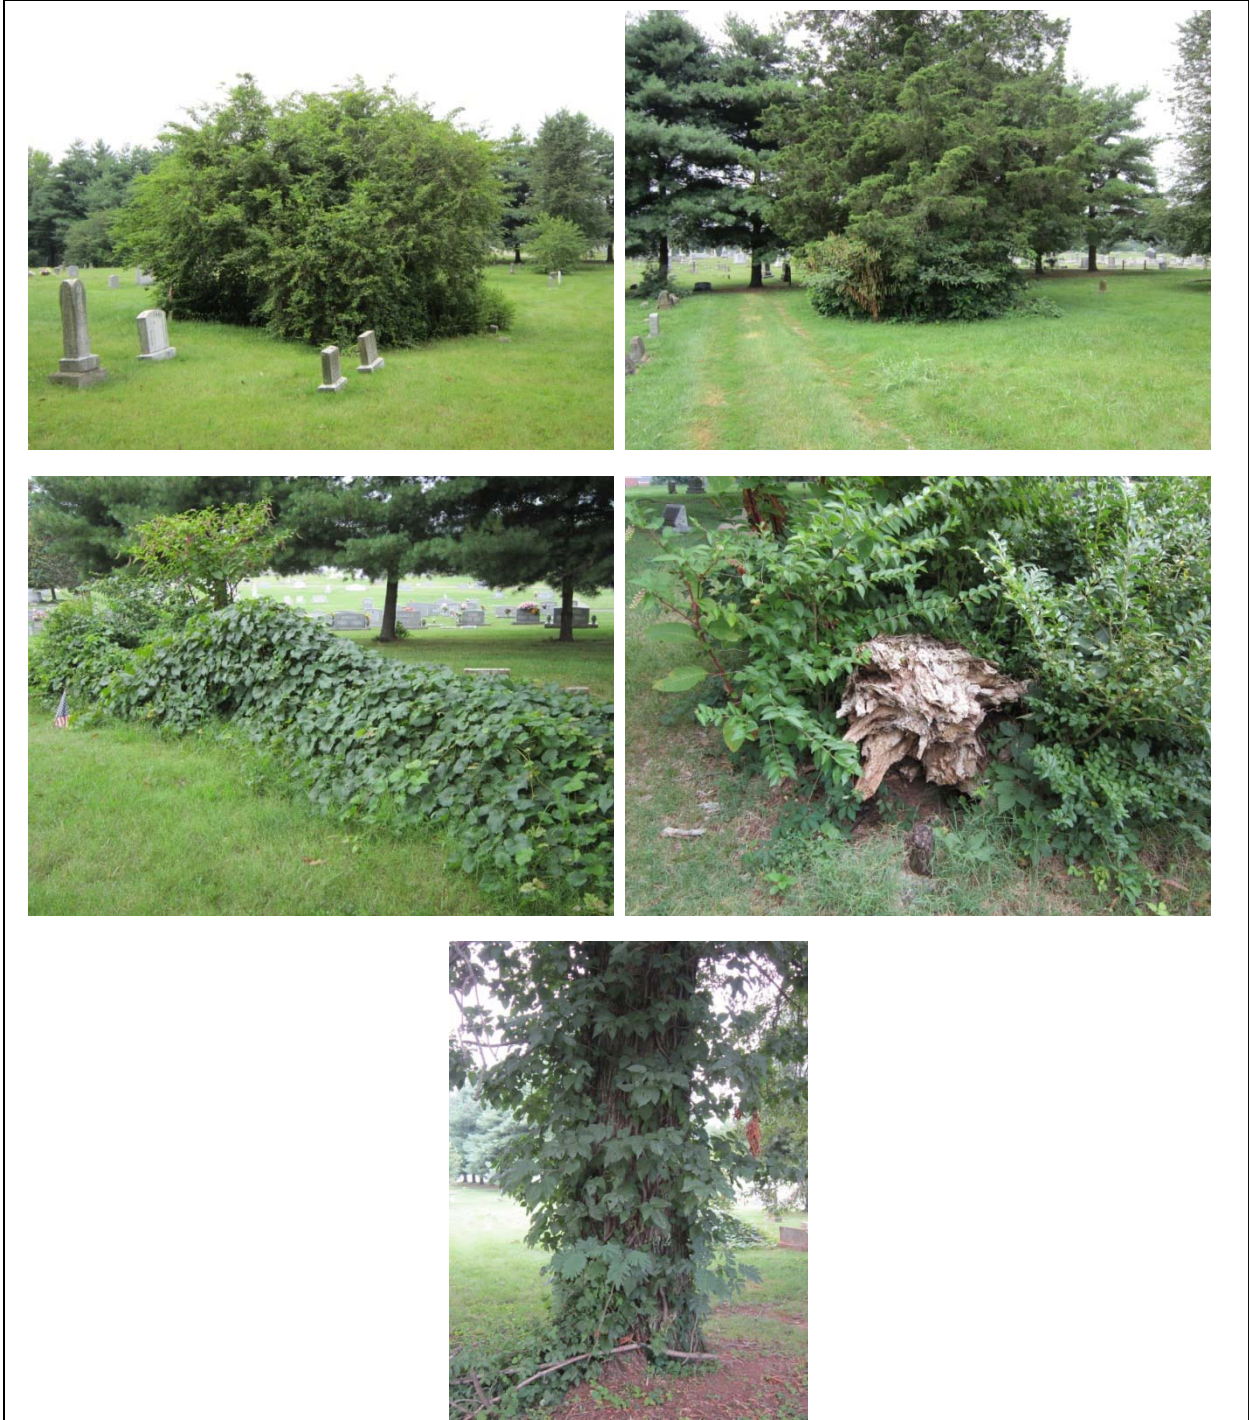
We observed several lots in the cemetery that, for unknown reasons, have been essentially abandoned and allowed to grow up into tangles of vegetation. These lots should be immediately cleaned out, removing the trash vegetation. As recommended above, stumps should be painted with a full-strength herbicide to prevent them from resprouting.

Also observed was a downed tree in the cemetery that has been ignored, with the result that it has been taken over by vines. This gives the cemetery an uncared for appearance. Immediate removal is necessary.

Virtually all of the trees in the cemetery are becoming overgrown with vines. This is harmful to the tree and many of the vines are poison ivy, which presents a real threat to the visiting public as well as maintenance workers. These vines should be manually removed and the stumps treated with herbicide.

Figure 11. Vegetation problems in the cemetery. The photos in the upper row show two plots taken over by vegetation. The middle row shows a downed tree in the cemetery that has been taken over by vines. All of these debris must be removed to restore dignity to the cemetery. The lower photo shows poison ivy completely taking over a tree in the cemetery.

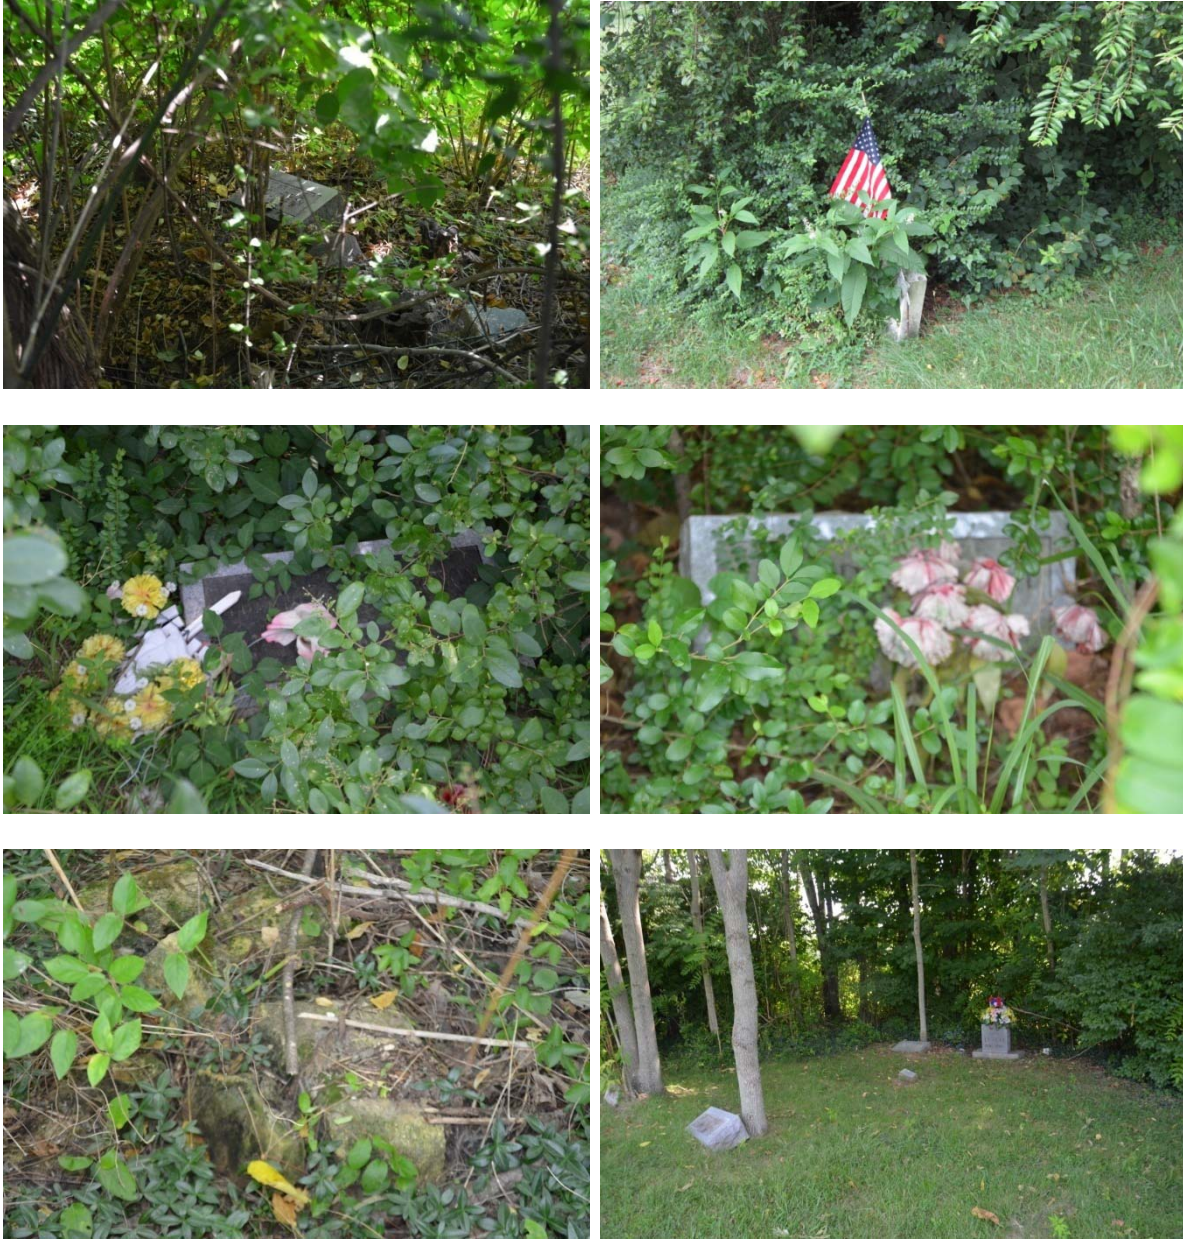
The eastern edge of the cemetery has been allowed to become overgrown and careful inspection reveals the presence of many graves totally overtaken by vegetation. While this provides some screening from the city lot, it is critical that this invading volunteer growth be

Figure 12. Vegetation problems in the cemetery. The first five photos show a variety of monuments on the east side of the cemetery that have been lost to vegetation. The final photo (bottom right) shows one area that has been “carved out” to reveal several stones and a variety of trash trees that should be removed from the cemetery.

removed to provide dignity to the burials in this area. Many of the volunteer trees in this area are under 4-inches dbh and should be removed.

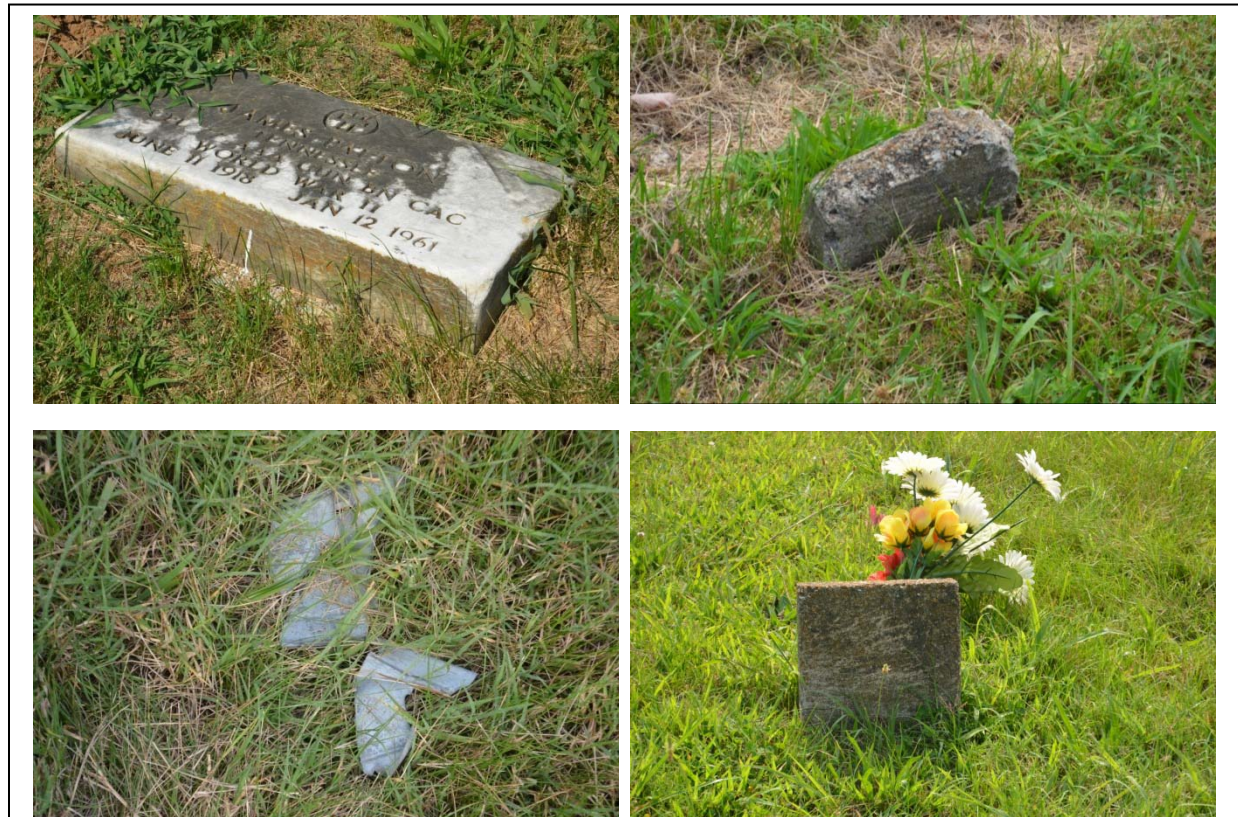
Figure 13. Examples of mower damage common at the cemetery. Upper left shows edge damage from a mower running over the monument. Upper right shows damage to the top of a footstone, also the result of being mowed over. Lower left photo shows a metal funeral home marker, shredded by mowing. The lower right photo shows damage caused by a nylon trimmer.

Finally, the tall grass is also an issue in the long-term care and maintenance of the monuments in the cemetery. We observed a very large amount of damage being done to stones by efforts to mow when the weeds obscured monuments (Figure 13).

The only viable alternative is to increase the frequency - and care - of mowing. A good introduction to proper mowing is available on-line at <https://utextension.tennessee.edu/publications/Documents/W161-I.pdf>. Consequently, we recommend that funding be sought to allow mowing the cemetery every one to two weeks. Although this will still be less than is generally recommended, it should serve to keep the weeds manageable, reducing the damage to stones, reducing the ability to hide trash, and minimizing the potential for the cemetery to hide pests.

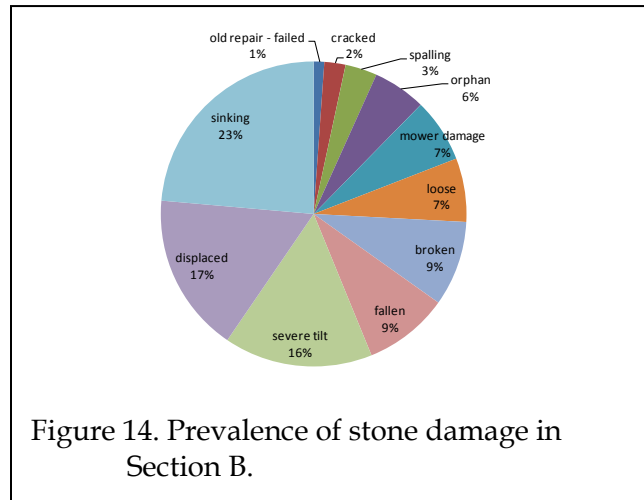
Eleven distinct problems were identified associated with the stones in Section B and a total of 89 stones were involved. The prevalence of these problems is shown in Figure 14. Fully 56% of the stone problems are identified as sinking (largely

the result of the stones being set on the grave and sinking as the grave collapses), tilting (similar to sinking, although the tilt can cause mechanical damage to the stone), or displacement (which is largely the result of being impacted by mowers). These are all problems that can be corrected by careful resetting using volunteers. Where this to be done, there would be an immediate improvement in over half of the stones present at the cemetery. Many (although not all) of the fallen monuments could also be reset, resulting in an even greater overall appearance.

Resetting monuments is fully explained at <http://www.chicora.org/resetting.html>. In general, the stone should be excavated, being careful to avoid shovel damage. There are some monuments that have been set in concrete and the removal of this material may require a conservator to ensure that the stone itself isn't damaged. Otherwise, the hole can be deepened and filled with pea gravel or decomposed granite as bedding. The lawn marker should be reset about 1 inch above the ground level – tall enough to prevent being covered by soil and grass, but not so tall that it will be damaged by mowing. Tablets should be set with about 25 to 33% of the stone below grade. Additional pea gravel should be packed in around the stone as it is being leveled. The upper inch of backfill should be soil to allow for revegetation.

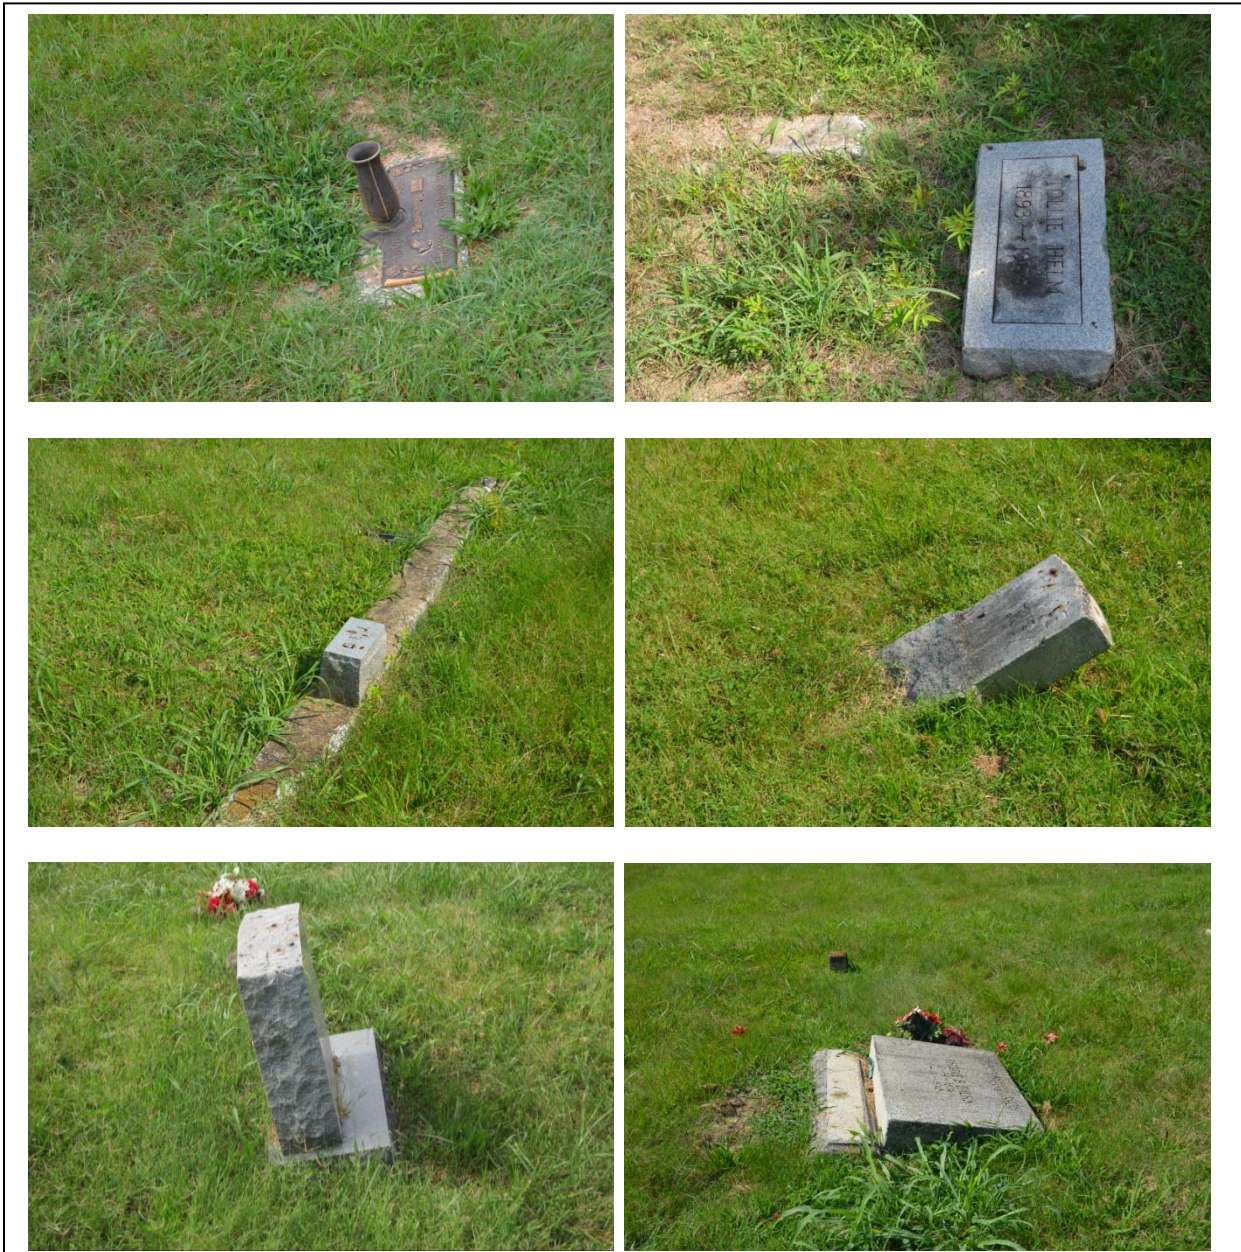
Figure 14. Examples of stone problems. Upper left is a sinking lawn marker. Upper right is a sinking cradle grave. Middle left photo shows a displaced footstone set on coping. Middle right photo shows a severely tilted headstone. Lower left photo shows a severely tilted die on base, with the die sliding and about to topple off the base. Lower right photo shows a stone that has fallen off its base.

In order to reset a die on base that is loose or shifted, it is first necessary to remove the die and set it aside. The base then must be checked to determine if it is both stable and level. In many cases it will be necessary to remove the base, establish a new foundation with pea gravel or decomposed granite.

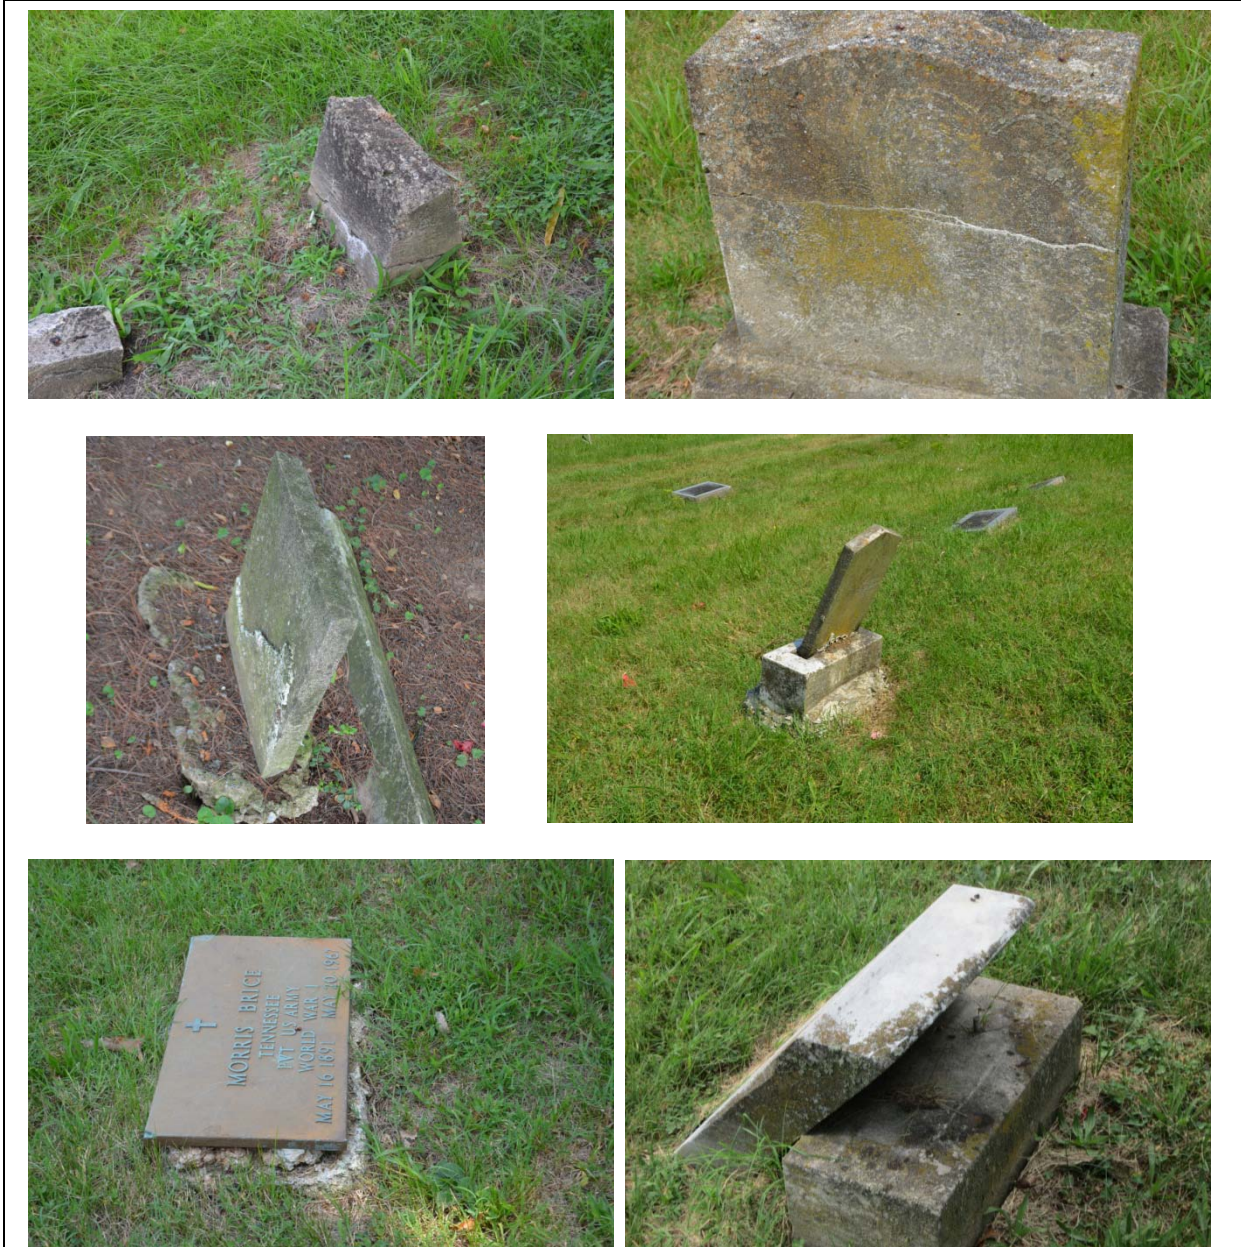
Figure 15. Examples of stone damage that requires conservation treatments. Upper left photo shows a broken die on base. Upper right is a cracked die on base. Middle left is a spalling limestone. To further complicate its preservation, the stone has been set in Portland cement, which must be carefully removed. Middle right is a tab in socket that is loose and requires resetting with a high lime mortar. Lower left is a bronze marker that has become detached from its base. Lower right is a die on base with ferrous pins. Repair of this stone will require drilling out the ferrous pins and replacing them with non-corrosive stainless steel or fiberglass.

If pins are to be installed holes must be drilled and cleaned in both the die and base. Either fiberglass or stainless steel pins should be inserted that are slightly shorter and smaller than the holes. While they may be set using epoxy or lime mortar, it is often acceptable to leave them loose. The purpose of these pins is to help secure the base and die, making it more difficult to accidentally (or intentionally) tip a monument over.
