June 2010

# Monumental Issues

## Chicora Treats Biloxi National Cemetery Monument

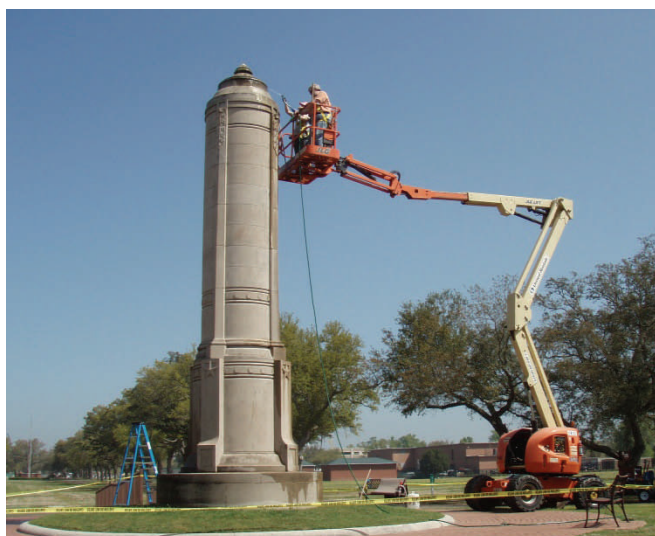
**Beginning at the bottom and working up, the Chicora team completely cleaned the monument using D/2.**

The work was undertaken by Chicora conservators in April. Because of the height of the monument an aerial lift was required. The monument was thoroughly cleaned using D/2 Biological Solution from Cathedral Stone and potable water. Afterwards, mortar joints were cleaned and repointed using NHL mortar from Virginia Lime Works. In several areas the limestone monument was patched using Jahn M-70 Mortar.

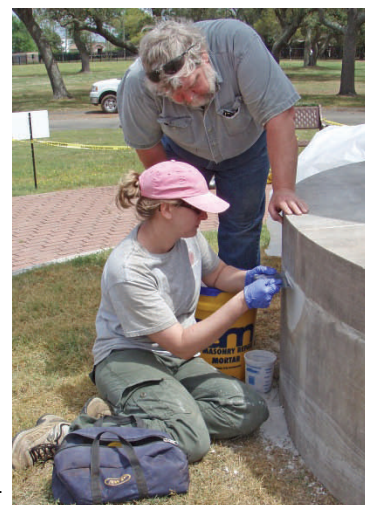
**Shaping the Jahn patch.**

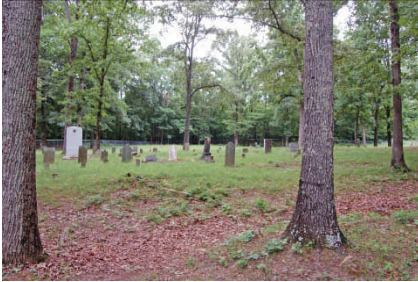
**Old Shiloh Cemetery**

The history – and even ownership – of the Old Shiloh Cemetery is uncertain, although stones reveal burials to at least the first decades of the 19<sup>th</sup> century. It is located in Grover, NC but extends across the border into SC.

We found significant damage to a broad range of the stones in the cemetery. Many of these stones also exhibited inappro-

priate repairs that had been made over the past 30 years in an effort to maintain the burial grounds. A number of stones were found out of the ground – these “orphan stones” should be reset to prevent their loss or damage by mowing.

Usually we don’t recommend herbicides because of the damage they can do to stones. In this situation, however, we decided the judicious application of the herbicide Garlon 4 (triclopyr) – followed by mulching – was the only cost and labor effective means of controlling the poison ivy problem. In addition, we recommend the removal of some diseased or weakened trees.

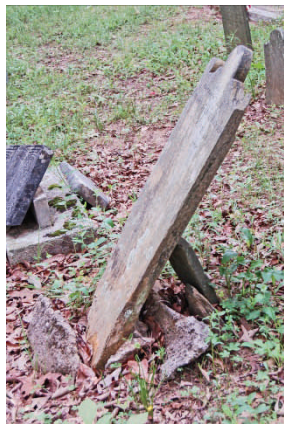
**The cemetery’s stones are beautiful, but many are broken and some – like this example – are certain to suffer additional damage if not properly repaired.**

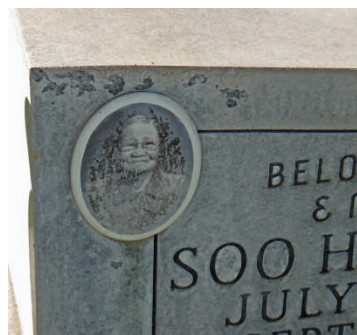
**Dissolved minerals are coating this stone, obscuring the porcelain photograph.**

This is a particularly serious issue in the southwest where often water is pulled from relatively shallow wells where the water is loaded with dissolved minerals.

The minerals are deposited on

– and in – stones as a result of irrigation. The results range from disfiguring monuments to the actual spalling of stone – even granite.

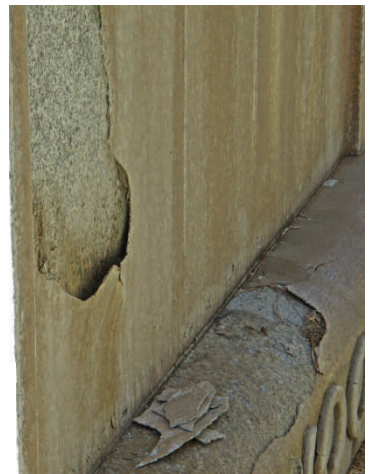
**Here the deposits are causing spalling of a granite monument.**

Solutions include curtailing irrigation, using flood irrigation, seeking new sources, or eliminating irrigation entirely.
