# Dr. Samuel Marshall Orr House

## Anderson, Anderson County

### South Carolina Historic Preservation Grants

DR. SAMUEL MARSHALL ORR HOUSE

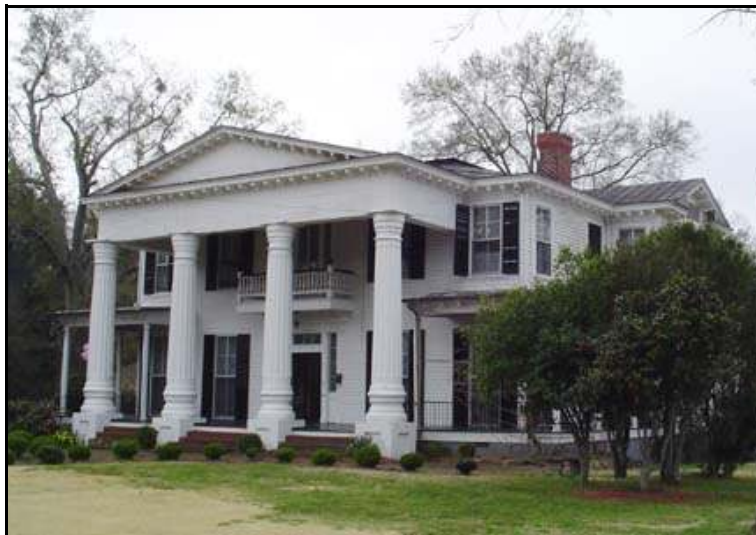
Photo 11: Front porch columns. The fluted columns supporting the porch entablature.

Photo 12: Columns and base typically have been painted over in masonry substrate.

**Columns**  
Four massive masonry columns with entablature support a broad entablature and tympanum at the gabled front porch. Stylically, these columns are unique. Located based on the Roman Doric order, the 10'-0" diameter circular columns are fluted and have tapered shafts and a simply tapered and entablature. The base is concavely ogee seated in proportion, with an exaggerated scotia molding between the shaft and molding. The capital resembles that from the molding in concave rings, and terminates in a finely proportioned abacus. The column sits on a subcapitalized shaft with recessed panels on the outside face.

**Paintwork**  
These massive columns and their bases are constructed of either cast in place concrete or masonry with a thick stucco coating. With the exception of the paint, which is cracked and peeling in places, the columns appear to be in good condition. No obvious displacement, settlement or significant cracking is noted.
