February 2008

Monumental Issues

Good Care of Ironwork

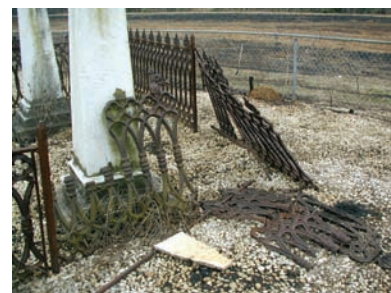
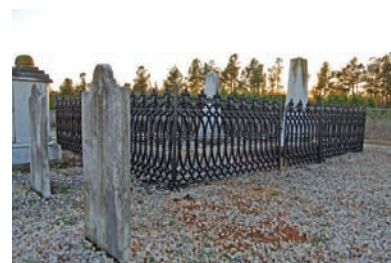
Before and after photographs of a fence treated by Chicora's conservators at Richardson Cemetery in Clarendon County, SC.

Timely treatments means that corrosion won't destroy connections and weaken the fence. So simple wire brushing will be adequate to remove loose rust.

Then one or two coats of the Rust-Oleum product Rust Reformer will convert the corrosion to a stable base that can receive a top coat paint.

Two thin coats are always better than one thick coat and will keep the fence looking good for years.

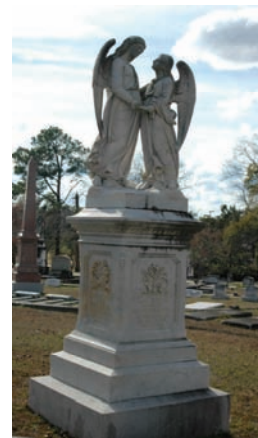
The result of our work is a 150 page assessment that evaluates the care and recommends changes, providing a detailed budget for the proposed work.

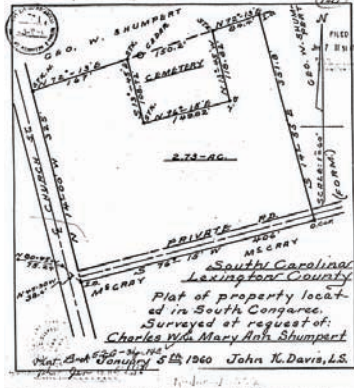
Plat showing the “lost” cemetery at the Lighthouse Baptist Church in South Congaree.

work also attracted the attention of an adjacent neighbor, who was interested in what we were doing. She quickly produced an old plat of the property — showing a cemetery!

The “rumors” were true — the church had purchased a 0.4 acre cemetery years ago as part of their church lot. Mystery solved — showing how often historic research can be as productive as field investigations!

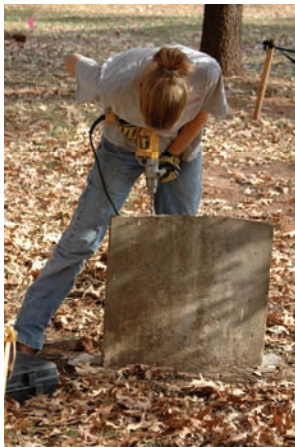
Conservator Nicole Southerland drilling one of the cemetery’s broken stones for insertion of threaded stainless steel rods.

The stone repair was relatively

straight forward, repairing breaks that were either caused by vandalism or natural events. One stone received a poultice to remove paint on its stucco.

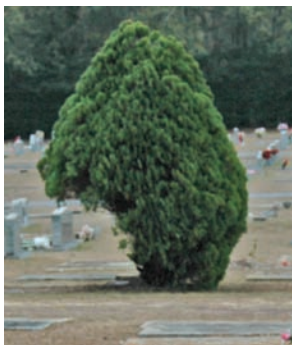
A graceful and beautiful arborvitae butchered by inappropriate pruning.

Beautiful arborvitae are not intended to be “carved out” like this example. Nor are they intended to have their crowns lifted. Any bad pruning isn’t recoverable — they don’t regrow!

Too often the crews responsible for the cemetery landscape aren’t trained in pruning — and the results can be disastrous as

seen in this illustration.
